HISTORIC STRUCTURE REPORT

Halsey House

City of Los Altos | December 2019

Architectural
Resources Group

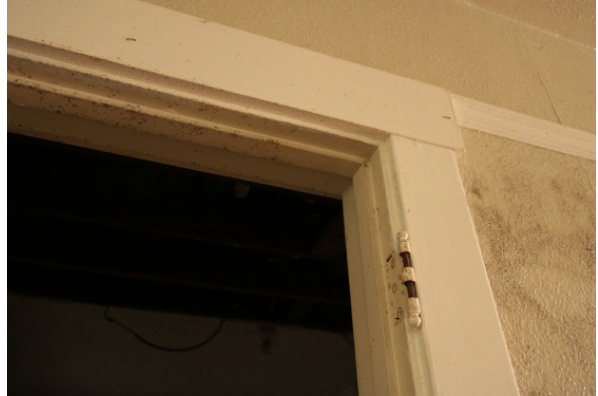
Mold along the wall and door trim at the north wall of the West Kitchen (ARG, 2019).

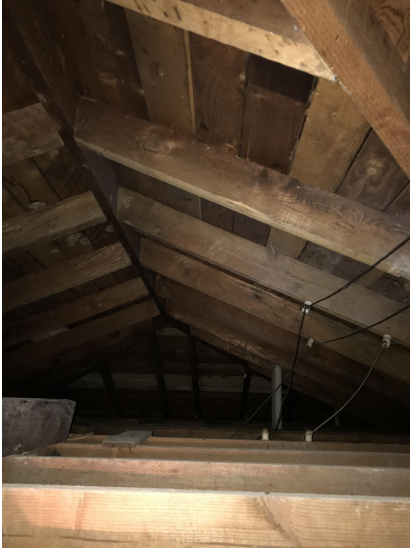
The roof framing was observed in the east wing and west wing of the building. The roof framing at the east wing of the building consisted of 1x straight roof sheathing over 2" x 5 1/2" roof rafters spaced at 18" on center with a 2" ridge board at the mid-span and supported by the perimeter wood framed bearing walls at the side walls. See Photo #11 and Photo #12. The roof framing at the west wing of the building consists 1x straight rood sheathing over 2" x 5 1/2" roof rafters spaced at 16" on center with a 1" ridge board at the mid-span and supported by the perimeter wood framed bearing walls at the side walls. See Photo #13 and Photo #14.

Photo #11: Roof Framing and Ridge Board at West Wing of the Building

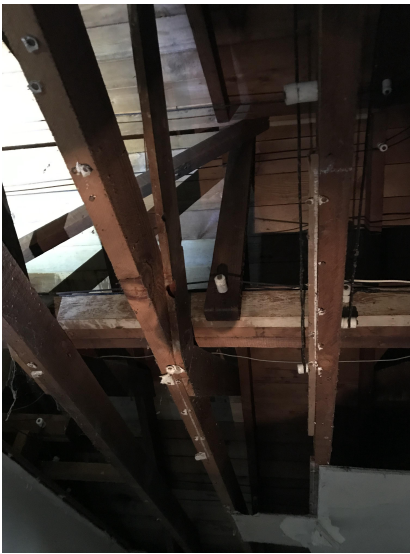
Photo #13: Roof Framing and Ridge Board at East Wing of the Building

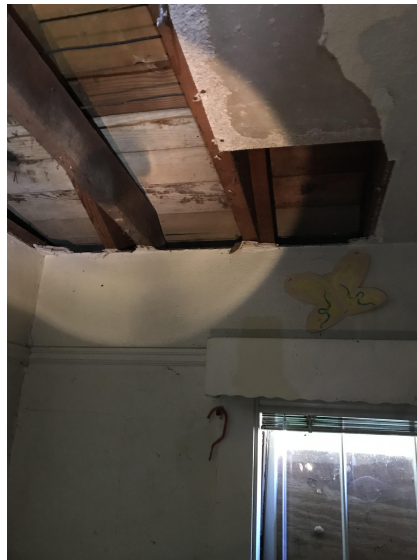
Photo #14: Roof Framing and Ceiling Joist at East Wing of the Building
