AGENDA REPORT

TO: Historical Commission
FROM: Sean Gallegos, Staff Liaison
SUBJECT: Halsey House Update

CIP Project, CF-01004 Halsey House Renovation/Replacement

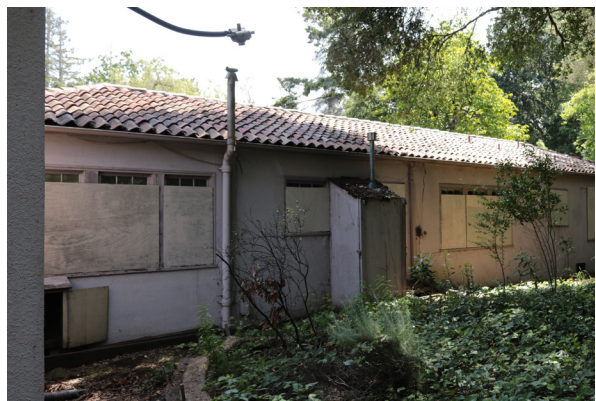
Plant growth along west elevation (ARG, 2019).

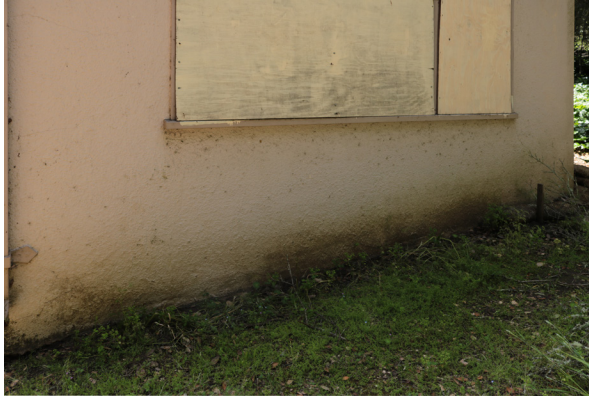
Biological growth along base of exterior wall at east elevation (ARG, 2019).

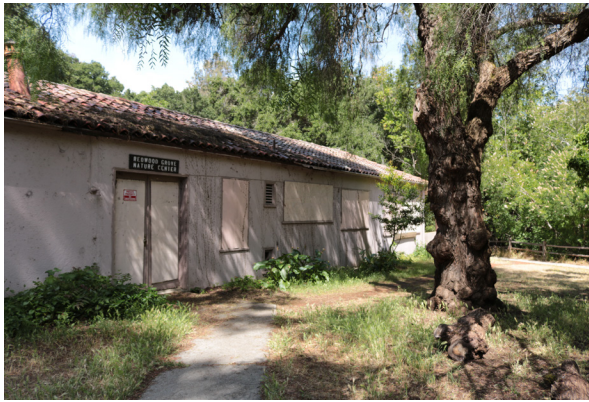
Concrete path at the east elevation (ARG, 2019).

Along the east elevation, a non-original concrete path adjoins a brick path and leads to the single exterior door on this side of the building. It is unknown when these paths were installed. While the concrete path is in overall good condition with some minor accumulation of tree duff present, the brick path is in fair to poor condition. This path is overgrown with plants, some pavers have settled creating an uneven walking surface, and there is significant soil erosion along and adjacent to the path.

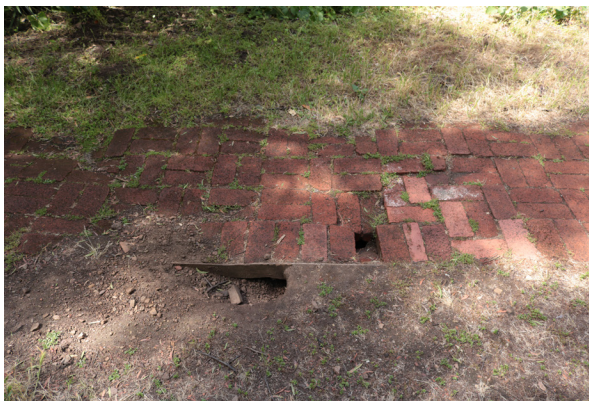
Detail view of brick path at east side of building. Note the soil erosion and uneven surface (ARG, 2019).

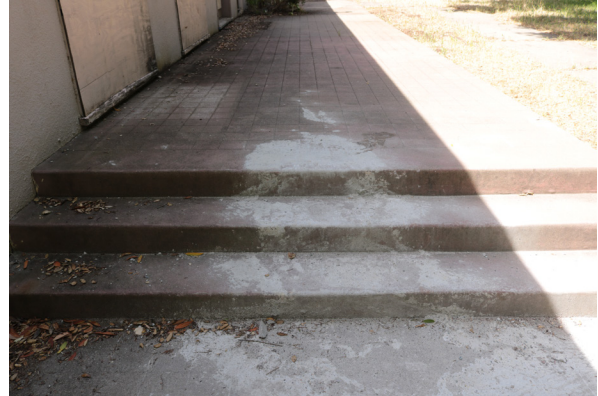
Paint stain at the north terrace stairs (ARG, 2019).

The concrete terrace at the north elevation is in overall good condition. Minor deterioration includes staining and biological growth due to an accumulation of tree duff and what appears to be a paint spill. Material deficiencies include minor spalling and limited loss of material. A section of non-original concrete pavement links the original north terrace and the original exterior concrete stairs leading to the Halsey Family Room. It is unclear when this section of

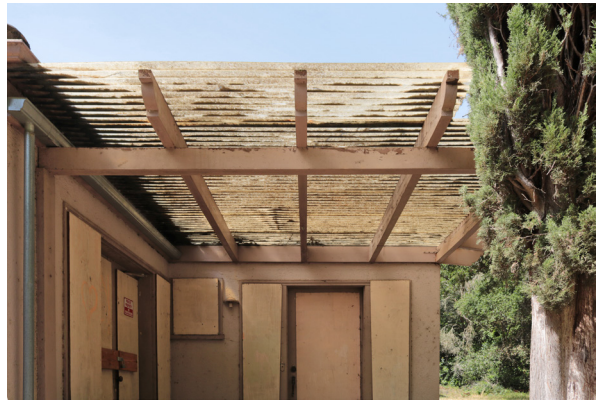
An original wood pergola exists at the north terrace main entry. The painted wood structure is in good condition with no visible signs of deterioration. A corrugated plastic sheet covers the structure and pitches south toward the building where an aluminum gutter collects rainwater and directs it to a single rain leader at the northeast corner. The corrugated plastic is covered in biological growth with a heavy accumulation of dirt.

Corrugated plastic roof at pergola (ARG, 2019).

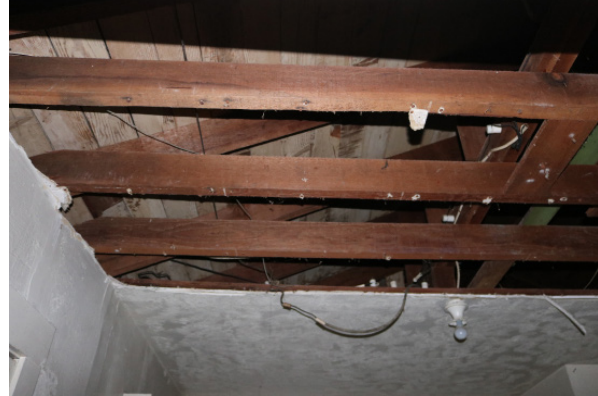
Missing drywall in the East Kitchen (ARG, 2019).

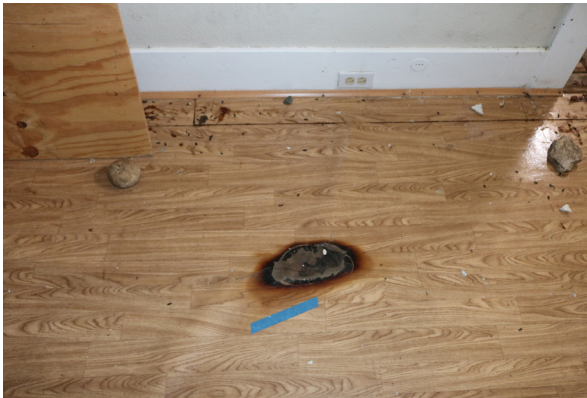
Burn damage at the floor of the Animal Room (ARG, 2019).

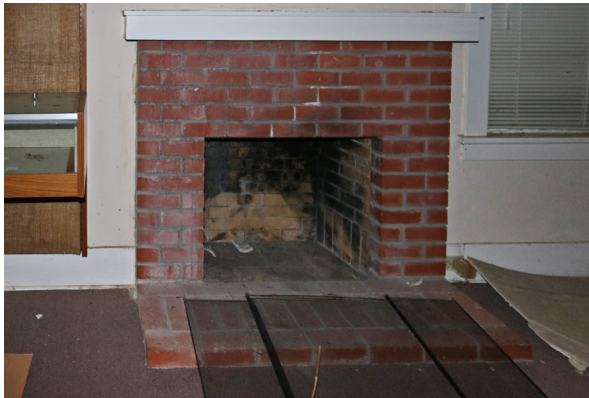
Fireplace in the Ohlone Room. Note the soot damage at the firebox (ARG, 2019).

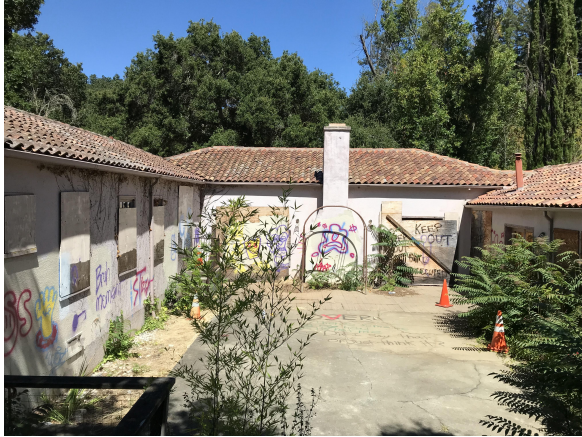
Photo #7 - South Elevation of the North Wing of the Building

There are two chimneys that extend above the roof, one is located on the south exterior wall of the north wing and the other is located on the west exterior wall of the northwest appendage of the building. The chimney at the northwest appendage is clearly an unreinforced brick (see Photo #2). The chimney located on the south exterior wall of the north wing is clad in stucco and it is unclear if the chimney is constructed with unreinforced brick (see Photo #7).

1. Strengthen the existing wood shear walls and add new wood shear walls in the longitudinal and transverse direction at the first floor to resist ASCE 41-13 design earthquake lateral forces.
2. Add sill bolts from the shear wall sill plates to the top of the concrete foundation walls to resist ASCE 41-13 design earthquake lateral forces.
3. Strengthen the roof diaphragm to resist ASCE 41-13 design earthquake lateral forces.
4. Add positive connections between the wood beams and wood posts in the crawl space.
5. Add positive connections between the wood posts and isolated concrete footings in the crawl space.
6. Provide continuous ties at the roof diaphragm chords of the building.
7. Provide positive anchorage of the unreinforced brick chimneys to the roof diaphragm and brace the top of the chimneys above the roof to the roof diaphragm.

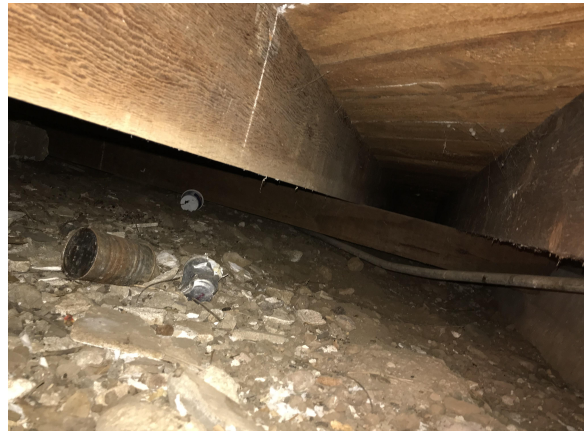
Photo #16: Isolated Concrete Footing at North and South Sections of Lodge

The floor framing was observed in a crawl space access hatch in the southwest corner of the east wing. See Photo #15. The floor framing at the east wing consists of 1x finished wood floor and 1x diagonal sheathing over 2" x 7 1/2" joists spaced at 16 inches on center that span to the perimeter foundation walls and a single line of interior wood beams. See Photo #16. The perimeter foundation consists of a continuous concrete foundation and the interior wood beams are supported on isolated concrete footings. Note that the interior beams and isolated concrete footings were not measured due to the approximately 12" crawl space height to the underside of the floor joists, but the Duquette structural drawings noted the interior beams were 4x6 and the isolated concrete footings were 1'-6" square. The building code requires 12" minimum clearance
