**Project:** Summerhill Avenue at South El Monte Ave  
**Project Identifier:** AD\_PA\_1000

**Issue:** Southeast corner of intersection floods during rain, also rocks, debris and other obstructions affect general drainage

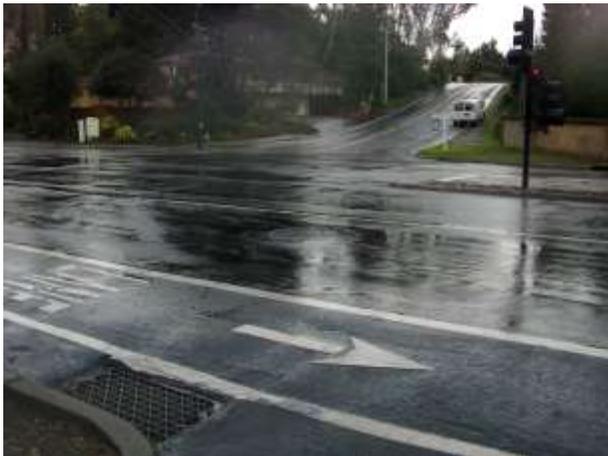
The intersection of El Monte Road and Summerhill Ave has experienced drainage problems during past storms. There is a significant amount of debris and sediment along the roadway and in the drainage system from nearby hills and development.

1. CCTV to investigate line between CB H2C-216 and H2D-217
2. Construct 2 additional CB inlets at the southeast corner of the intersection on both Summerhill Avenue and South El Monte Avenue. Improvements to consist of ~200 LF of 18" RCP and 2 CB connections

Additional inlets on the SE corner of the intersection, where the debris is greatest, will improve roadway conditions.

Regular cleaning and maintenance of the system should also be performed to assure the system functions optimally during storm events.

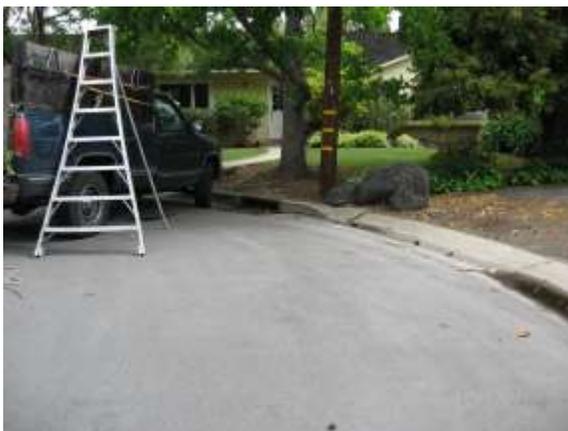
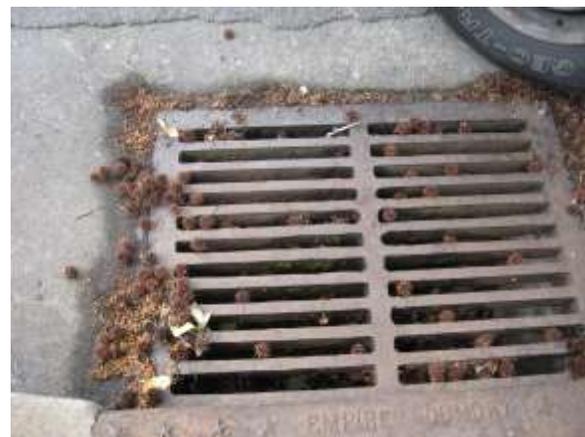
Catalina Court has poor drainage with ponding in front of 110 Catalina Court during rain events. The City has removed debris, including balls, on numerous occasions. Manhole C2D-314 has a 12 inch inlet from the south towards 110 Catalina that appears to be abandoned and no longer in use.

Catch basin C2C-315 was observed to have some debris buildup in the sump of the basin due to a protruding outlet pipe. The outlet pipe causes debris to collect and impedes flow thru the outlet.

1. Reshape catch basins on Catalina Ct
2. Install a new CB (if needed)
3. Upsize pipe on Catalina Ct to 18-inch RCP
4. Replace bubble system with 18-inch underground system on Catalina

Installing a catch basin on the south side of the street will eliminate ponding in front of 110 Catalina and the neighboring homes. Catch basin C2C-315 should also have the outlet pipe re-formed to make a smoother transition from basin to outlet pipe

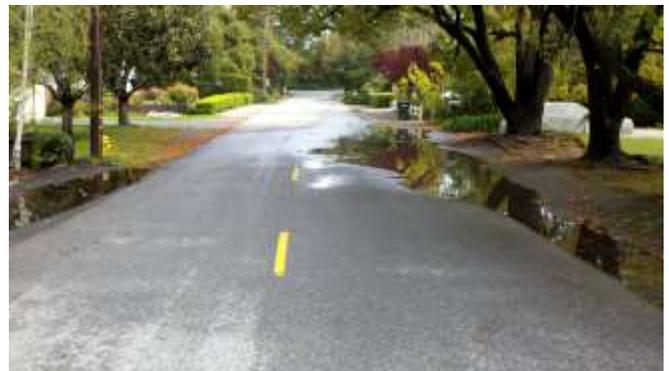
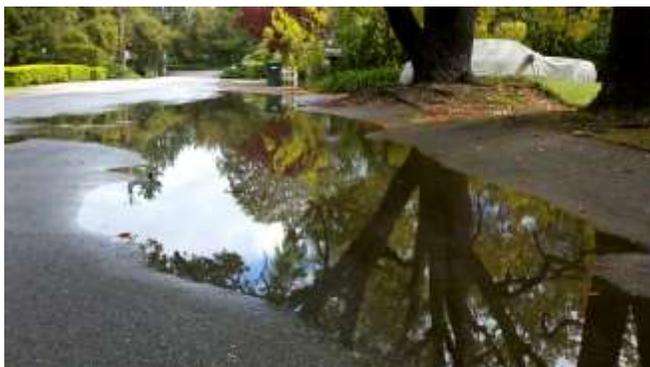
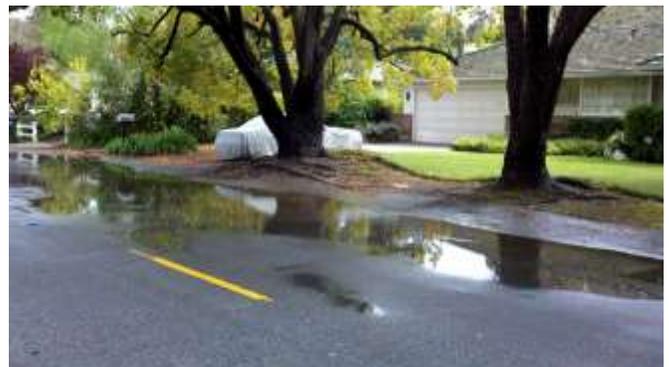
Milverton Rd, approximately 515 feet NW of S El Monte Rd, has experienced drainage problems. Drywells exist, but function poorly.

New inlets at the low point in Milverton Rd will improve roadway conditions by draining the street and carrying the runoff to the existing city SD system.

1. Add new 18" RCP line along Milverton Rd. Top of system is approximately half way between S El Monte Ave and the bend in Milverton Rd. Tie into existing system at MH G2D-608 (S El Monte Ave at University Ave).
2. Construct 3 new inlets on Milverton Rd at the low point where flooding occurs. Drywells should be removed. Improvements consist of 772 LF of 18" RCP, 2 new MH connections, and 1 MH connection to an existing line.

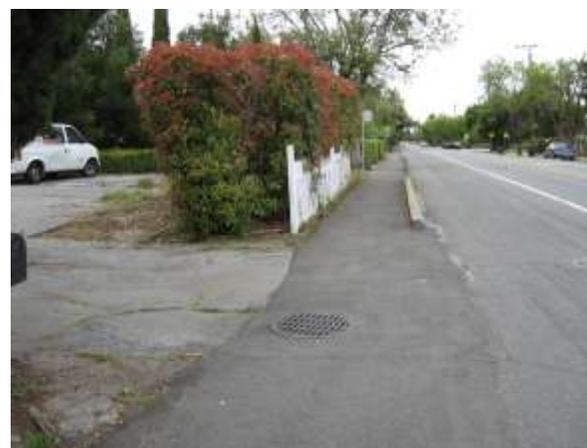
Springer Rd is connected to Fremont Avenue. Not much information is known about this problem area, but it was brought to attention by the City of Los Altos and O&M staff for pooling of water.

The proposed improvements were analyzed with the City’s hydraulic model to determine impacts. This project is determined as a moderate priority due to ponding between 6” and 12” from a 10 year storm.

1. Replace 370 ft. 18” RCP line along Marilyn Drive and tie into existing system
2. Replace 5 MH along S Springer Rd. This includes MH I4F-118, I4F-401, I4F-402, I4F-403, and I4F-404.

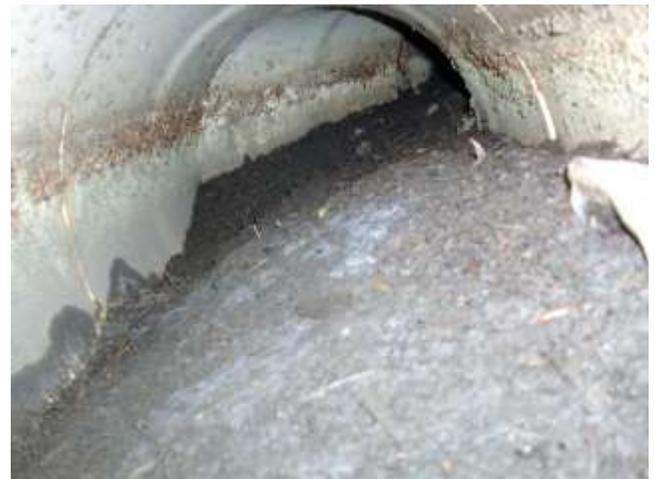
**Issue:** CBs plug during rainy season, CBs full of sediment, CBF4F-204 discharges in upstream direction of Hale Creek. CMP protruding into basins

Sunshine Drive has experienced drainage problems during past storm events. CB and outlet pipes have limited conveyance due to debris and pipes in poor condition. There also appears to be a backwater issue from the Hale Creek.

1. Reconstruct CBs F4F-21- and F4F-201 by removing corrugated metal pipe section protruding into basin.
2. Replace CMP pipes as needed.
3. Hydro jet pipes
4. Install flap gate on CB F4F-204
5. Routine maintenance during rainy season

CMP sections in poor condition should be replaced with RCP. Flap gates should be installed to prevent backflows. The system should be cleaned and maintained on a regular basis.

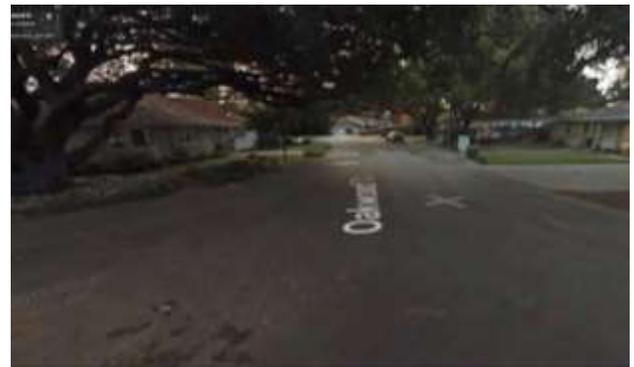
Oakwood Ct is connected to Riverside Drive and Covington Rd. Not much information is known about this problem area, but it was brought to attention by the City of Los Altos and O&M staff for pooling of water.

The proposed improvements were analyzed with the City’s hydraulic model to determine impacts. This project is determined as a moderate priority due to ponding between 6” and 12” from a 10 year storm.

1. Add 50 ft. of new 18” RCP line along Oakwood Ct. Add 433 ft. of new 18” RCP line along Riverside Drive. Add 450 ft. of new 18” RCP line along Covington Road and tie into existing system at inlet H40-221 (Covington Road between Parma Ave and Riverside Dr).
2. Construct 1 new inlet on Oakwood Ct. Improvements consist of 933 LF of 18” RCP, 4 new CB connections, 4 new MH connections, and 1 MH connection to an existing line.

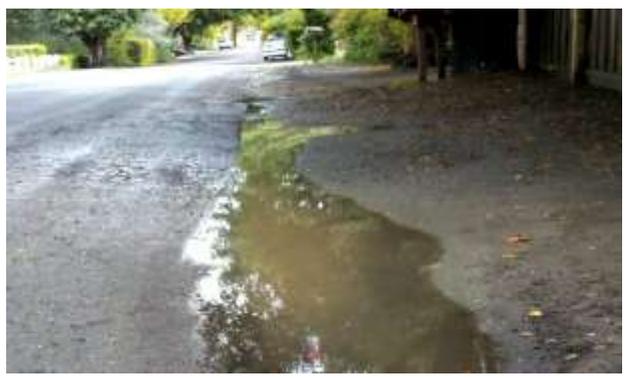
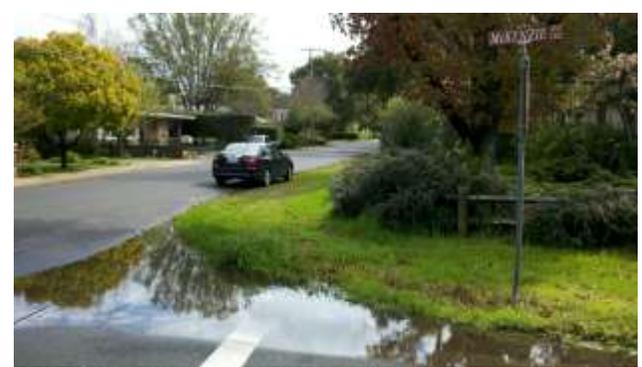
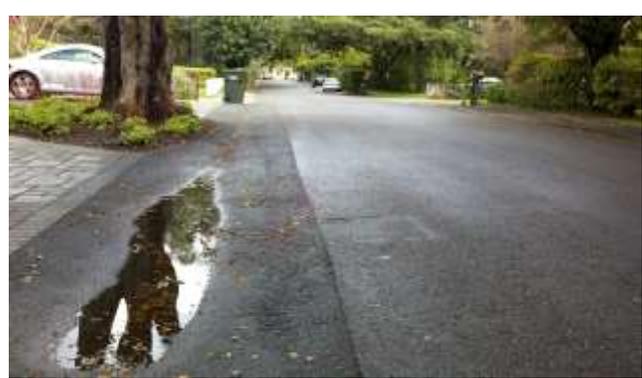
**Project Summary:**  
 Payne Drive, approximately 270 feet E of Oakhurst Ave, has experienced drainage problems. There is a low spot in the street without a formal drainage system. The corner of McKenzie and Oakhurst is also a low spot that experiences drainage problems.

New inlets at the low point on Payne Dr and at McKenzie and Oakhurst will improve drainage conditions by conveying runoff to the existing city SD system on Portland Ave.

1. Add new 18” RCP line along Payne Dr and Oakhurst Ave. Upstream inlets are approximately 3-4 lots east of Oakhurst Ave on the north leg of Payne Dr, and on the SW corner of McKenzie Ave and Oakhurst Ave. Tie into existing system at MH I5D-502 (Portland Ave at Oakhurst Ave).
2. Construct 2 new inlets on Payne Dr at the low point where flooding occurs. Construct 1 new inlet on the SW corner of McKenzie Ave and Oakhurst Ave. Improvements consist of 1,370 LF of 18” RCP, 3 new CB connections, 2 new MH connections, and 1 MH connection to an existing line.

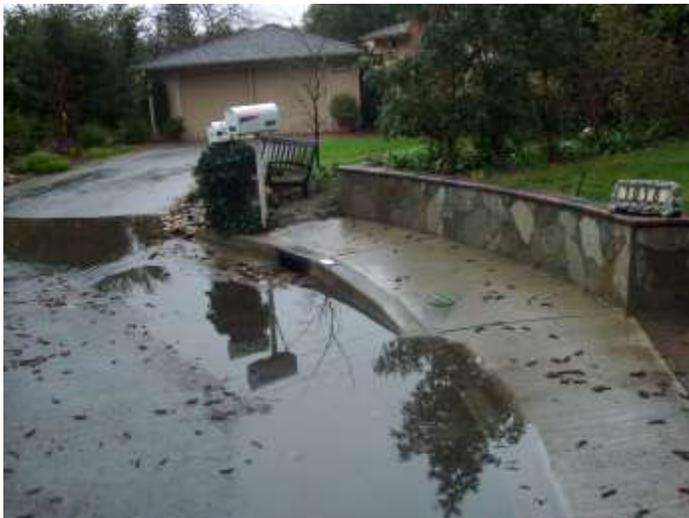
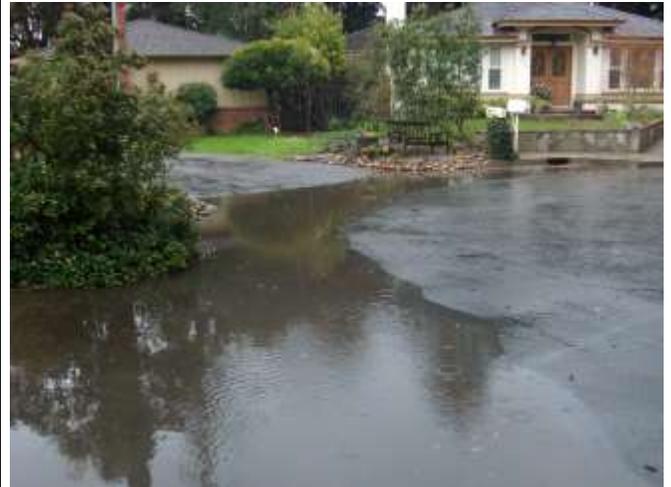
**Issue:** The storm inlet is too high resulting in poor drainage

Loma Prieta Court experiences significant ponding after most storm events. The existing inlet in the court is not at the lowest point. Driveway entrances were graded lower causing standing water.

Lowering the existing CB and minor gutter grading should improve drainage. Alternatively, additional inlets can be added to existing low spots in the court and connected to the existing CB.

1. Lower inlet grading of CB H5F-404 below the surrounding gutters

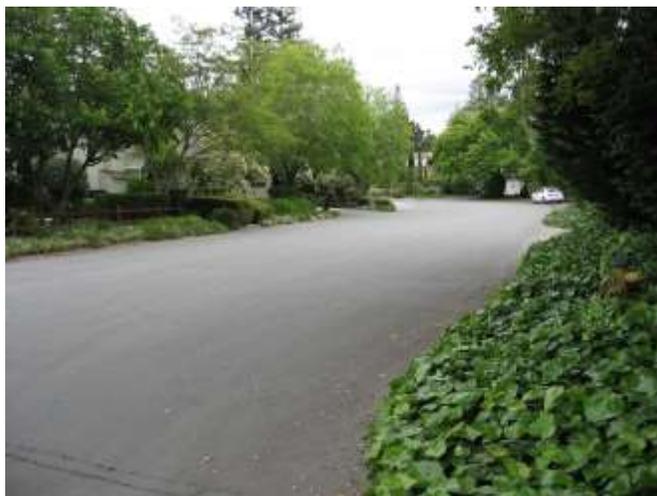
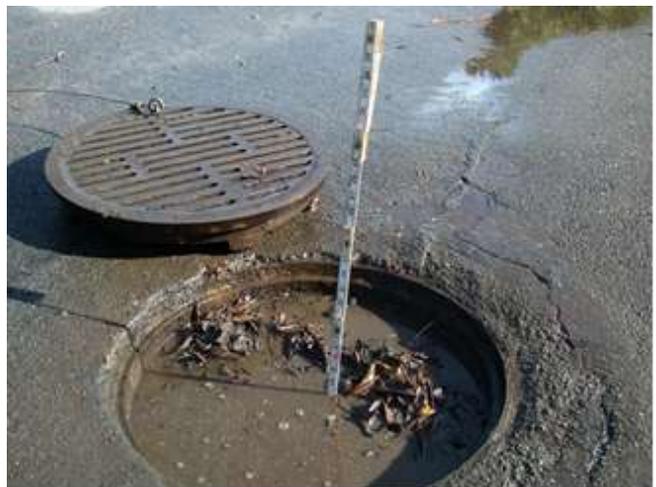
**Project:** 1640 Dallas Court  
**Project Identifier:** PS\_PA\_1000  
**Issue:** Slight ponding at the end of the cul-de-sac  
**Priority:** High  
**Cost:** \$200,000

There have been drainage issues in Dallas Court. The existing drywell percolation rate is not adequate.

Replace the drywell with a CB and connect to the existing system on Fremont Ave. Add additional inlets if needed.

1. Restore MH . K6F-225
2. Install new CB and connect to MH K6f-226 in Fremont Ave.

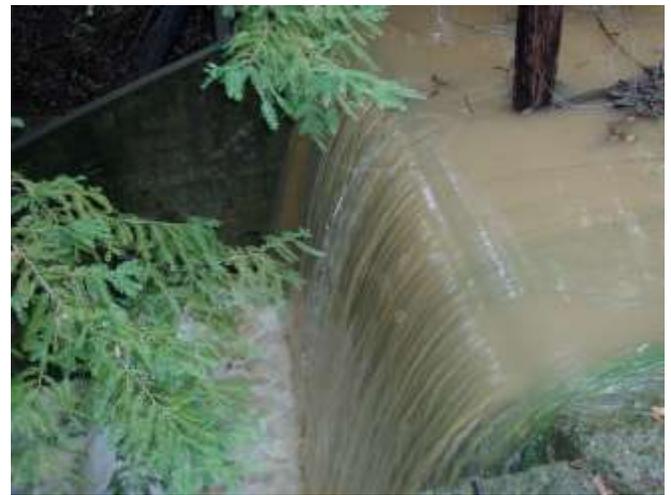
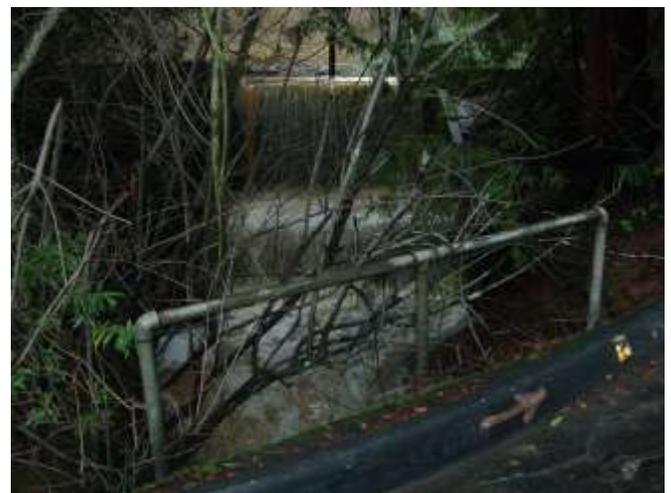
**Issue:** The City has indicated that logs and debris are clogging the creek in the area

There has been past drainage issues near Woods Lane and Citation Drive. Debris from upstream limits the conveyance in the existing 36-inch pipeline. There is an existing drop structure upstream of the culvert inlet.

1. Install 36" trash rack at check dam or inlet to storm water pipe
2. Routine maintenance along creek and pipe junction

Installing a trash rack at the check dam or inlet to the 36-inch culvert will reduce debris flowing down stream. This device will need routine inspection and maintenance to assure the system functions optimally during storm events.

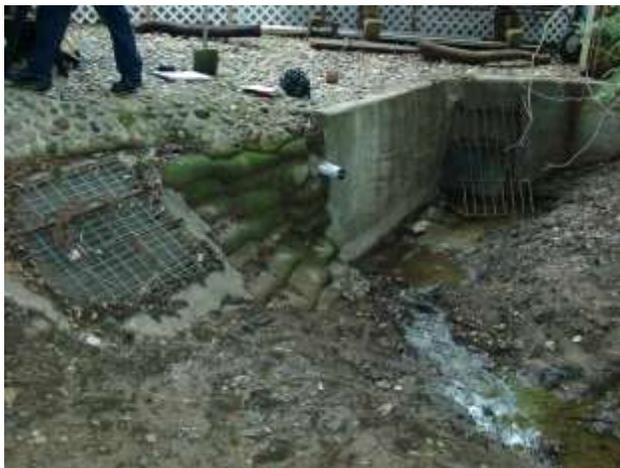
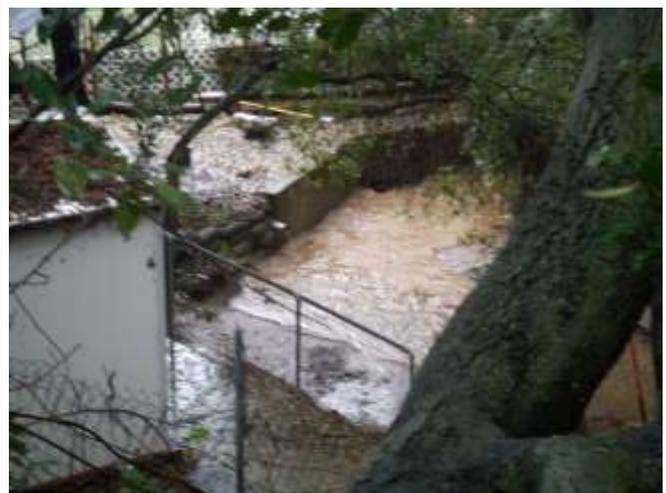
**Issue:** Trash rack behind residence gets blocked with debris. Gate structure M5D-207 is paved over

The drainage system along Stonehaven Drive upstream of Sierra Ventura has experienced significant drainage problems during storm events. The existing ditch enters the City drainage pipe network at a concrete headwall. There appears to be significant sediment and debris issues. The adjacent landowner has attempted to provide some additional flood protection.

We recommend replacing the headwall and culvert. A 36-inch RCP line to the existing junction box in Stonehaven is required. The new headwall should be higher and include an engineered trash rack. The ditch channel should be improved to prevent erosion.

1. Improve creek channel approach to SD headwall and inlet
2. Remove asphalt over gate structure and bring hatch to grade
3. Continue routine maintenance and cleaning of trash racks behind home and exercise gate structure

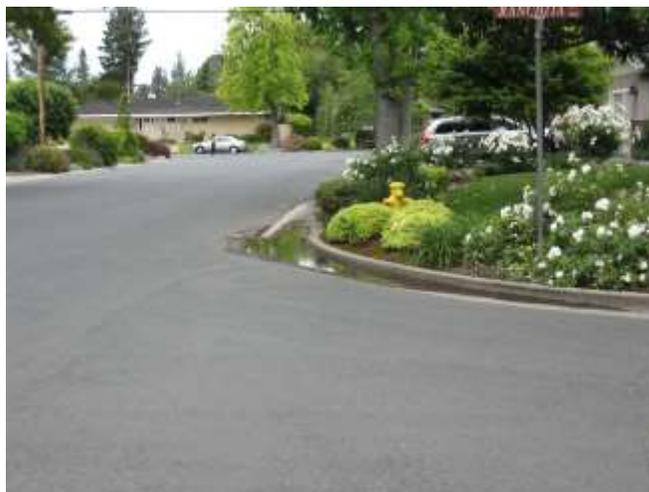
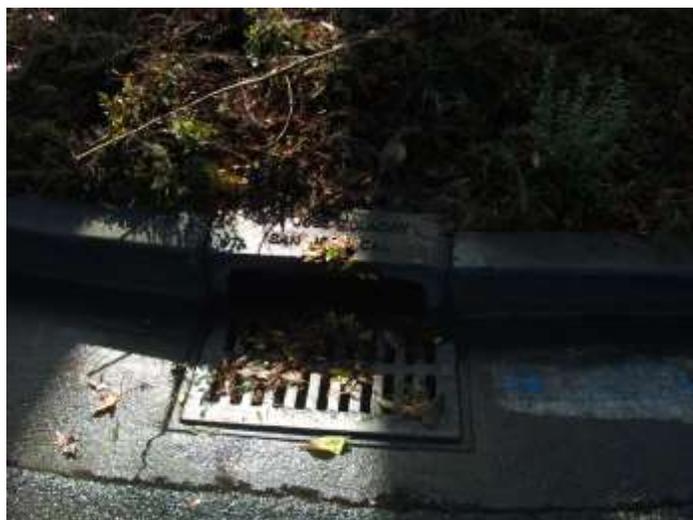
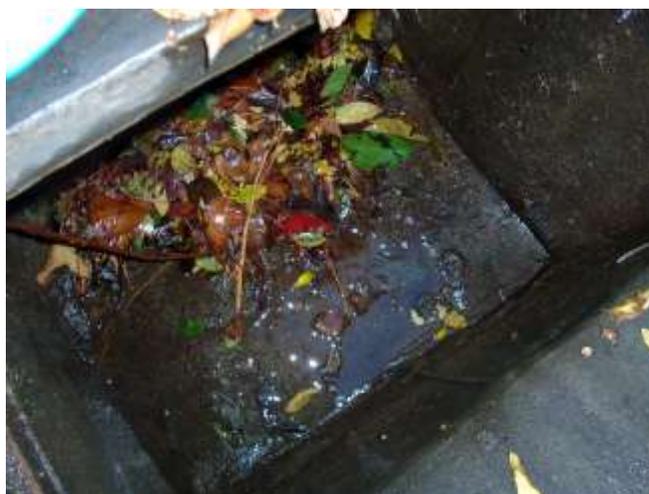
**Issue:** No sump in CB. Flooding east of Julie and Ranchita, drainage issues due to a crowned road

The area near Ranchita Drive and Julie Lane has experienced drainage problems. There is one existing inlet on the SE corner that regularly clogs with debris. The roadway grading limits drainage to the inlet.

Replace the existing inlet with a CB that includes a sump to collect debris. Regular cleaning of CB should be conducted. Adding an additional CB east of the existing inlet could also improve drainage.

1. Replace inlet CB J6C-225

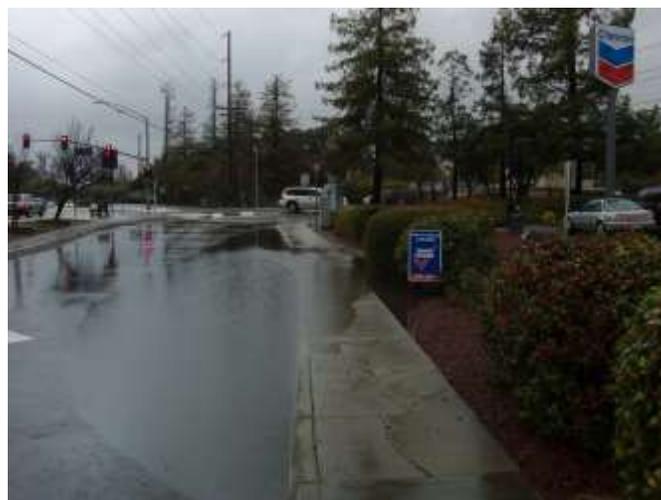
**Issue:** Poor drainage on offramp.

The offramp from northbound Foothill Expressway to Homestead Road routinely floods. There is a significant sag in the roadway and no storm drain system.

Install an inlet and catch basin at the sag point in the roadway. Connect to undocumented system at corner on Homestead Road.

1. Install a new catch basin alongside the Foothill Expressway offramp, near the Chevron station.
