Facility Condition Assessment Services

Tier 1 Report of
Facility Condition Assessment

For
City of Los Altos
City Hall
3 N. San Antonio Road
Los Altos,
California 94022-3000

Date of Report: September 16, 2016

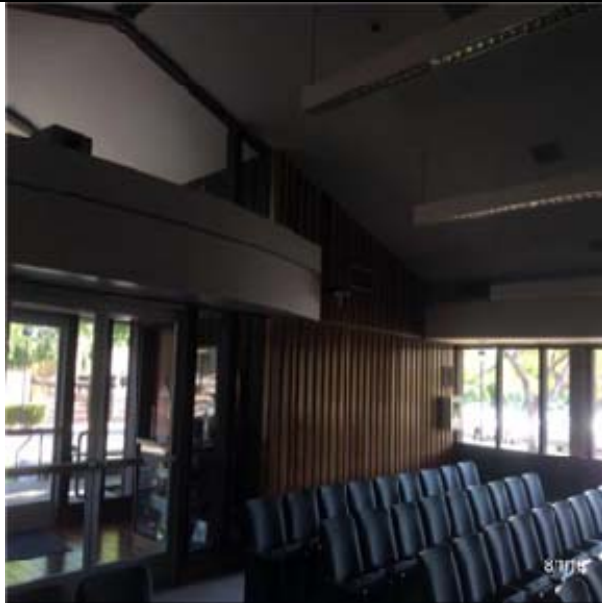
E2015 Fixed Multiple Seating:- View of Seating, Auditorium Chair, Fully Upholstered, Spring Seat
