AGENDA REPORT

SUBJECT: Receive an update on the Halsey House Historic Structures Report, and direct staff accordingly

HISTORIC STRUCTURE REPORT - DRAFT

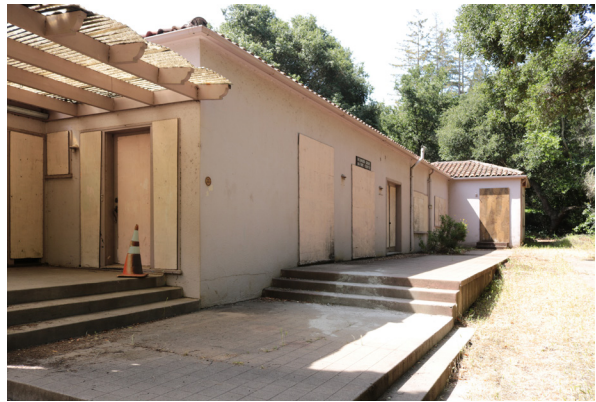
View of north elevation looking west. Note the lack of handrails at both sets of stairs (ARG, 2019).

the building. Primary access to the interior is gained from a set of original concrete stairs located at the north terrace. These stairs lack handrails. Two sets of concrete stairs provide entry into the house from the courtyard at the west. The wrought iron handrails exhibit significant corrosion and lack compliant extensions. Exterior doors are typically elevated above exterior grade which further contributes to a lack of universal access.

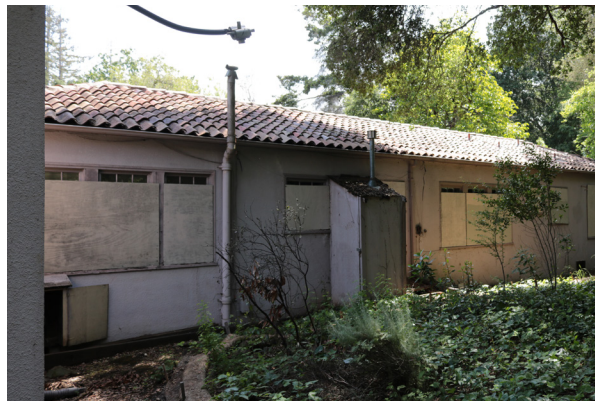
The Halsey House is set on a sloping site with water directed toward the west/southwest side of the building. Plant growth and tree duff adjacent to the building further contribute to excess moisture retention at grade which in turn has caused biological growth to form at the base of the exterior stucco walls. Coir rolls are installed along the length of the west elevation as a stopgap measure to prevent soil erosion and excess moisture infiltration caused by improper grading.

Plant growth along west elevation (ARG, 2019).

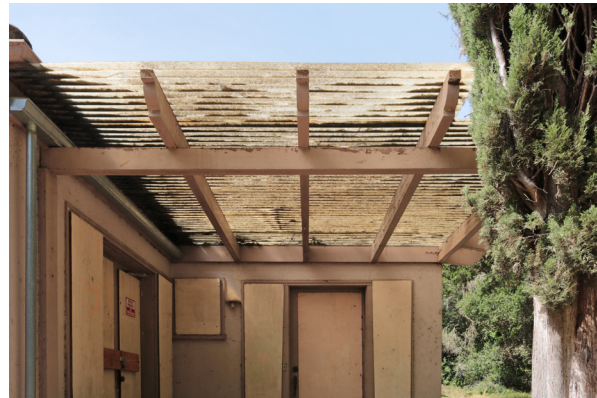
Corrugated plastic roof at pergola (ARG, 2019).

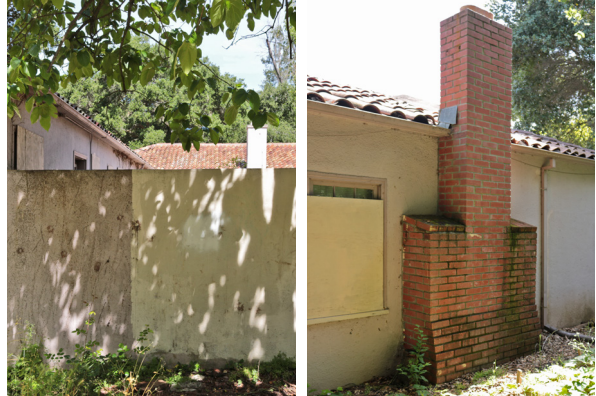
Dissimilar paint colors along the south elevation (left); biological growth at the west chimney (right); (ARG, 2019).

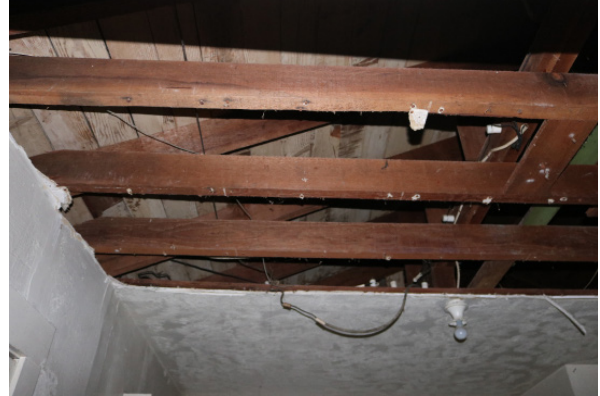
Missing drywall in the East Kitchen (ARG, 2019).

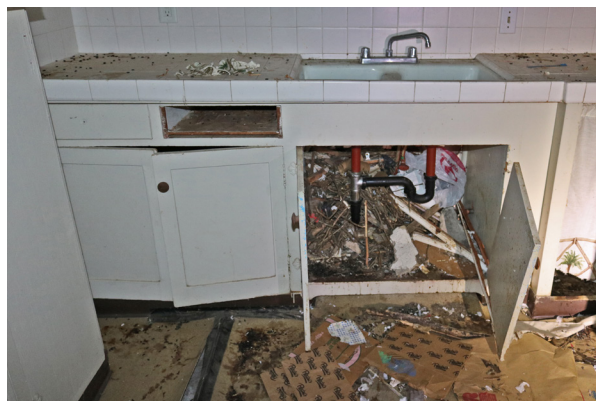
Large rodent nest at the sink base cabinet in the East Kitchen. Note the missing drawer and missing hardware (ARG, 2019).

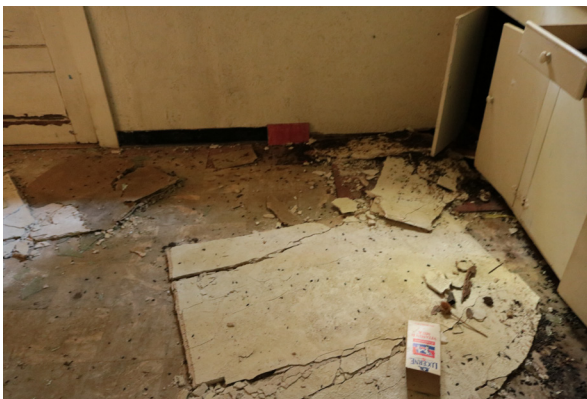
Vinyl tile in the West Kitchen (ARG, 2019).

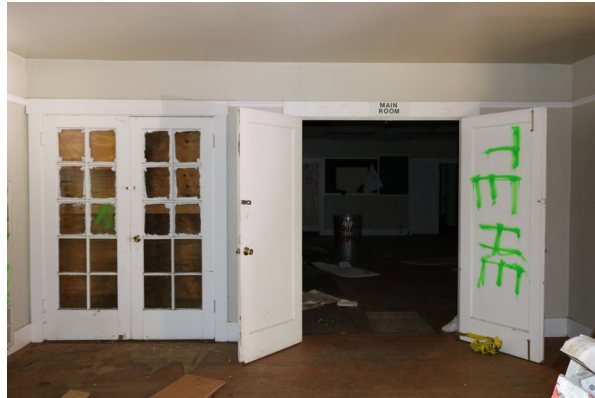
The historic interior doors are largely intact and in good condition. Original doors include panelled or French doors with some original glass door knobs intact. Damage is largely limited to paint loss and scuffing typical of everyday use. Graffiti is present on the paired doors of the Entry. The door of the pantry in the West Kitchen is missing and a large section of paint is missing from a door in the Animal Room.

Graffiti at the original paneled wood door of the Entry (ARG, 2019).

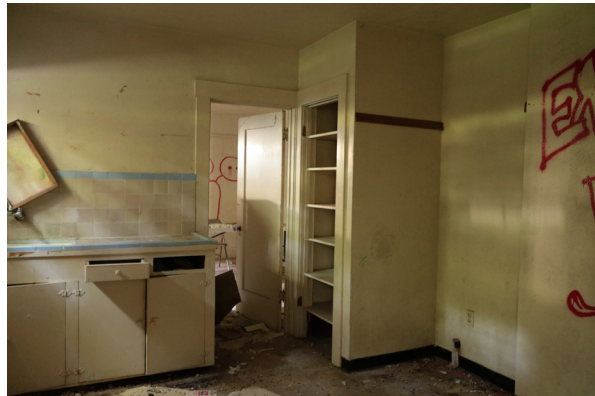
Note the missing door at the pantry of the West Kitchen (ARG, 2019).

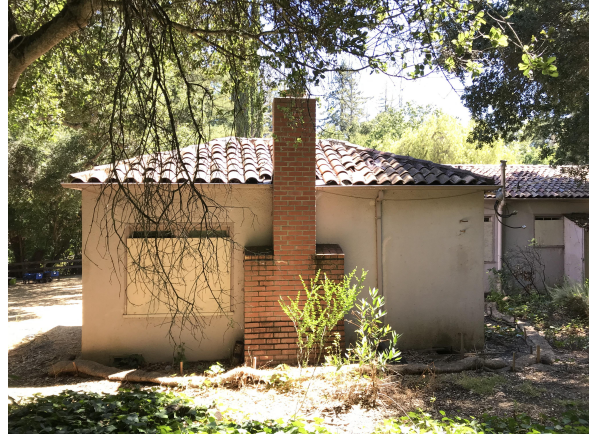
Photo #2 - West Elevation of the Northwest Appendage of the Building

There are two chimneys that extend above the roof, one is located on the south exterior wall of the north wing and the other is located on the west exterior wall of the northwest appendage of the building. The chimney at the northwest appendage is clearly an unreinforced brick (see Photo #2). The chimney located on the south exterior wall of the north wing is clad in stucco and it is unclear if the chimney is constructed with unreinforced brick (see Photo #7).
