PROJECT ADDRESS: 542 Benvenue Ave., Los Altos, CA

PROJECT SCOPE: NEW FOUR BEDROOM, THREE BATH HOME, WITH UNCONDITIONED BASEMENT AND ATTACHED ONE-CAR GARAGE. NEW OUTDOOR KITCHEN, HARDSCAPING AND LANDSCAPING.

# WOODFORD Residence

542 Benvenue Avenue, Los Altos, CA 94024

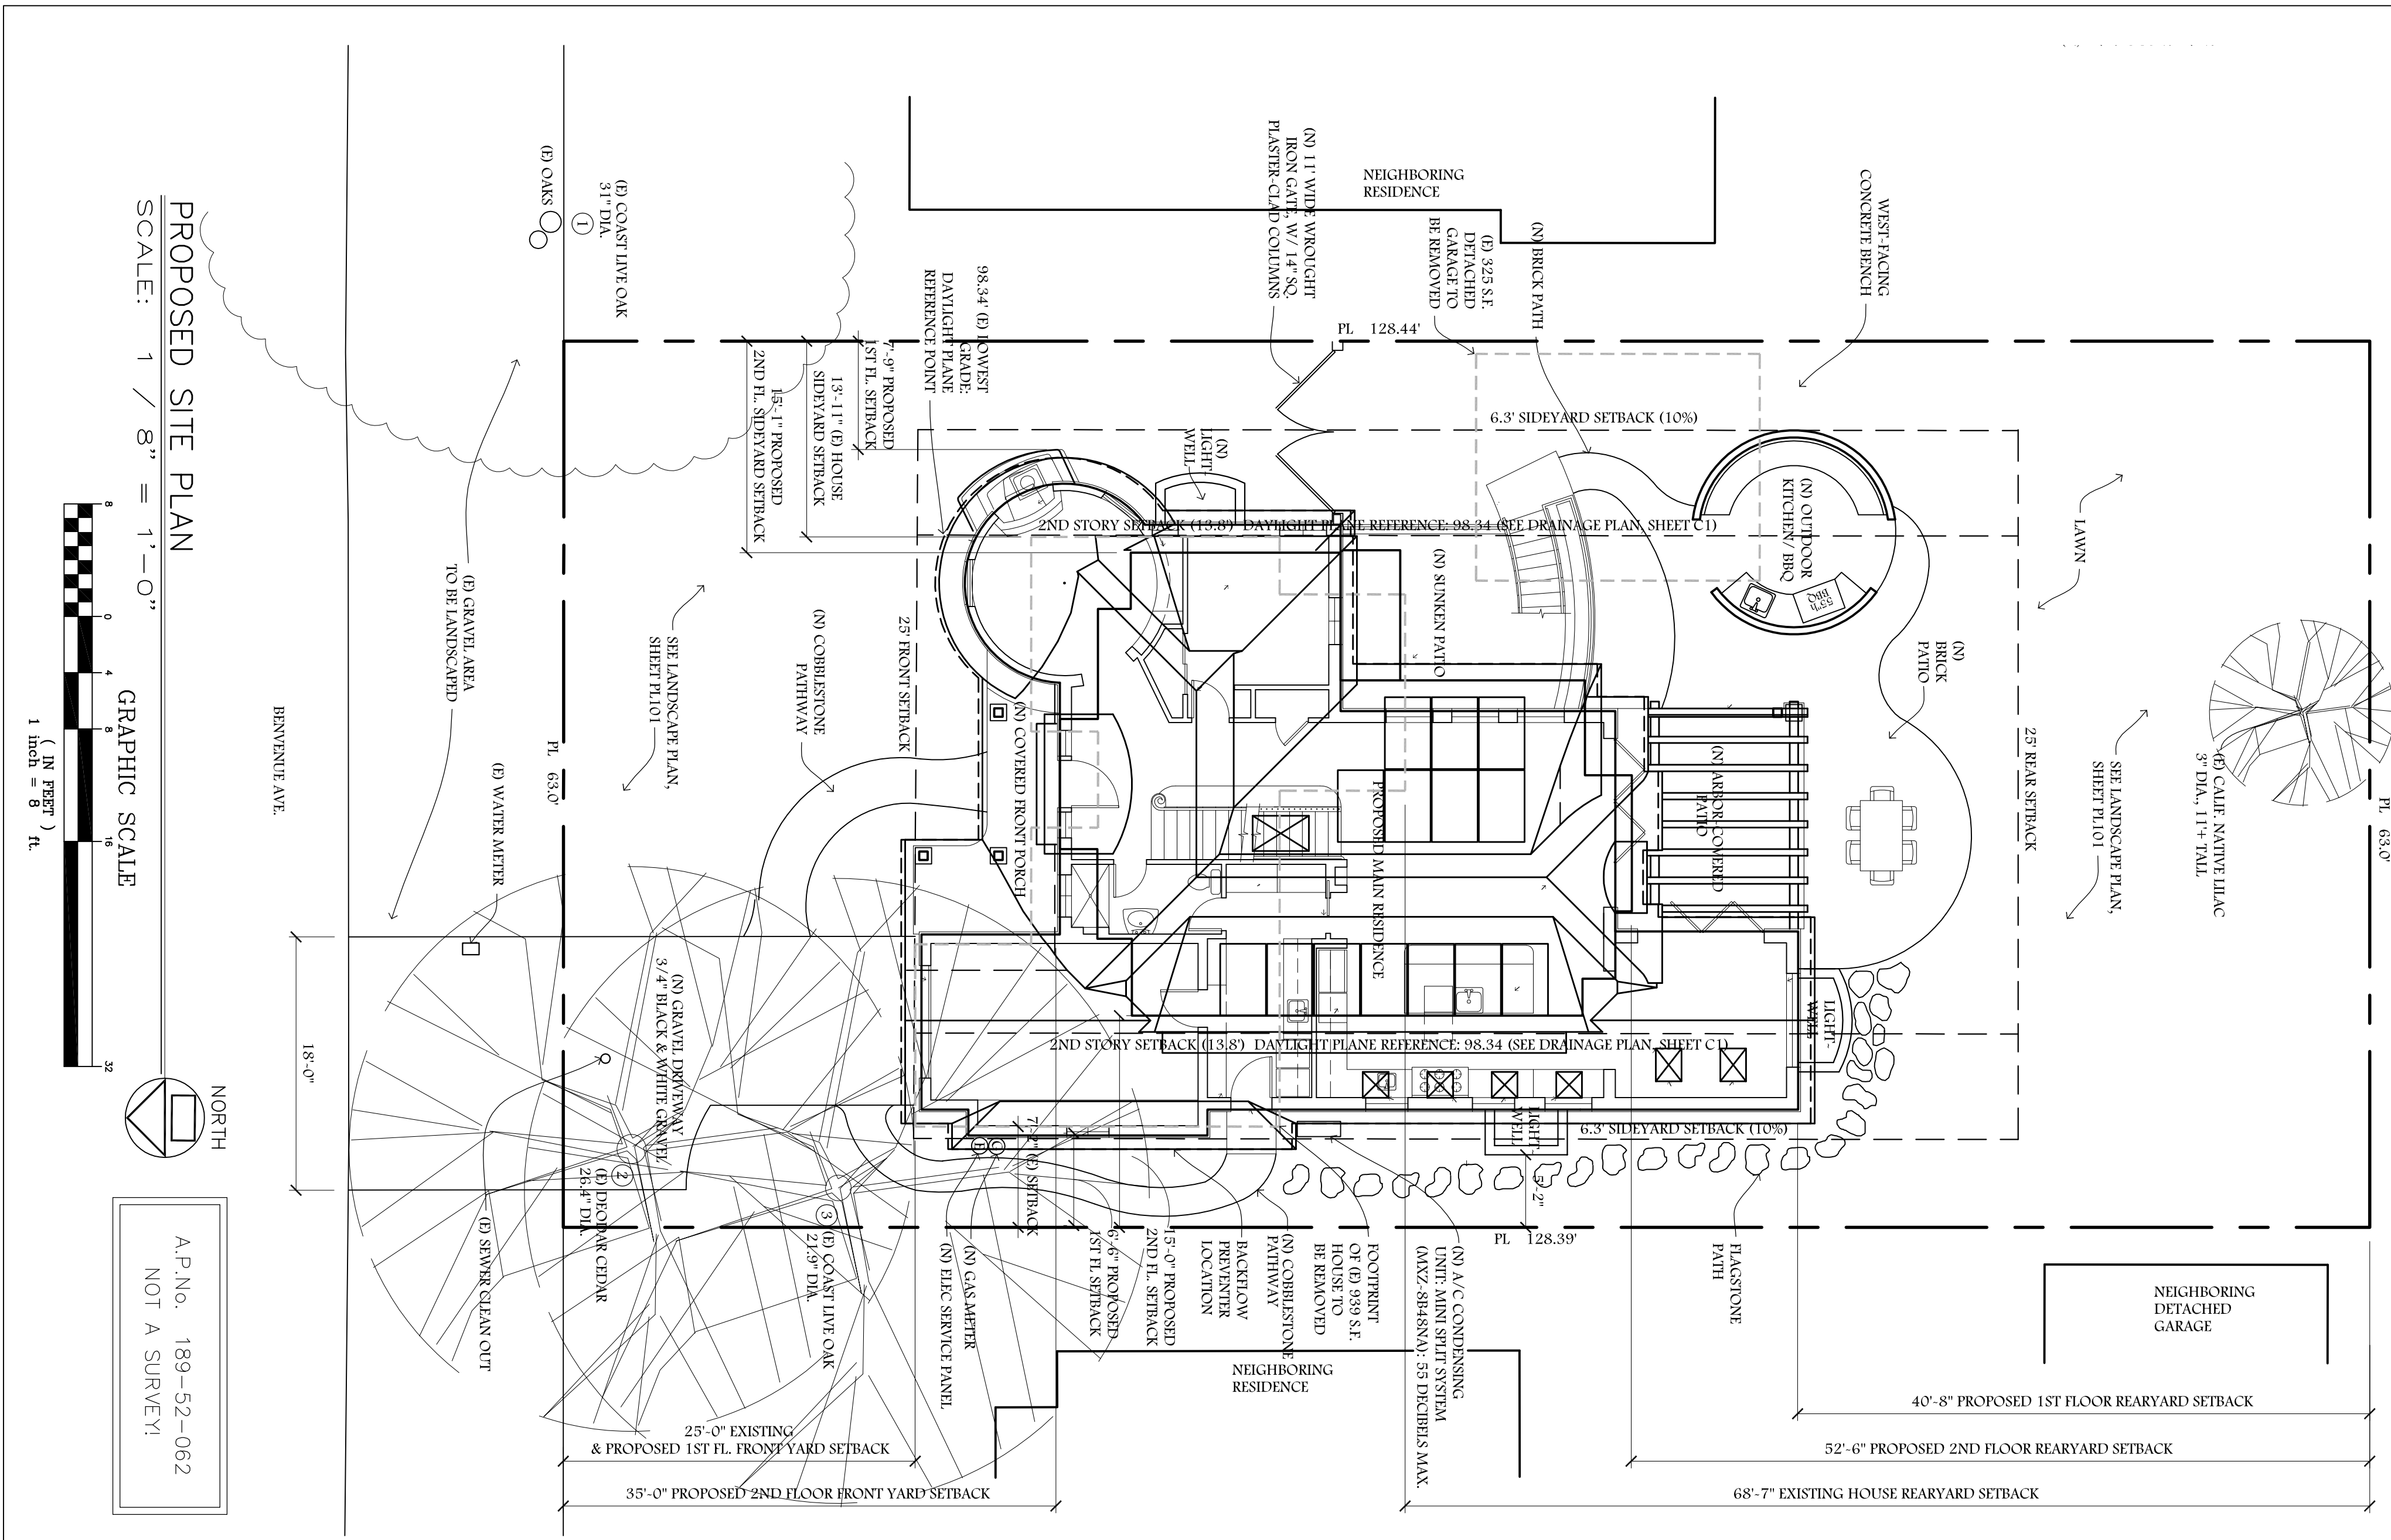
PROPOSED SITE PLAN

SCALE: 1 / 8" = 1'-0"

A.P.No. 189-52-062  
NOT A SURVEY!

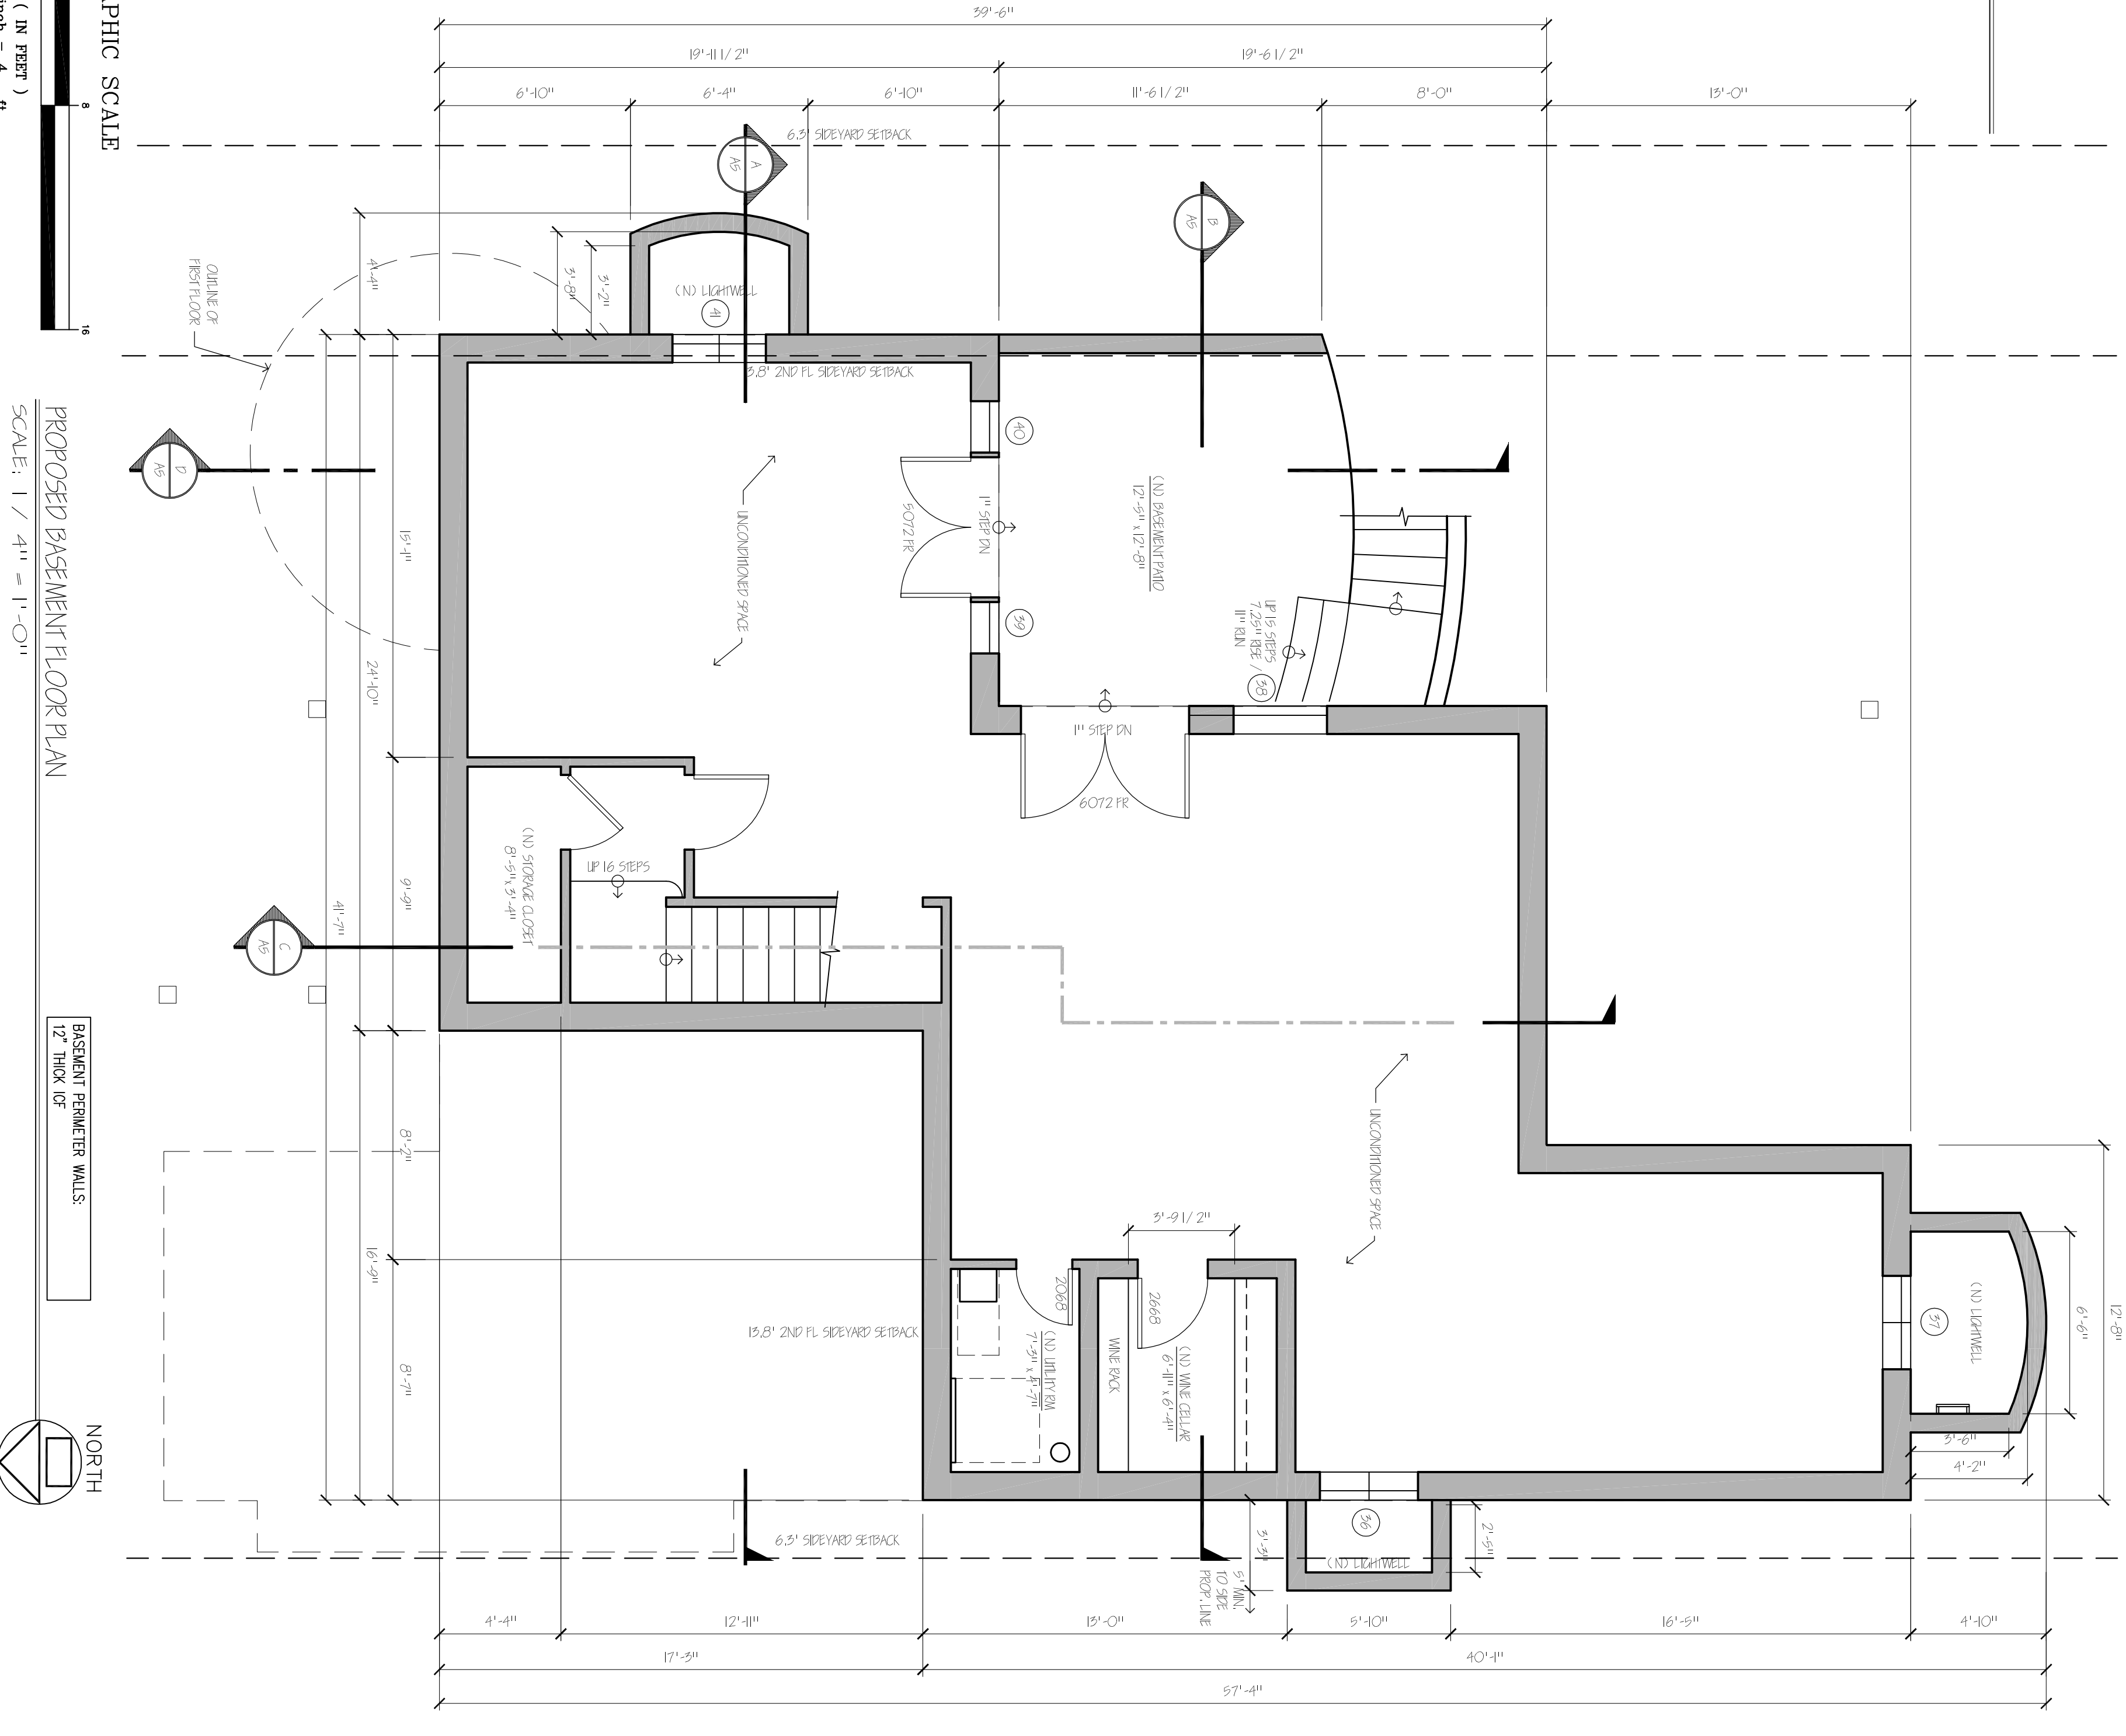
PROPOSED BASEMENT FLOOR PLAN  
SCALE: 1/4" = 1'-0"

BASEMENT PERIMETER WALLS  
12" THICK UCF

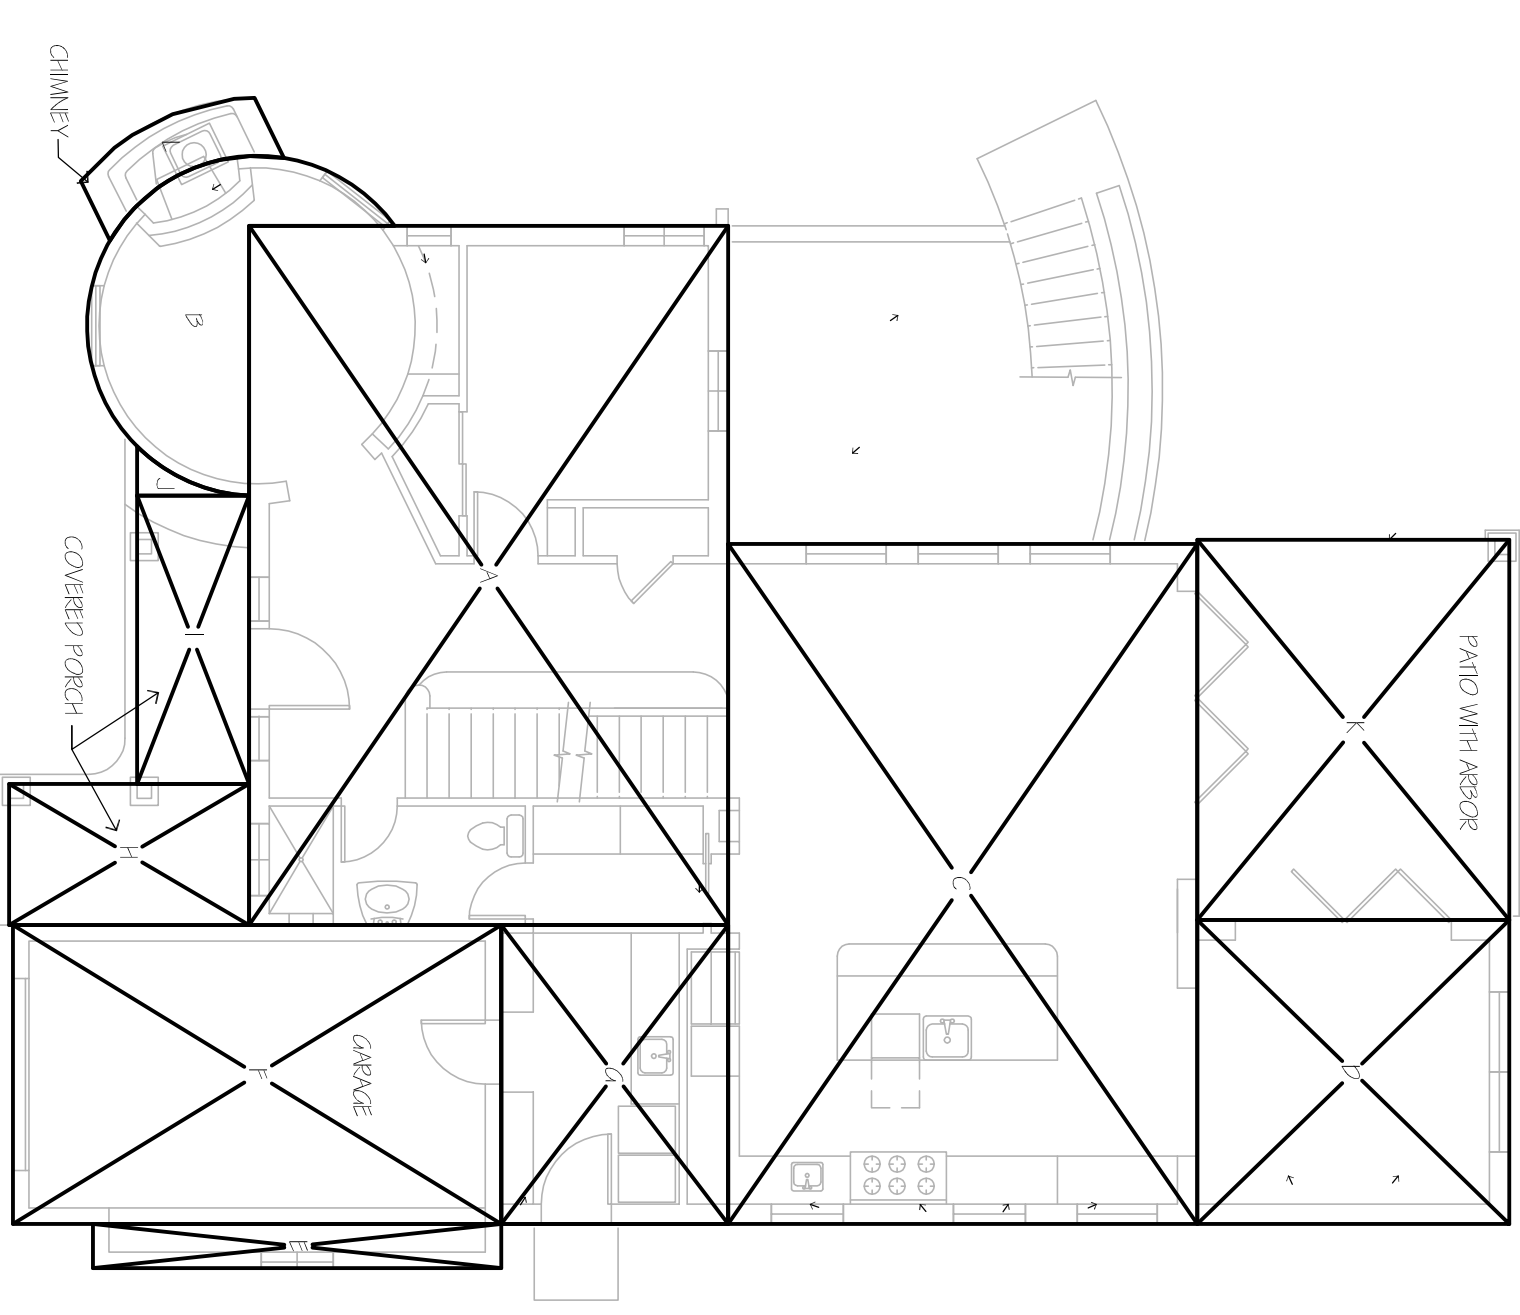
PROPOSED FIRST FLOOR AREA BLOCKOUT  
SCALE: 1 / 8" = 1'-0"

SECTION	DIMENSIONS	AREA
A	29'-1.5" X 19'-11.5"	581
B	14'-2" X 6'-1"	87
C	28'-4" X 19'-6.5"	554
D	12'-8" X 19'-0"	165
E	1'-10" X 17'-0"	31
F	12'-5.5" X 20'-2"	253
G	12'-5.5" X 9'-5.5"	118
TOTAL FLOOR AREA =		1789 sq. ft.
H	5'-10.5" X 10'-0"	59
I	12'-0" X 4'-8"	56
J	2'-11" X 4'-8"	3
K	19'-10" X 19'-0"	206
L	2'-9" X 8'-0"	20
TOTAL COVERAGE =		2155 sq. ft.

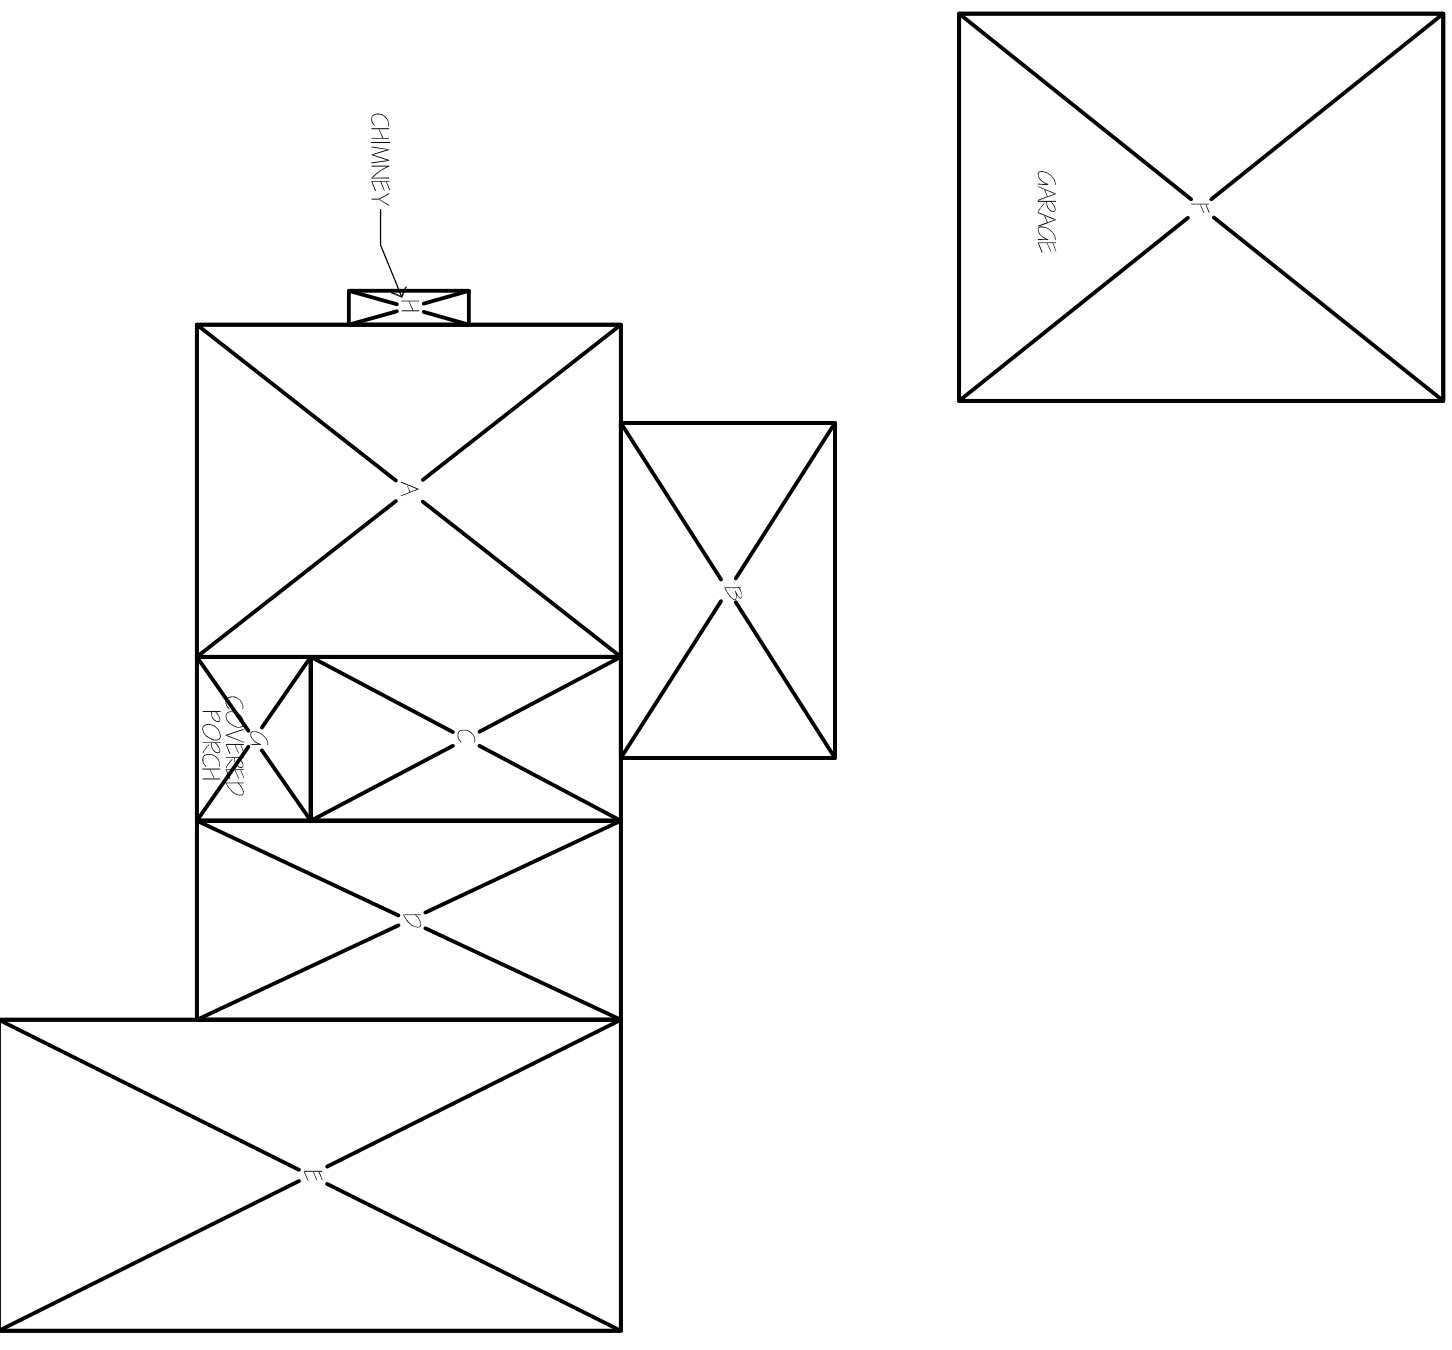
EXISTING FLOOR AREA BLOCKOUT  
SCALE: 1 / 8" = 1'-0"

SECTION	DIMENSIONS	AREA
A	15'-10" X 17'-8"	244
B	15'-11.5" X 8'-11"	124
C	6'-10" X 12'-11"	88
D	8'-5.5" X 17'-6"	147
E	12'-11.5" X 25'-1"	336
F	16'-11.5" X 20'-2"	328
TOTAL FLOOR AREA =		1264 sq. ft.
G	8'-10" X 4'-9"	32
H	1'-5" X 5'-0"	7
TOTAL COVERAGE =		1409 sq. ft.

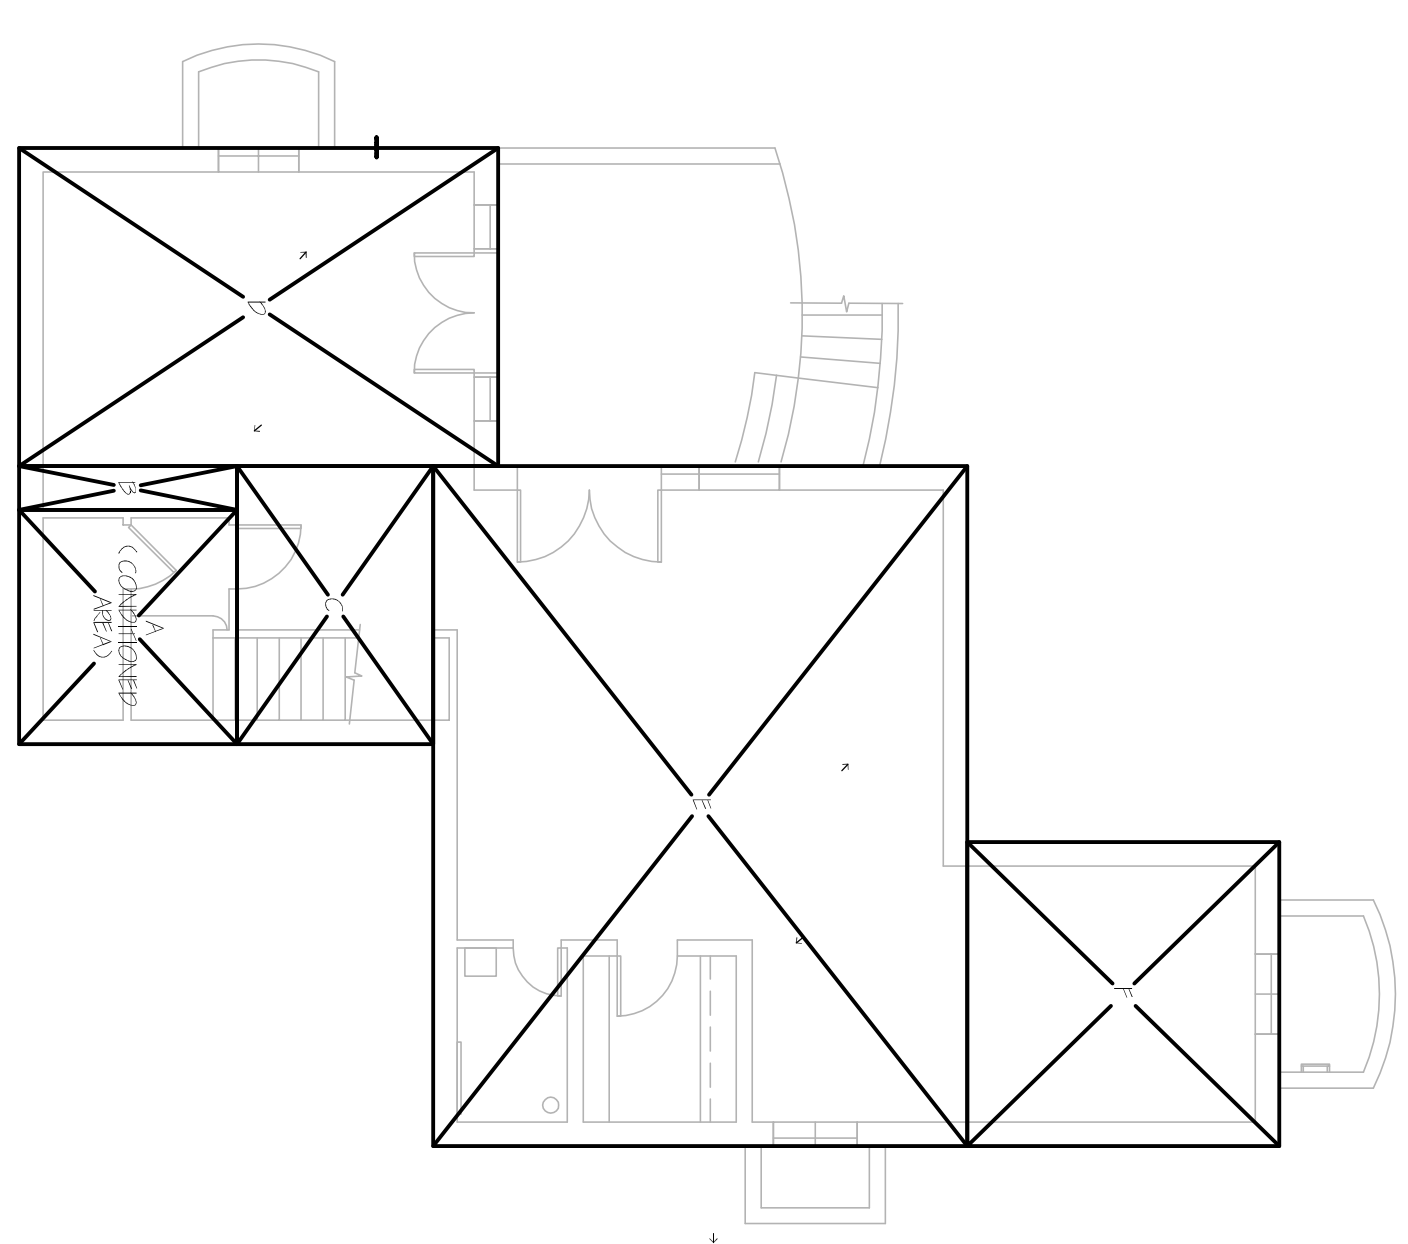
PROPOSED BASEMENT FLOOR AREA BLOCKOUT  
SCALE: 1 / 8" = 1'-0"

SECTION	DIMENSIONS	AREA
A	9'-9" X 9'-1"	89
B	1'-0" X 9'-1"	17
C	11'-7" X 8'-2"	94
D	15'-5" X 19'-11.5"	284
E	28'-4" X 22'-5"	630
F	12'-8" X 19'-0"	169
TOTAL AREA =		1299 sq. ft.

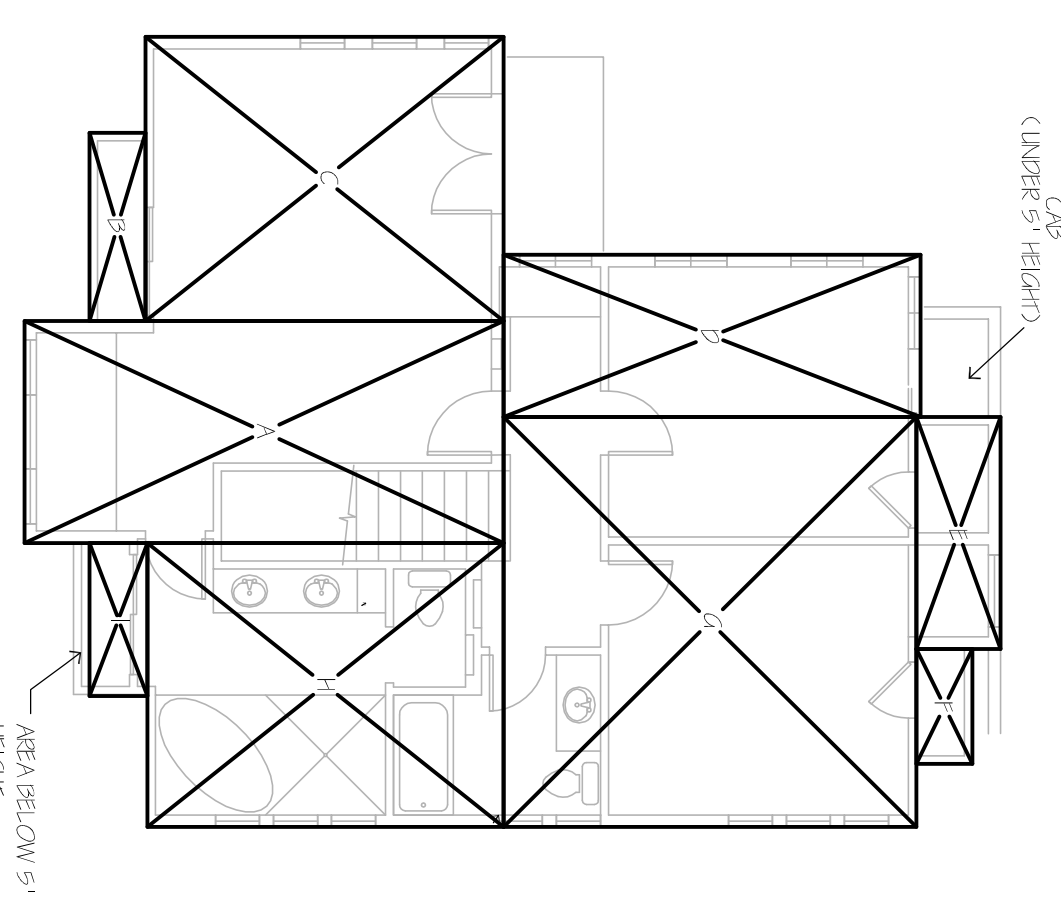
PROPOSED SECOND FLOOR AREA BLOCKOUT  
SCALE: 1 / 8" = 1'-0"

SECTION	DIMENSIONS	AREA
A	9'-5" X 19'-11.5"	185
B	7'-10" X 2'-4"	18
C	11'-10" X 14'-11"	176
D	8'-9" X 17'-4.5"	117
E	9'-8" X 9'-6"	34
F	4'-9.5" X 2'-4"	11
G	17'-1" X 17'-2.5"	294
H	11'-10" X 14'-10"	176
I	6'-4.5" X 2'-5"	15
TOTAL FLOOR AREA =		1026 sq. ft.

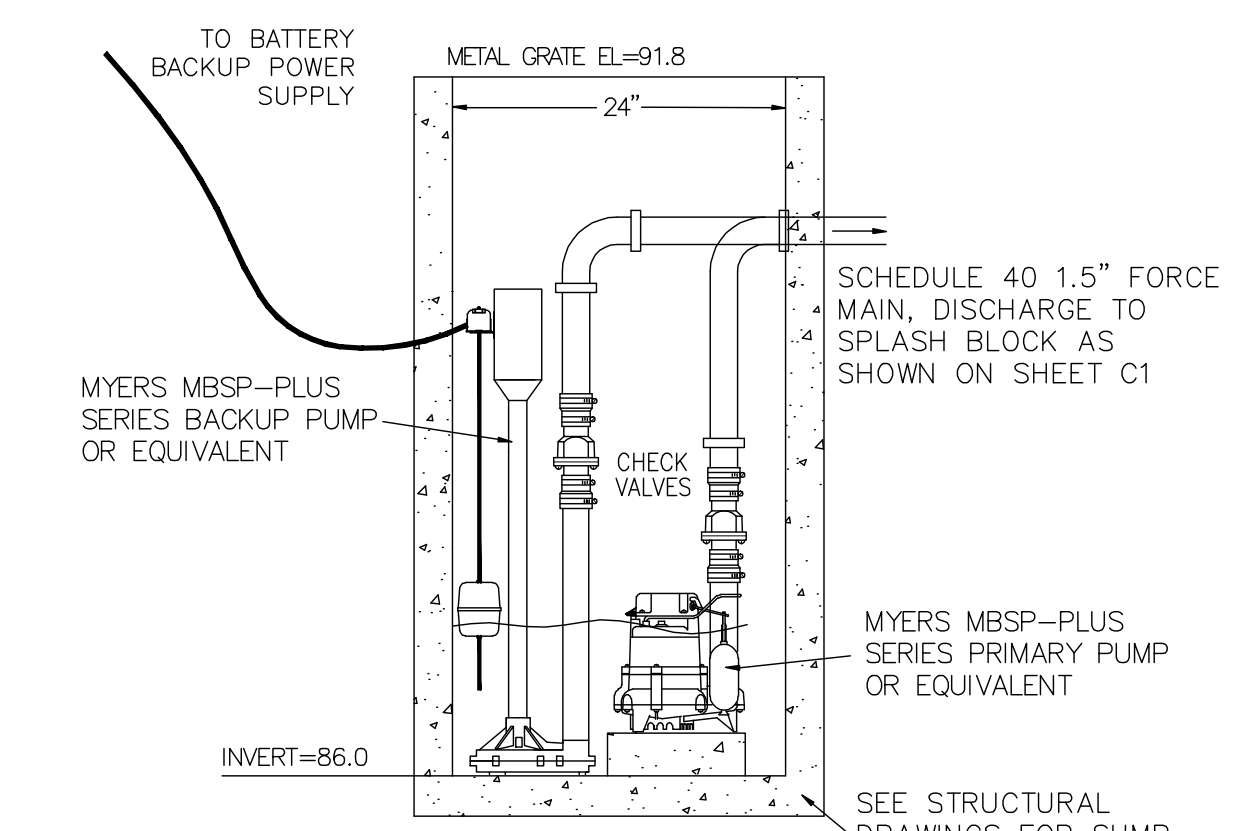
**SUMP DETAIL**  
NOT TO SCALE

1. INSTALL PUMPS PER MANUFACTURER'S RECOMMENDATIONS.
2. CONTRACTOR SHALL SUPPLY A COMPLETELY SELF CONTAINED MOTOR CONTROL PANEL. THE CONTROL PANEL SHALL PROVIDE SHORT CIRCUIT AND OVERLOAD PROTECTION FOR THE PUMPS.
3. PROVIDE BENTONITE PASTE AT ALL PIPE CONNECTIONS TO PUMP BASIN.
4. SUMP PUMP MAINTENANCE REQUIREMENTS: CLEAN STORM DRAIN VAULT AND PUMP OF DEBRIS EVERY SIX MONTHS MINIMUM.
5. PROVIDE BACKFLOW PREVENTERS ON ALL GRAVITY PIPE ENTERING THE PUMP BASIN.

NOTE: PUMPS MAY ALSO BE SET IN PRECAST CONCRETE MANHOLE OR DROP INLET IN LIEU OF FIBERGLASS BASIN. DISCHARGE PIPING OF PUMP MUST BE EQUIPPED WITH A CHECK VALVE, BALL VALVE, TRUE UNION AND LIFTOUT CABLE.

CONTRACTOR SHALL ENSURE THAT SUMP PUMP IS PROPERLY VENTED SUCH THAT ODORS ASSOCIATED WITH SANITARY SEWERS DO NOT ACCUMULATE IN THE LIGHTWELL.

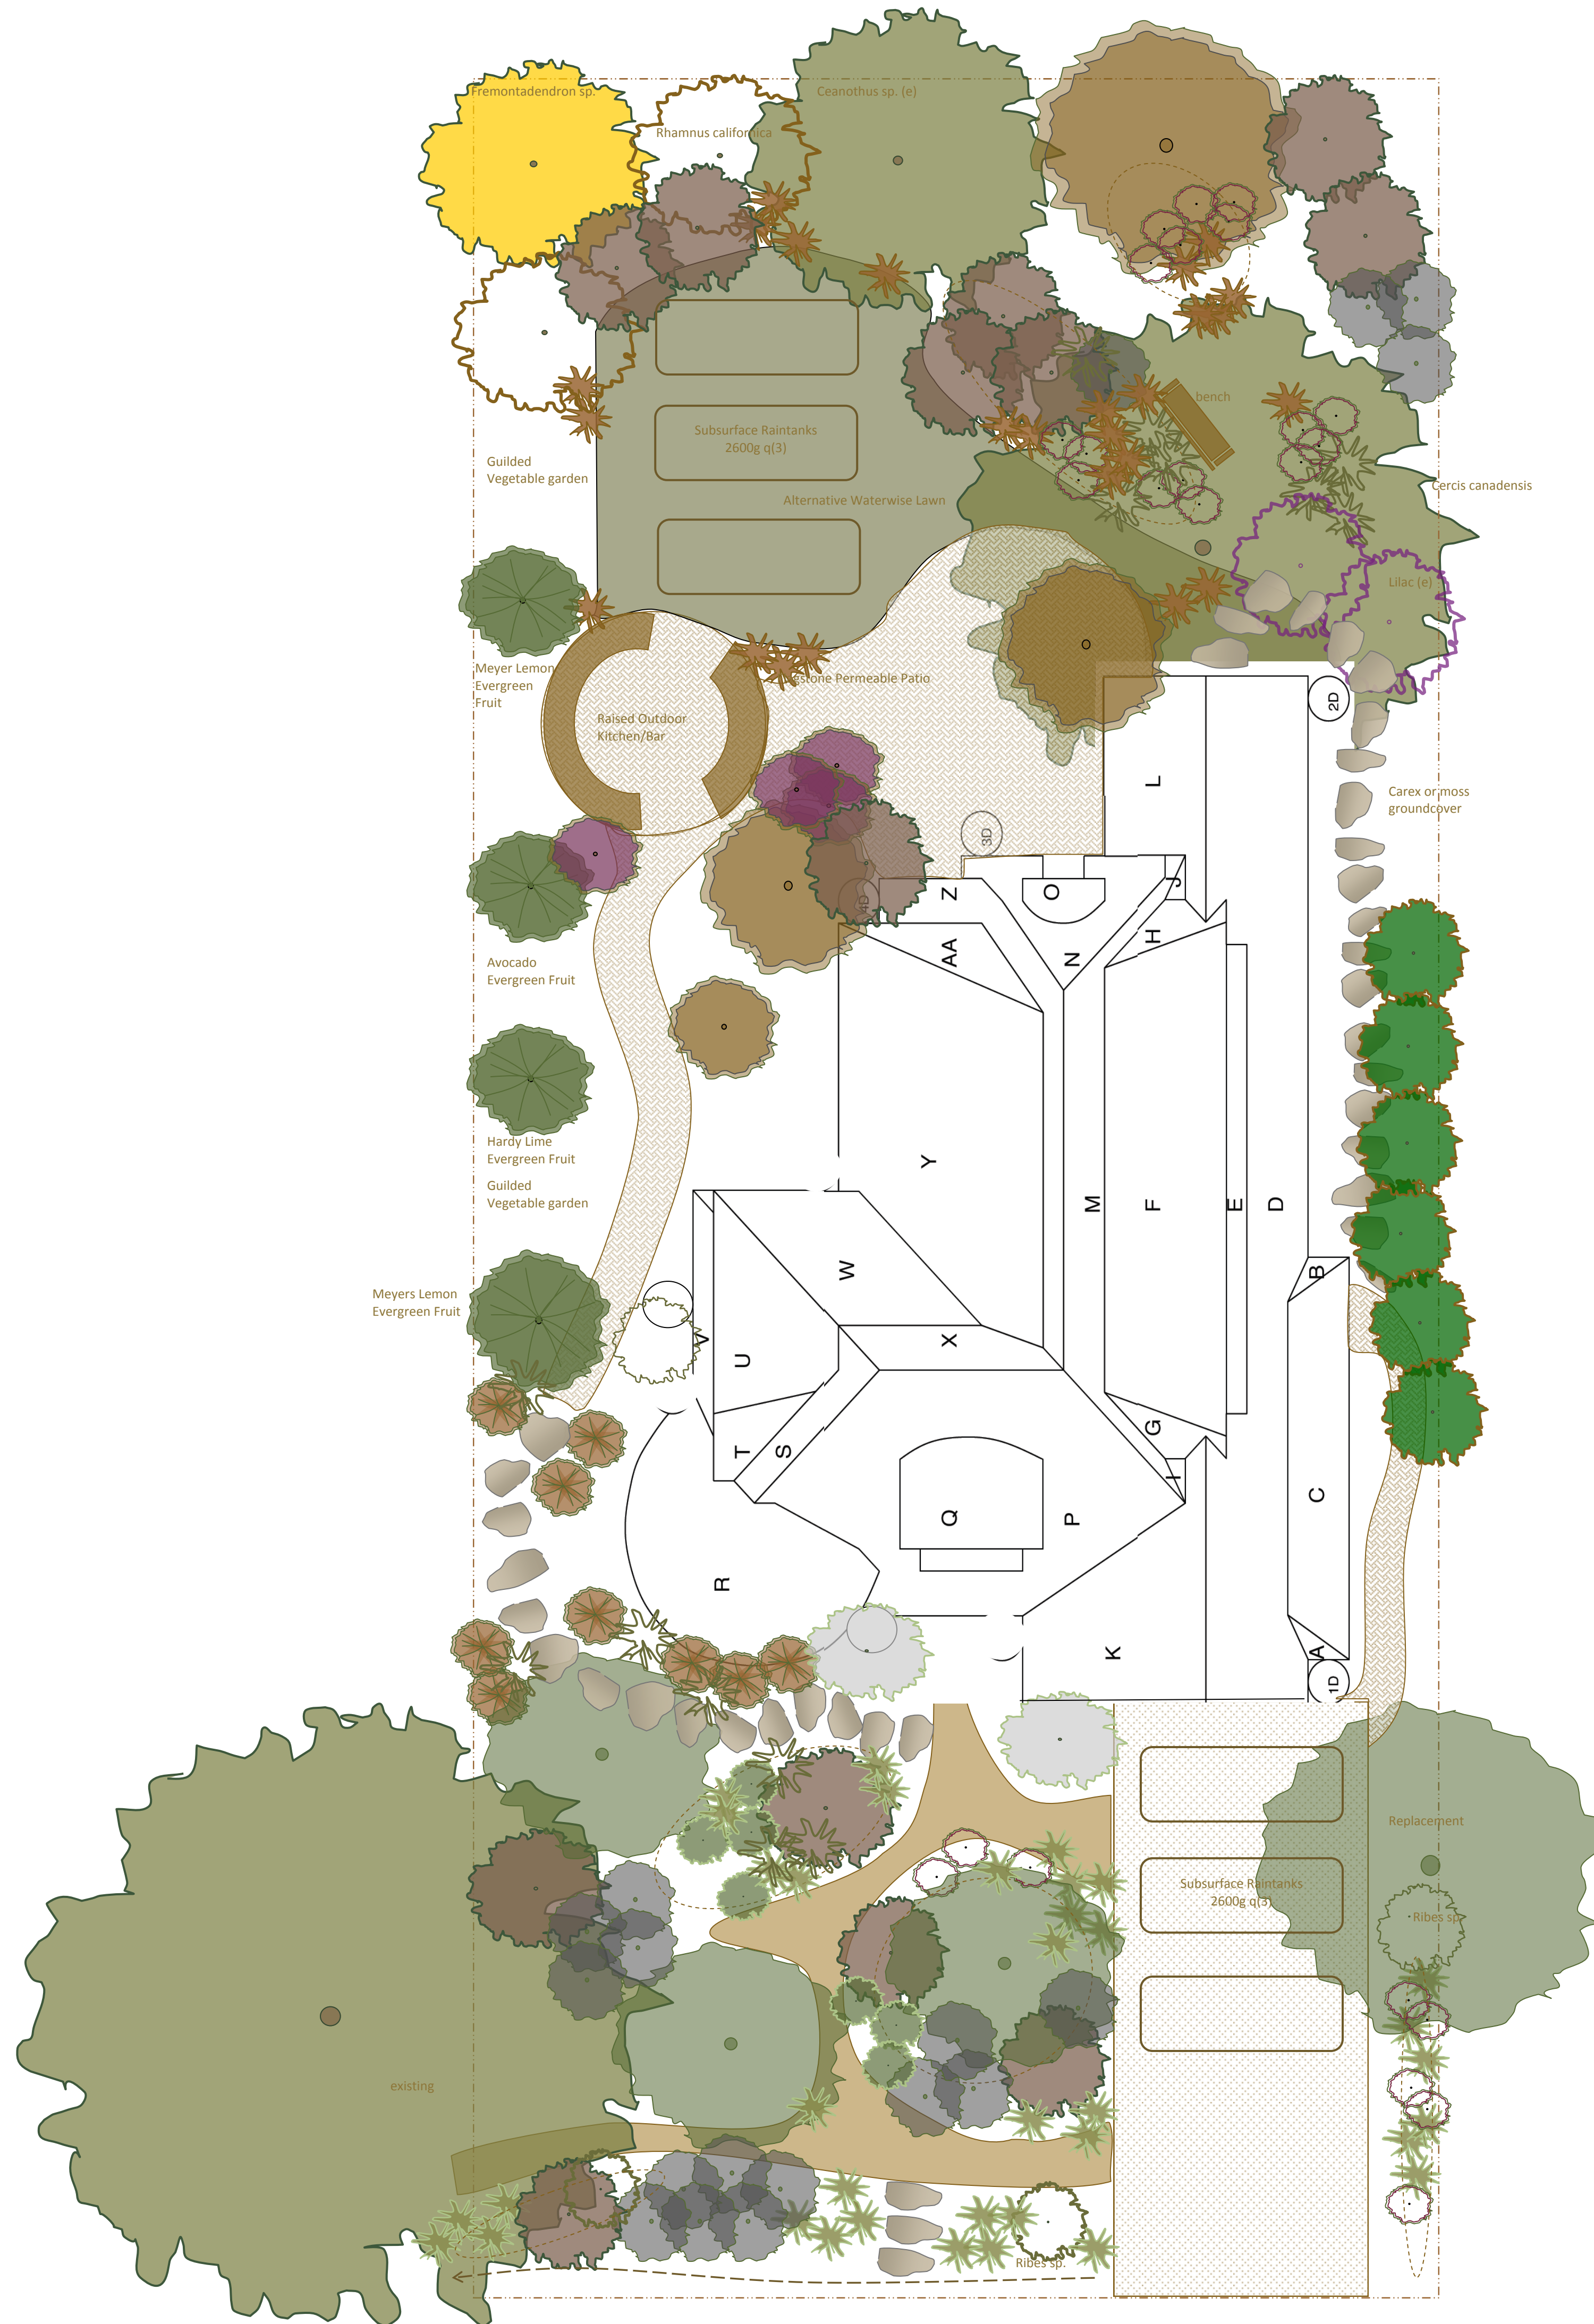
Woodford Landscape CONCEPTUAL

- Irrigation and plant schematic based on Exhibit A, Woodford gallon weekly capture/reuse of greywater.

- Infiltration Basin, SD 2.1
- Stepped Planted Bioswale, SD 2.2
- Municipal Water Meter
- Mulch Basin Type S2 > 5' diameter, SD 2.3
- Polyline, 1"
- PVC sch. 40 1"
- ABS 2" at >2% slope
- Log Material
- Boulder Material

All topography and lines are approximate. Installation may alter slightly due to natural occurrence of conditions. Safety information: Identify volunteer worker needs to be signed prior to any onsite visit by a non-MSL staff, sub-contractor, crew member during installation of project. Contractor is responsible for pedestrian and vehicular safety for duration of this installation.

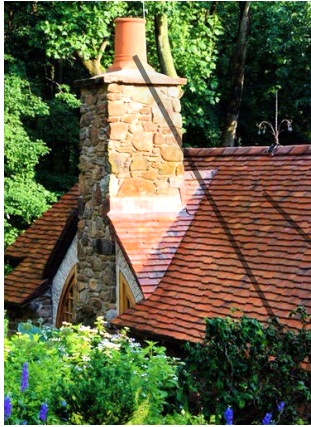
Northern Roof Tiles  
French Style Flat  
Clay Tile Roof

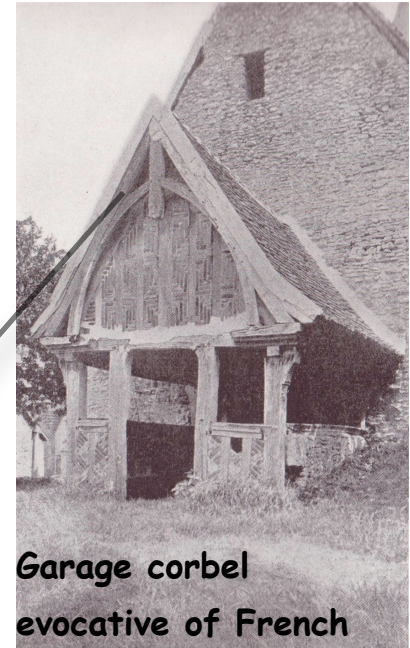
Garage corbel  
evocative of French  
Country Stable house
