Demolish (E) Single Story Home, driveway & landscape
Construct (N) Two Story Home with Basement, driveway and patios

452 Paco Dr, Los Altos
District: R1-10
Property Size: 11,557 sf
Occupancy Type: R3
Type of construction: V-B

Hartenstine Residence
452 Paco Dr
Los Altos, CA 94022

Project Overview

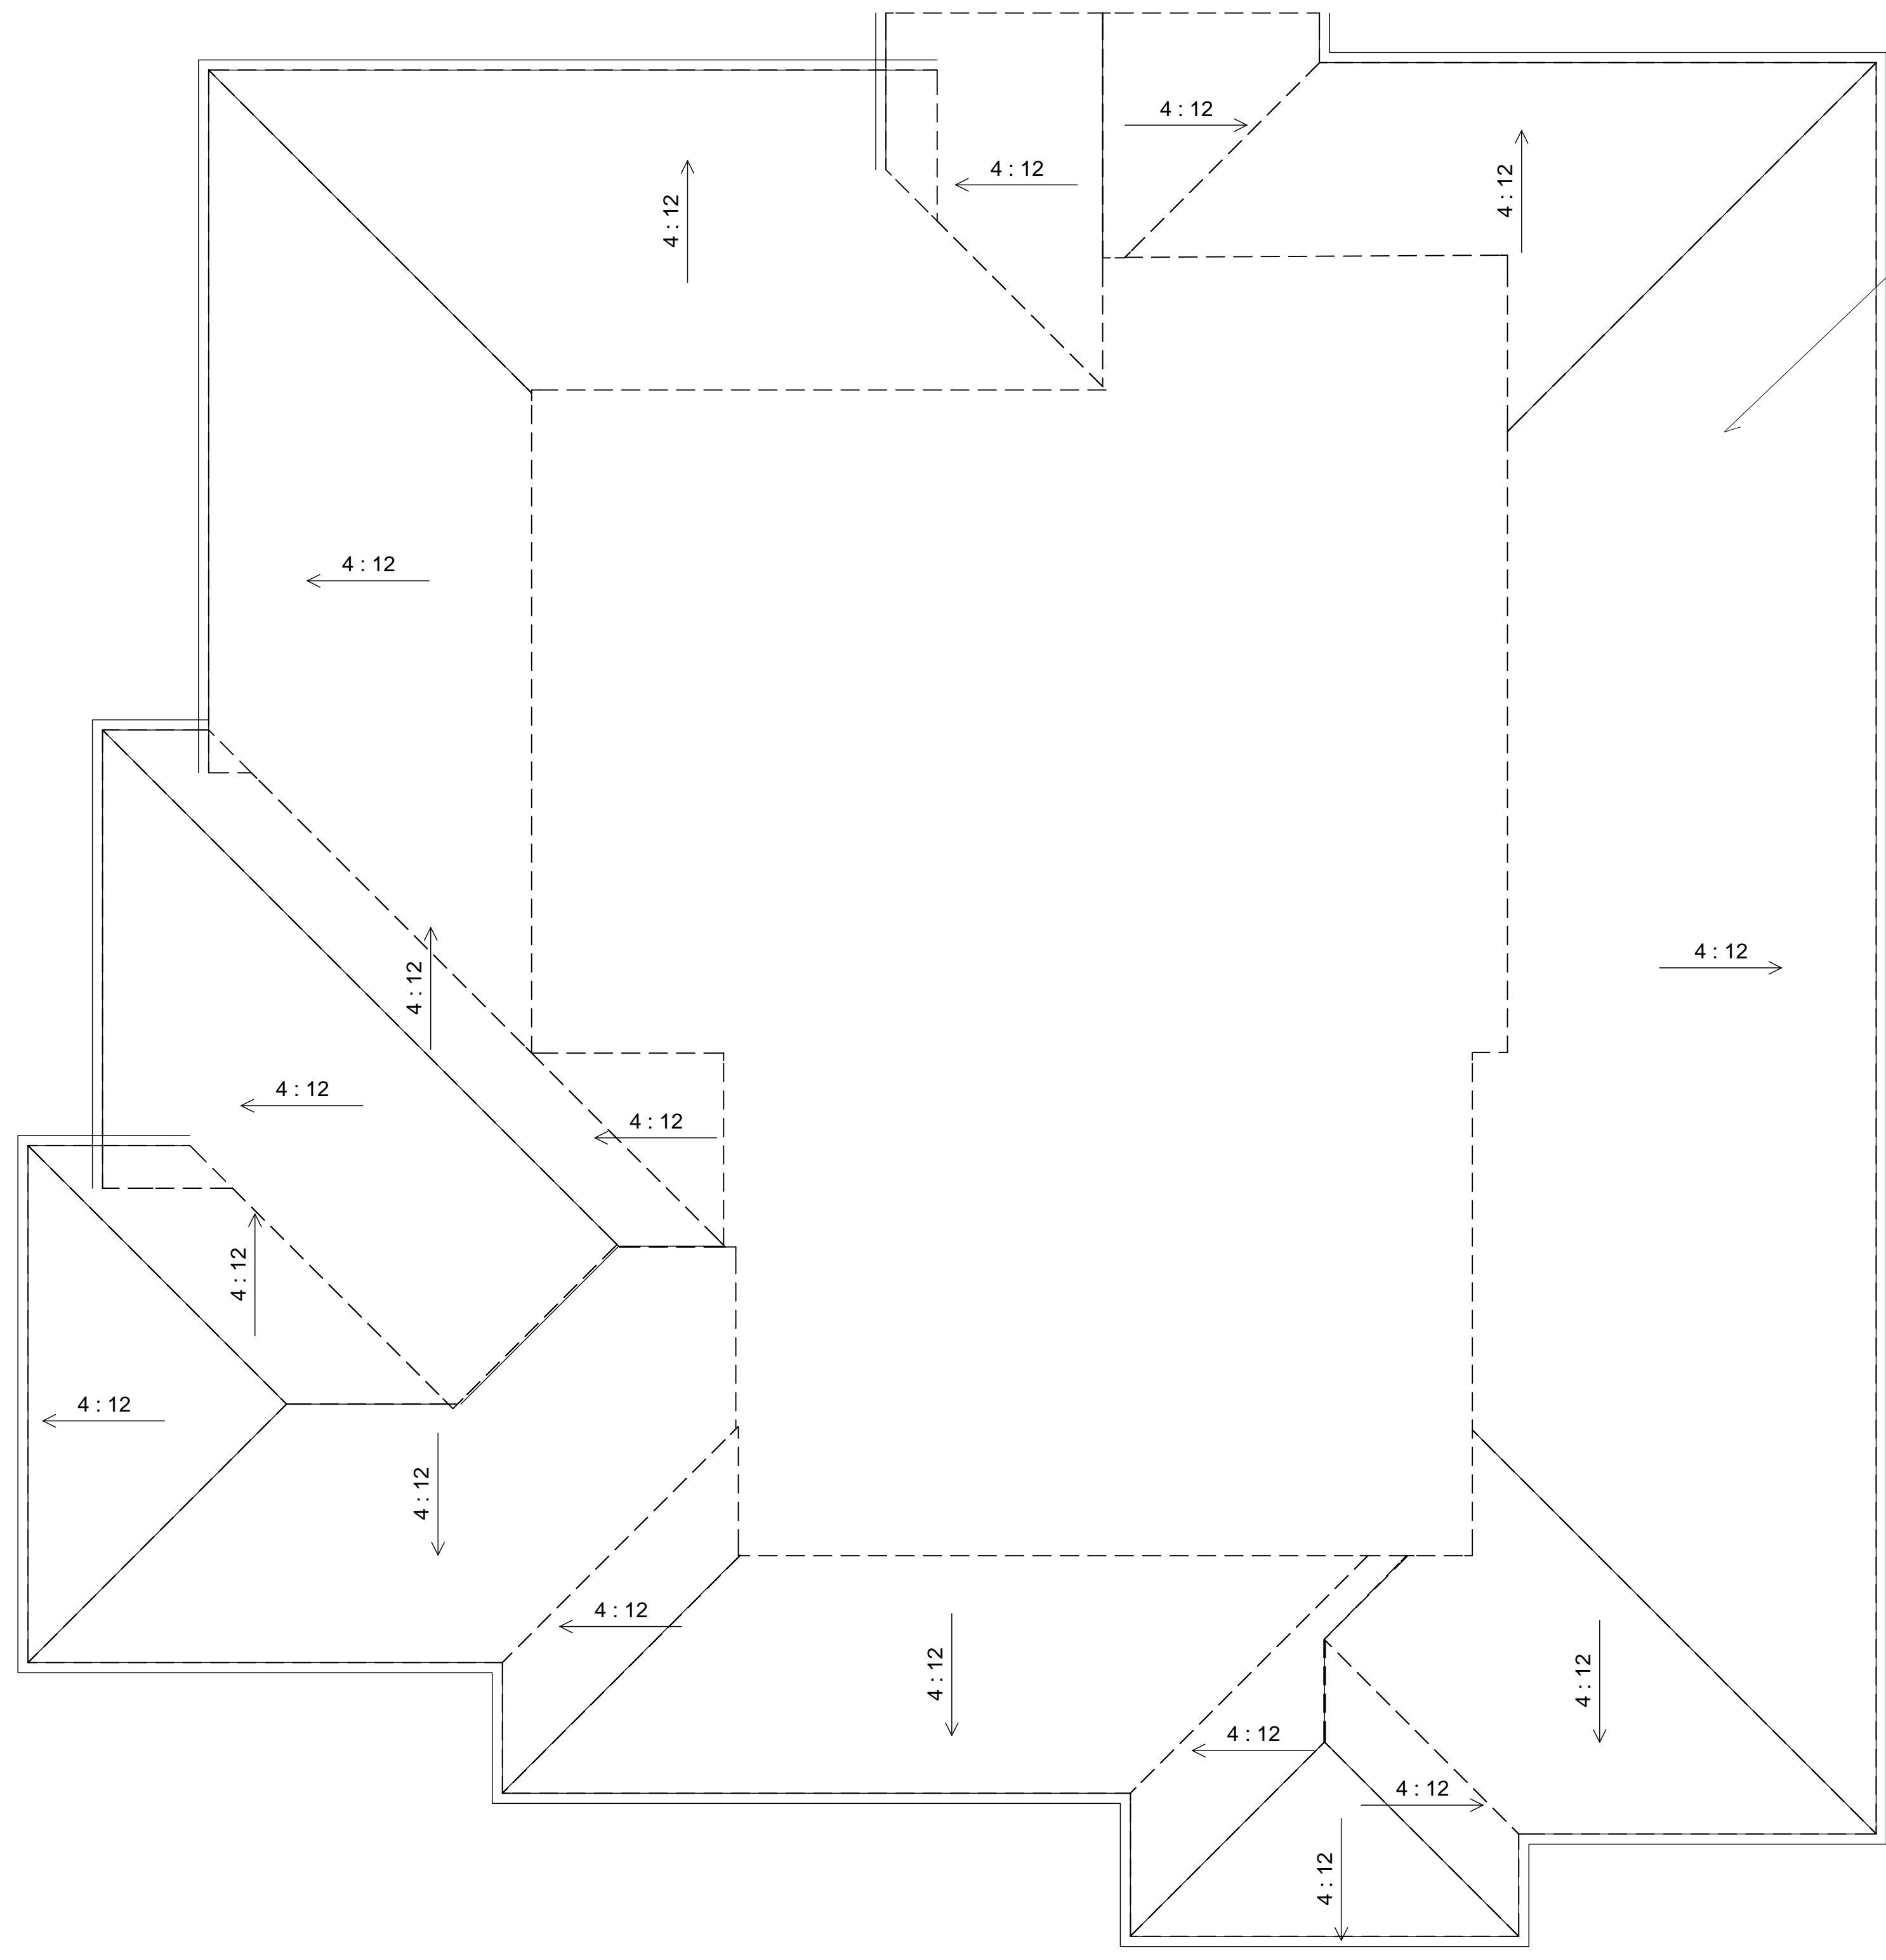
1st Floor

Comp Shingle roofing over 2 layers of #15 felt for entire roof

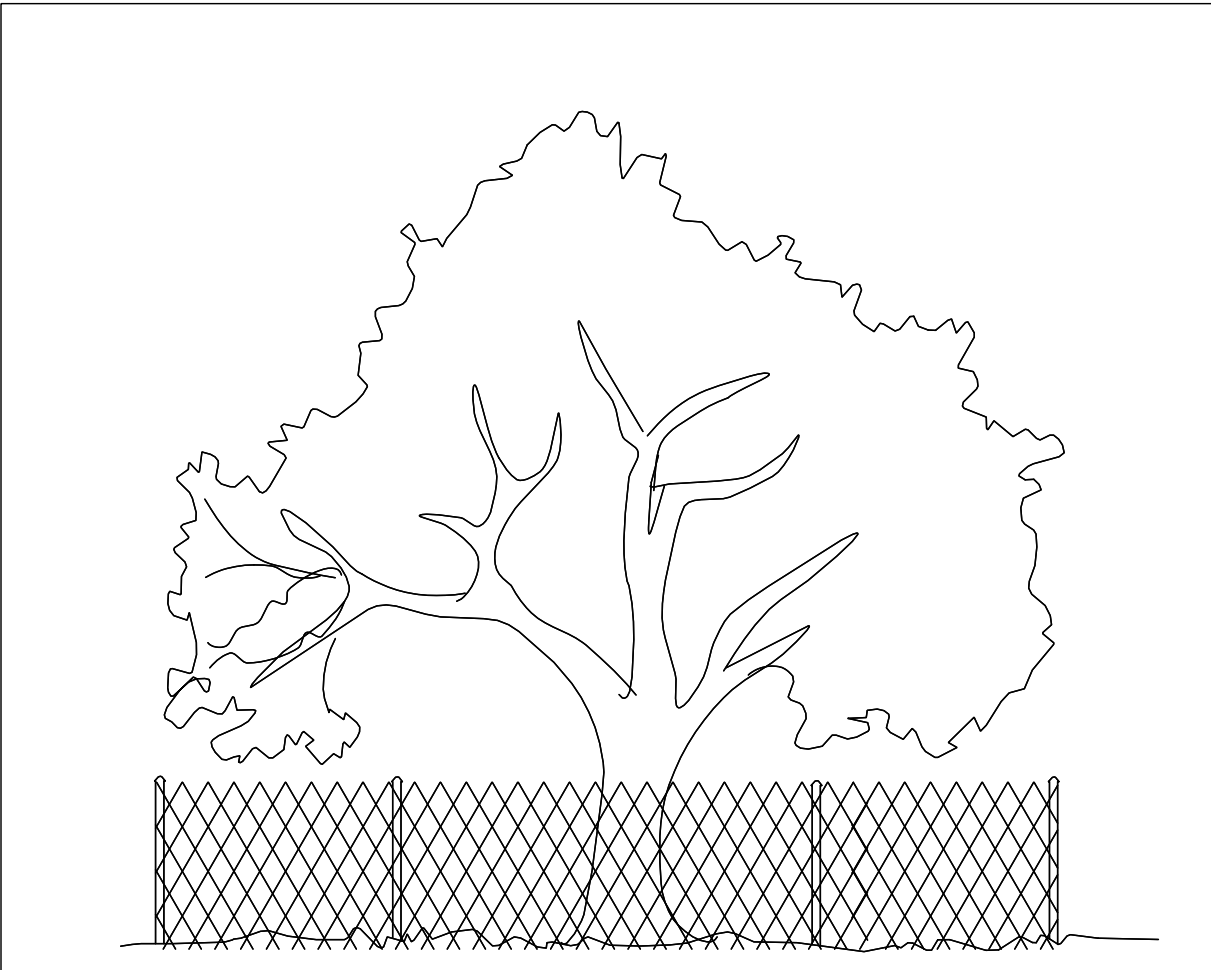
Tree Protection N.T.S.

Chain Link to be 5' tall min
Chain link to follow the dripline of the tree
Posts to be 4' on center
Posts to be driven 2' into the ground
