# MORTON AVENUE RESIDENCE

## 1716 Morton Avenue, Los Altos, CA 94024

MORTON AVE.  
RESIDENCE  
LOS ALTOS, CA

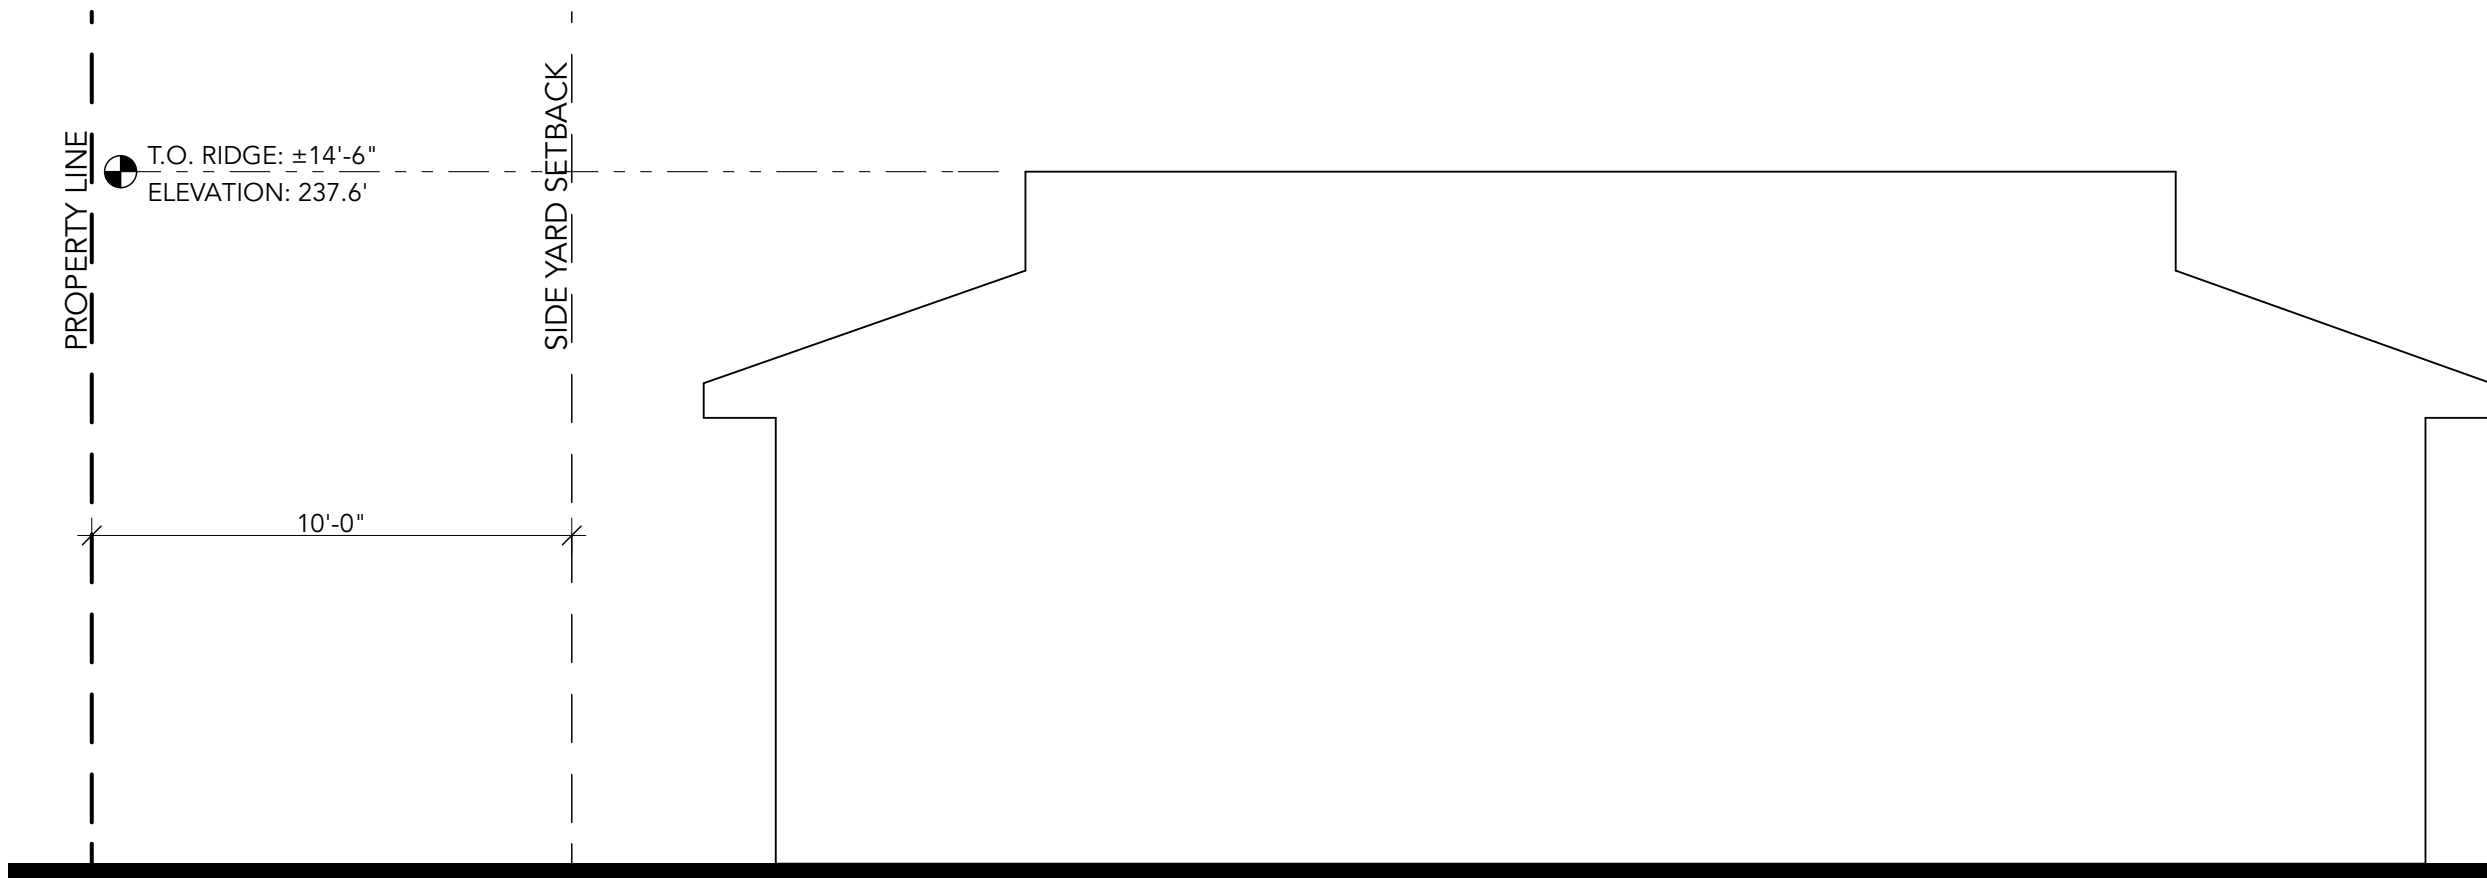
**E0 EXISTING FRONT ELEVATION**  
SCALE: 1/4" = 1'-0"

**NOTE:** PROPOSED GRADE AND NATURAL GRADE ARE VIRTUALLY IDENTICAL. PROPOSED STRUCTURE'S MAXIMUM HEIGHT IS BELOW THE TOLERANCE OF VARIATION BETWEEN THE NATURAL AND PROPOSED GRADE AT ALL POINTS.
