**TO:** Design Review Commission  
**FROM:** Sierra Davis, Assistant Planner  
**SUBJECT:** 15-SC-44 – 1716 Morton Avenue

**PROJECT DESCRIPTION**

This is a design review application for a new two-story house. The project includes 3,710 square feet on the first story, 1,008 square feet on the second story and a 562 square-foot detached garage. The following table summarizes the project's technical details:

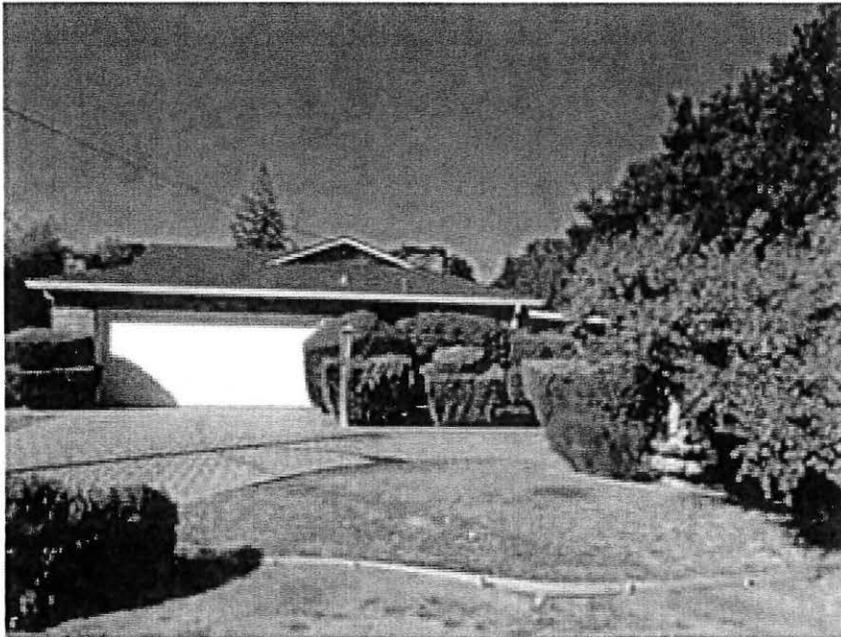
Tree Survey of  
1716 Morton Avenue,  
Los Altos, CA 94024

This survey provides a numbered map and complete and detailed information for each tree surveyed. There are 15 trees included in this report. Seven of the trees surveyed are protected under City of Los Altos tree ordinances. The health of trees surveyed was rated from Poor to Good and their structure was rated from Fair/Poor to Fair. One protected Monterey pine was recommended for removal due to health and structure issues. Two protected trees and 3 non-protected trees will be removed related to the proposed project. Impacts to a third protected tree can be adequately protected by procedures recommended in this r=report.
