TO: Design Review Commission
FROM: Zachary Dahl, Planning Services Manager, Current Planning
SUBJECT: 16-SC-16 – 735 Raymundo Avenue

PROJECT DESCRIPTION

This is a design review application for a new 4,450 square-foot one-story house that exceeds 20 feet in height. The following table summarizes the project's technical details:

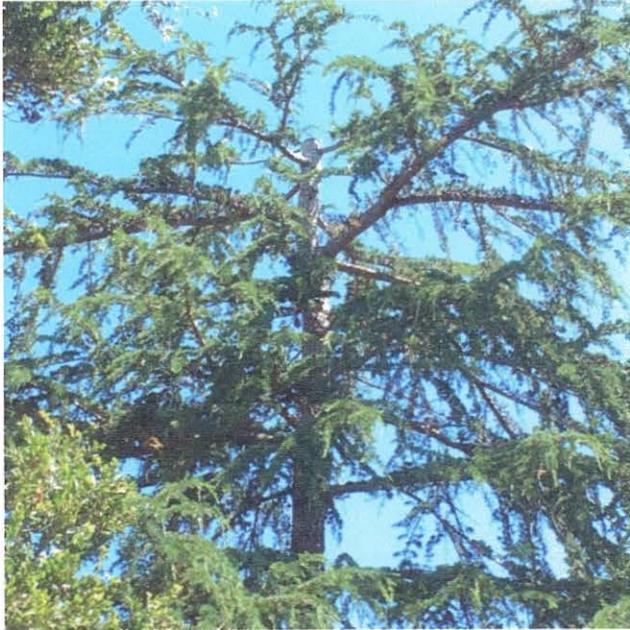
Showing topped cedar #2

#2-Deodar cedar tree #2 has a diameter of 20.7 inches making it a protected tree in the city of Los Altos. This tree is located in the center of the front yard and has been skinned up for vertical clearance and topped. As a result, the tree is top heavy as the tree has a poor live crown ratio of 50%, making the tree more susceptible to wind throw. The topping of the tree will create codominant limbs that will not develop proper branch to trunk unions, and that are prone to failure. The new proposed landscape in this area shows an orchard of fruit trees to be planted. In order for the owner to enjoy his property he would like to restore some of Los Altos history of an orchard town, by planting a small orchard in the front yard area, similar to the orchard in front of town hall. It is necessary to remove this tree in order for the owner to enjoy his property.

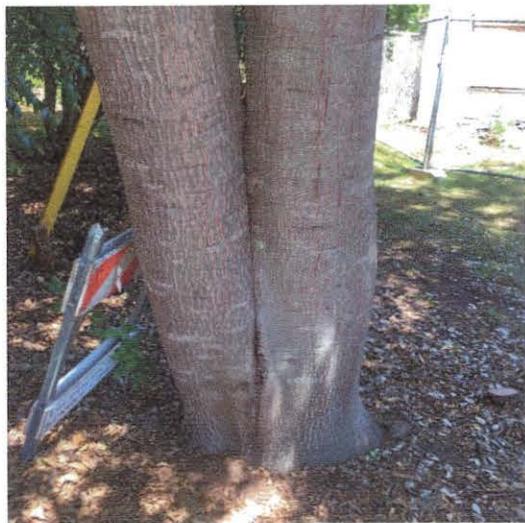
Showing poor crotch on oak

#3-Coast live oak tree #3 has some serious form flaws that have made the tree an immediate hazard. This tree is codominant at 3 feet with included bark. Included bark forms in the junctions of codominant stems where there is a narrow angle union, meaning the junction looks like a "V" rather than a "U." As the tree grows the narrow union will essentially fill with bark and create a growing area of structural weakness in the tree. Even in young trees, when you notice a very narrow angle (creating a "V" at the junction of branches) it is likely that stress put on the either of the codominant stems can cause splitting, or even cause the stem to break off at the junction. As the 2 leaders grow they have the potential to push against each other often until the point of failure. This area of included bark is bulging on both sides of the poor crotch and a seam down to the base of the tree is present. These are all signs of a large leader failure in the near future. This tree is a hazard and should be removed. Also this tree is in the foot print of the new driveway and will need to be removed to perform necessary property improvements.

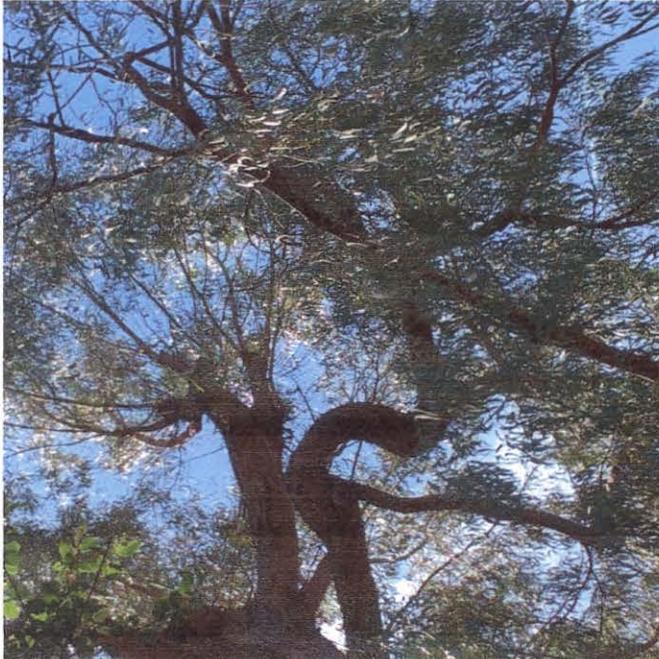
Showing topped tree with water sprouts

#15-Eucalyptus tree #15 has been topped in the past. Topping trees is never recommended as it creates new watersprout growth. These watersprouts do not develop proper branch to trunk unions and are prone to failure in normal weather conditions. Girdling roots were also present at the base of this tree. This tree is located only a few feet from the existing garage. Roots of this tree have damaged the existing garage foundation as large cracks are seen on the garages floor. Demolishing the garage will have a high impact on the eucalyptus tree. Because of the proximity to the existing garage and because the trees poor health, this tree is being recommended for removal as it will be highly impacted by construction activity and because of its hazardous nature created by poor pruning practices.

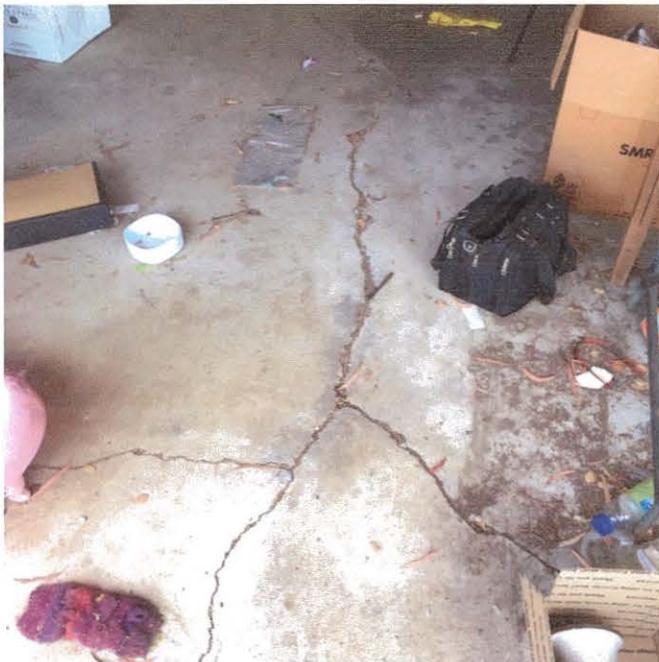
#16-Coast live oak tree #16 is in fair health. This tree is also located in close proximity to the existing garage and has caused damage to the garage foundation. This tree is proposed for removal to facilitate the construction of a spa, gazebo, and a pool equipment room. Because of the proximity to the existing garage and because of the damage caused to the garage, this tree is proposed for removal. It is also necessary to remove this tree in order for the construction of the spa, gazebo and pool equipment room.

Showing damage to garage
