DATE: June 15, 2016  
AGENDA ITEM # 4

**TO:** Design Review Commission  
**FROM:** Sierra Davis, Assistant Planner  
**SUBJECT:** 16-SC-17 – 839 Parma Way

This is a design review application for a new two-story house. The project includes 2,971 square feet on the first story and 875 square feet on the second story. The project also includes a 1,760 square-foot basement. The following table summarizes the project’s technical details:

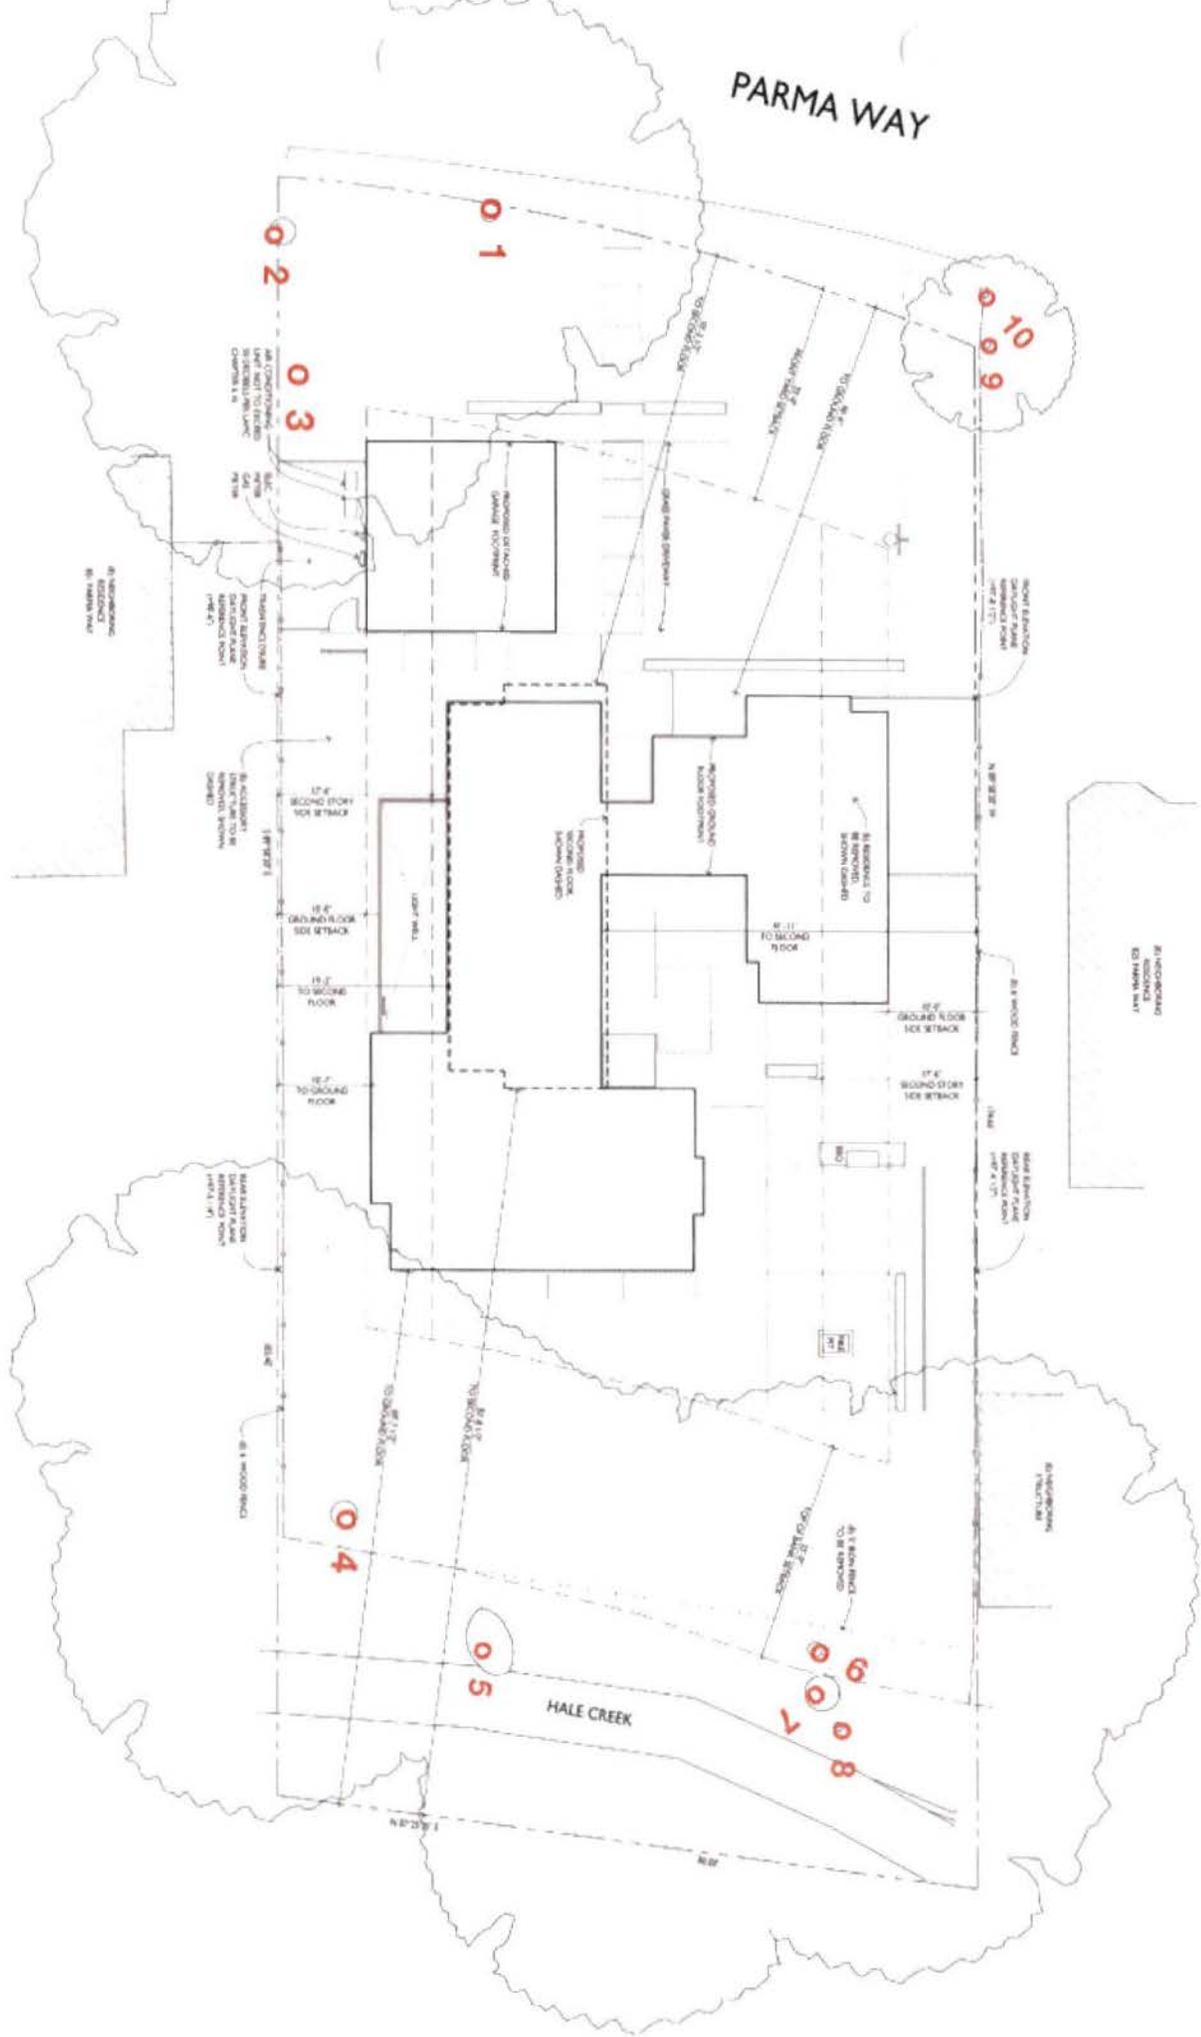
**TREE SURVEY** urban tree management, inc.

PARMA WAY

**Client:** Arcanum Architecture, Inc  
**Address:** 839 Parma Way, Los Altos, CA 94024  
**Date:** 12/17/2015

This survey provides a numbered map and complete and detailed information for each tree surveyed. There are 10 trees included in this report. Eight of the trees surveyed are protected under City of Los Altos tree ordinances. The health of trees surveyed was rated from Fair/Good to Good and their structure was rated from Fair/Poor to Fair. No trees are recommended for removal due to health and structure issues.

Trees 5, 7 and 8 appear to be located at or below the high water line of the creek. Tree 5 and 7 are particularly large oaks with substantial weight leaning towards the backyard and home. With forecasts for a very wet winter ahead, end-weight reduction and close monitoring of their root structures for erosion is recommended.
