TO: Design Review Commission
FROM: Sean K. Gallegos, Assistant Planner
SUBJECT: 13-SC-33 – 1650 Morton Avenue

PROJECT DESCRIPTION

This is a design review application for a new two-story, single-family house. The proposed project will demolish an existing one-story house and accessory structure and construct a new house with 2,289 square feet on the first story and 1,261 square feet on the second story. The following table summarizes the project:

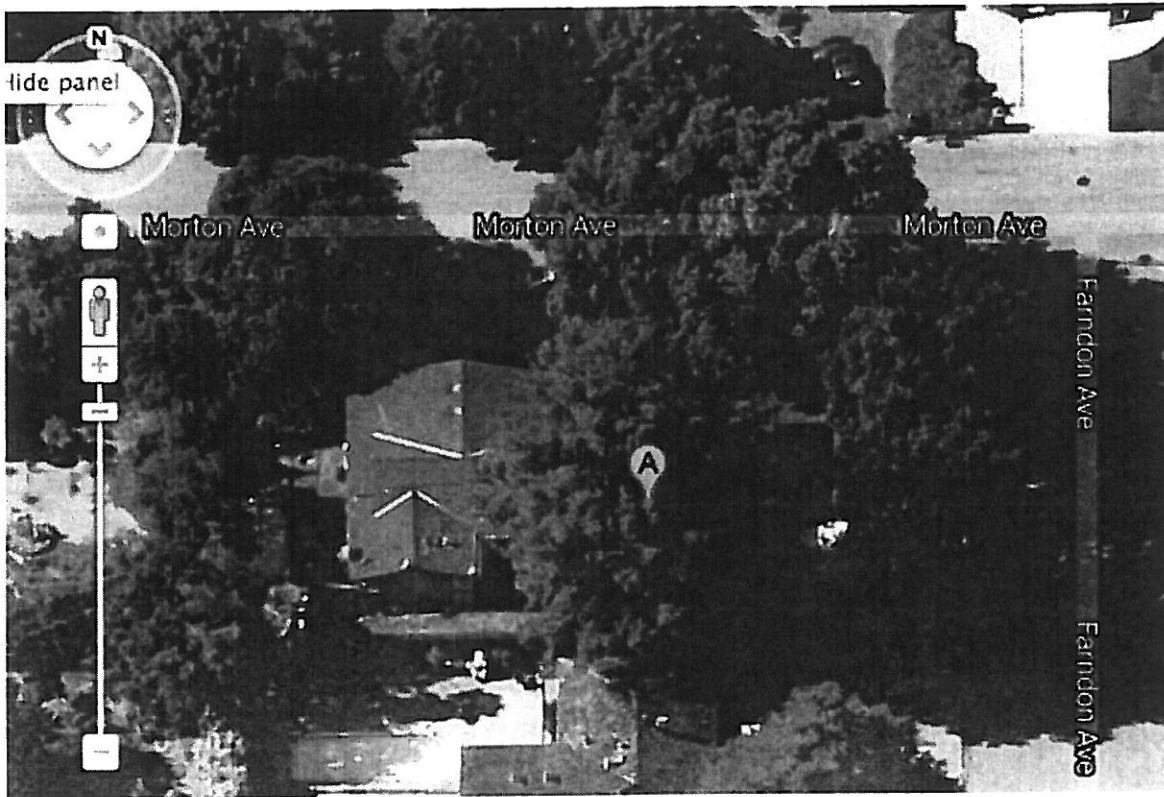
Image 1: Aerial overview of the property with the "A" situated over the two coast redwoods

The property is located at the corner of Morton Avenue and Farndon Avenue (Image 1). There is a single story residence with three holly oaks and three soap bark growing around the outer perimeter along the road front. Two coast redwoods are growing against the south boundary near the neighbor fence and one tree may have shared ownership.

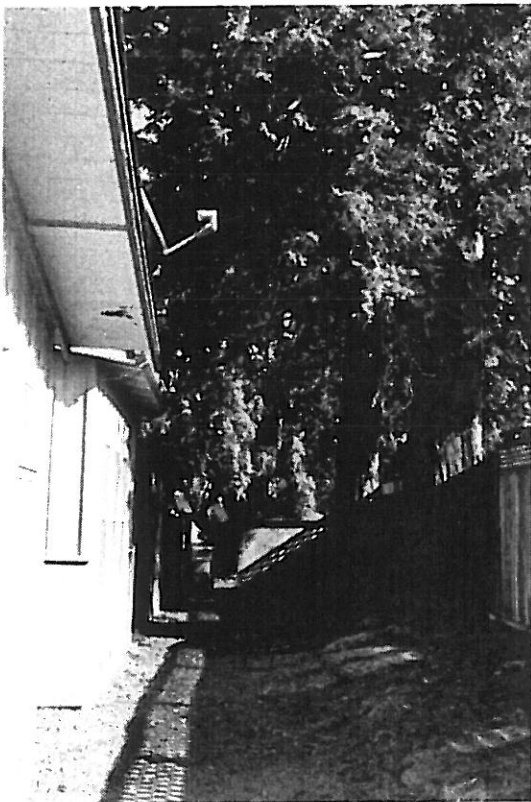
Photo 1: Coast redwoods near the footprint of the house on the south side

All the trees will be moderately affected by the proposed development. Each tree will likely be influenced on at least one side of its root zone depending on construction techniques, future landscaping, and new driveway construction (Photos 1 and 2).

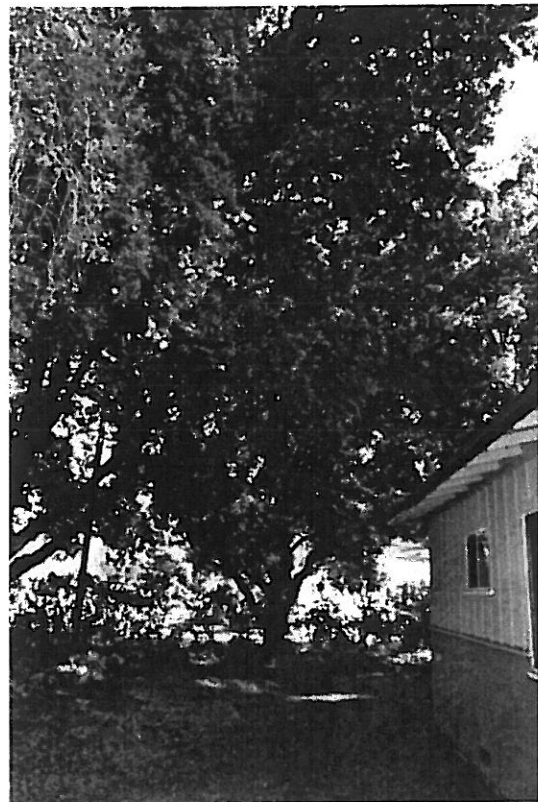
Photo 2: Holly oak near the footprint of the house on the south side

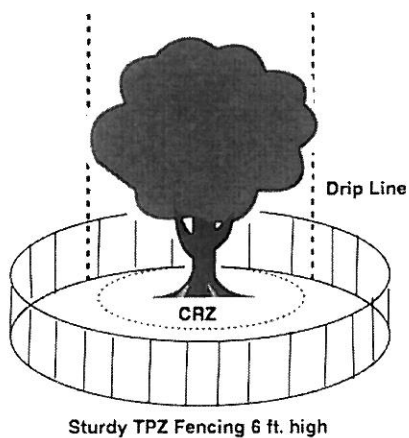
Figure 1: The image above depicts the drip line, CRZ and TPZ.

Tree protection focuses on protecting trees from damage to the roots, trunk, or scaffold branches from heavy equipment (Appendix D). Two zones of protection need to be determined to protect the tree's health and structure, the tree protection zone and the critical root zone (Figure 1).

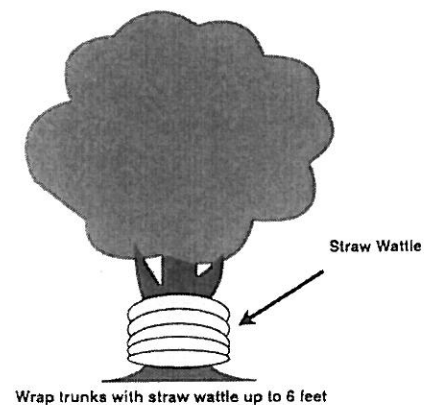
Figure 2: The image above depicts wrapping the trunk with straw wattle.

Preventing **mechanical damage** to the main stems from equipment or hand tools can be accomplished by wrapping the main stem with **straw wattle** (Figure 2). The wattle will create a porous barrier around the trunk and prevent damage to the bark and vascular tissues underneath.

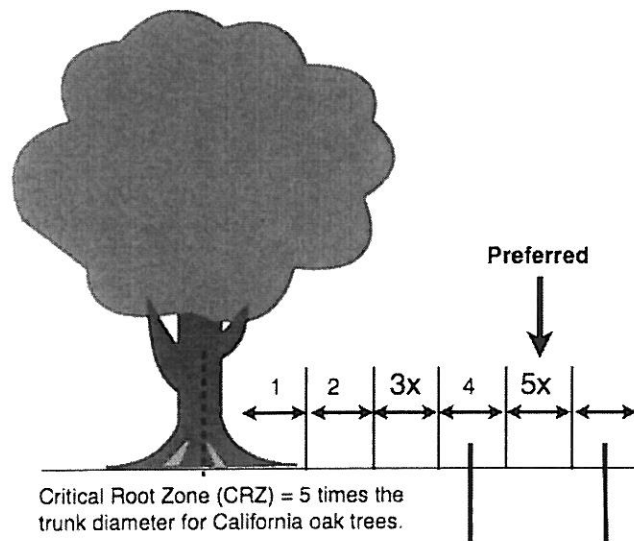
Figure 3: The image above depicts the preferred Critical Root Zone distance for oaks.

The recommended maximum encroachment distance into the root zone of oaks on one side is five times the trunk diameter (Coate, B.)(Costello, L., Hagan, B., Jones, K. 2011) (Figure 3).

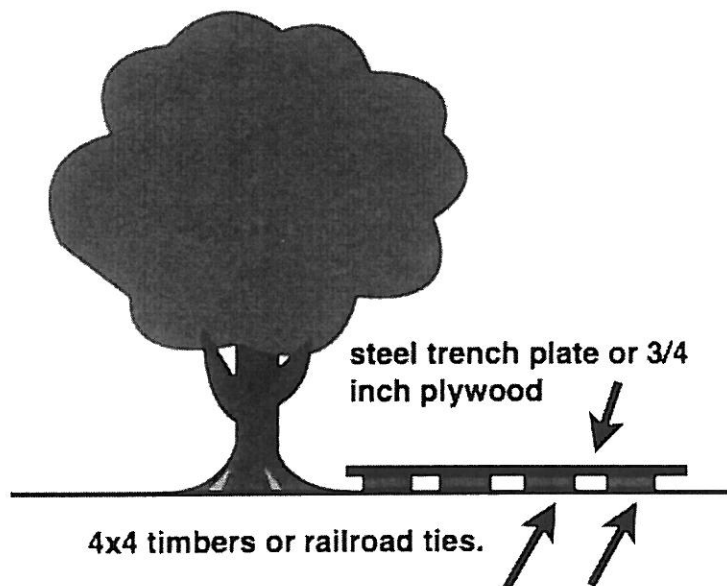
Figure 4: The image above depicts bridging for a work platform under the trees.

Placing **mulch** and plywood or steel road plates over the CRZ/TPZ or building a low scaffold will create a work platform that can be used to help protect the roots from compaction (Figure 4).

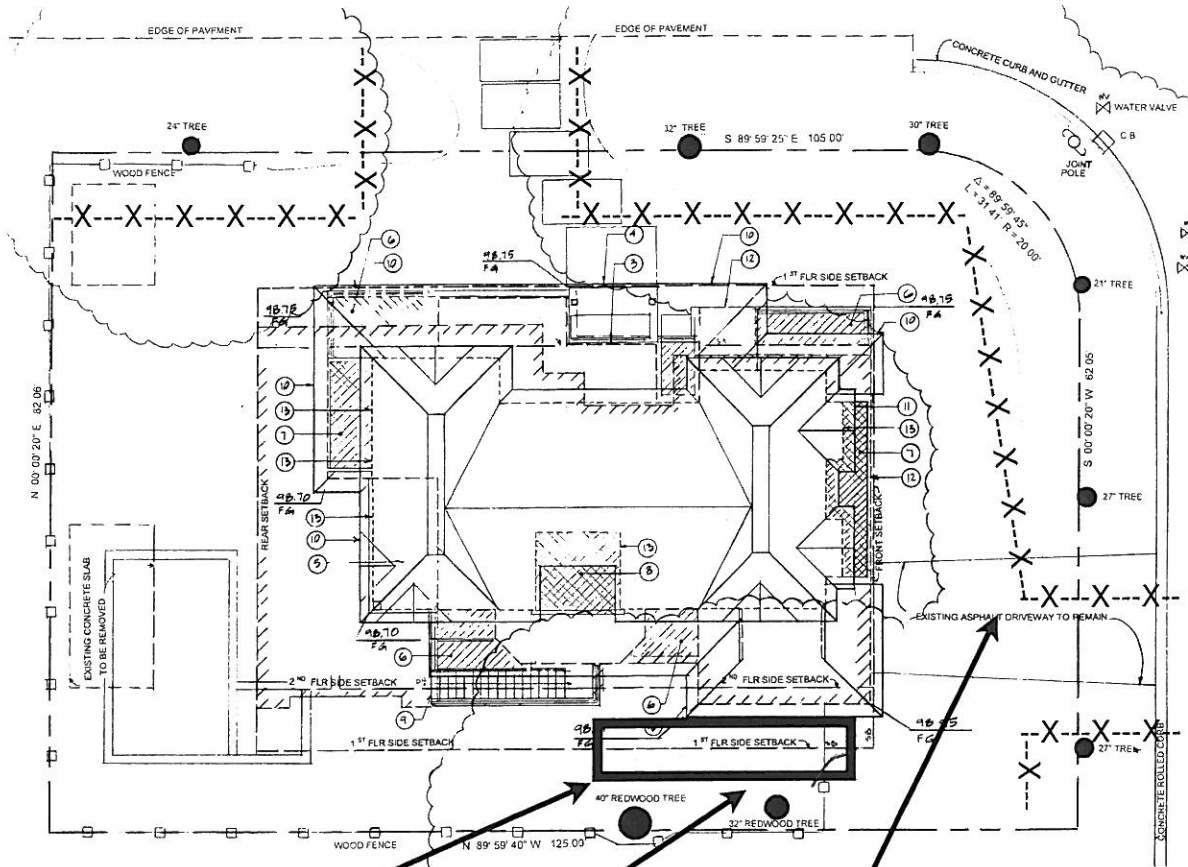
Appendix A: Protection Map

Bridge with mulch or timbers and plywood or road plate near the coast redwoods.

Place tree protection fencing 13 feet from the trunks or at edge of pavement.

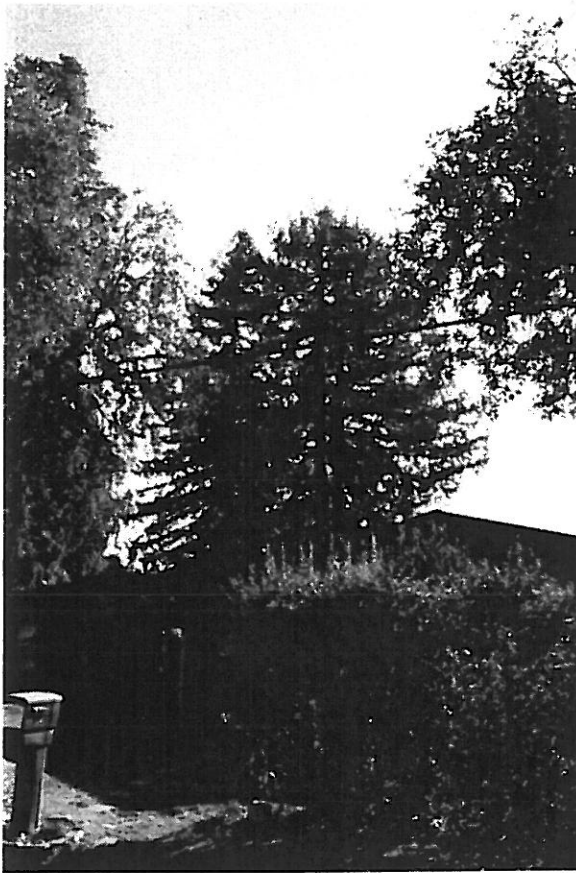
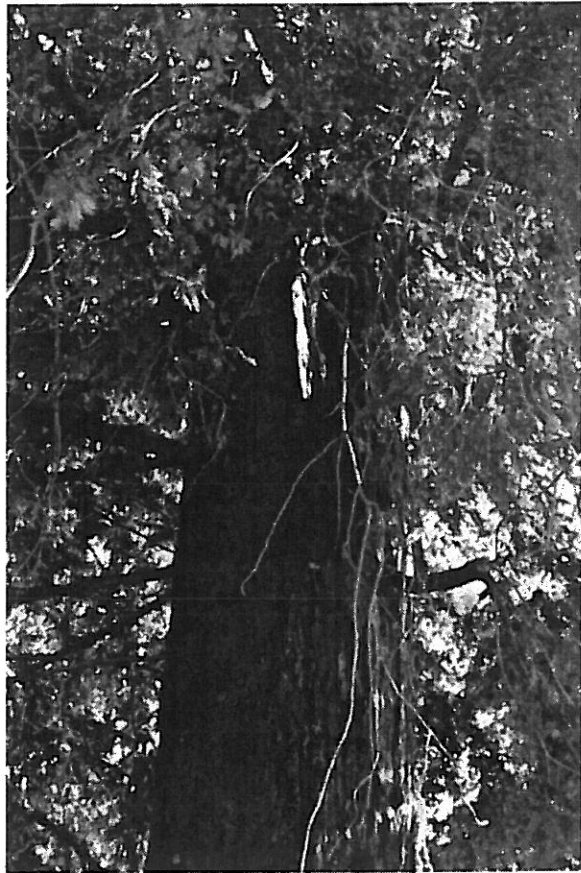
C2: Coast redwood with codominant tops

The eastern most coast redwood has a single stem while the western most tree has **codominant stems** originating approximately 20 feet above grade. Foliar color, size, and density are normal for both coast redwood trees. The trees are growing along the southern property boundary and at least one tree may be co-owned as its trunk flare straddles the fence line, and the fence needed to be configured to accommodate the growth.

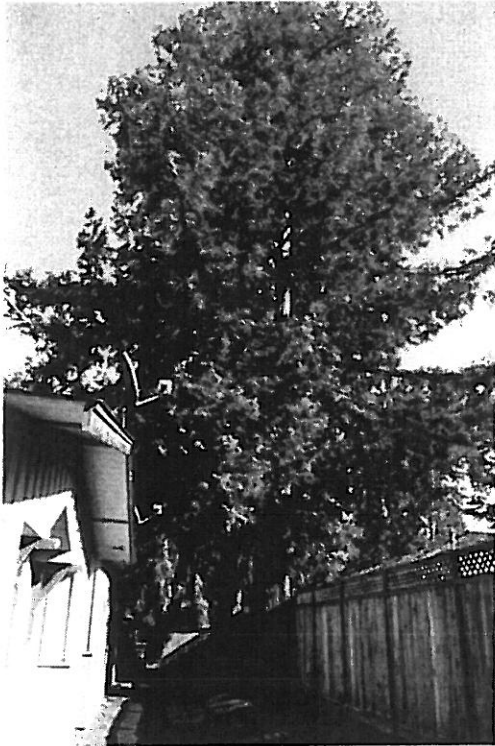
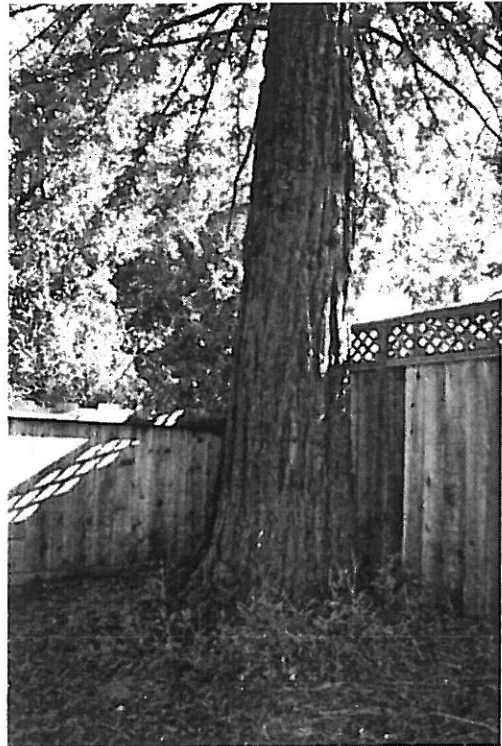
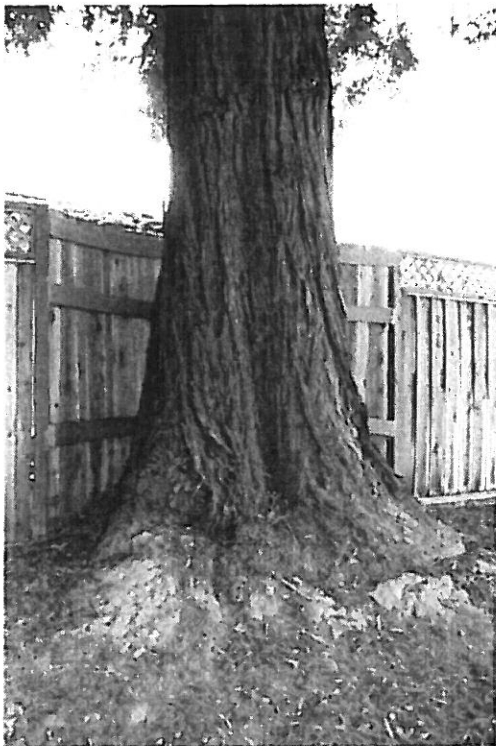
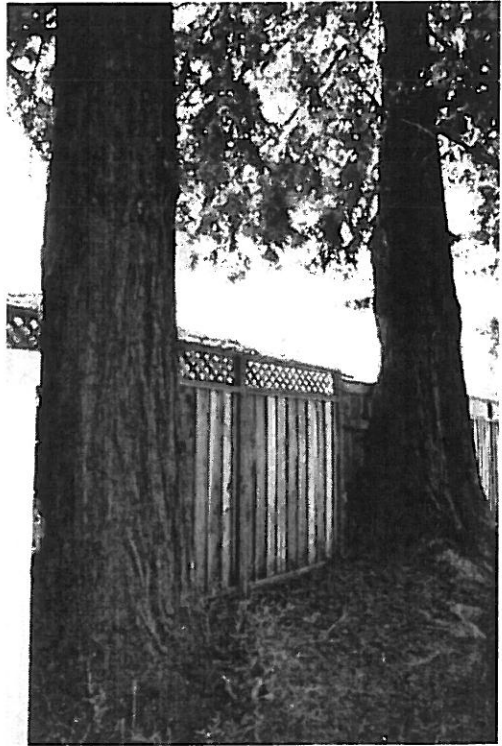
C3: Coast redwoods along the south side
