16-SC-08 - 581 University Avenue

# RECOMMENDATION:

# PROJECT DESCRIPTION

Tree Survey of 581 University Avenue, Los Altos, CA 94022

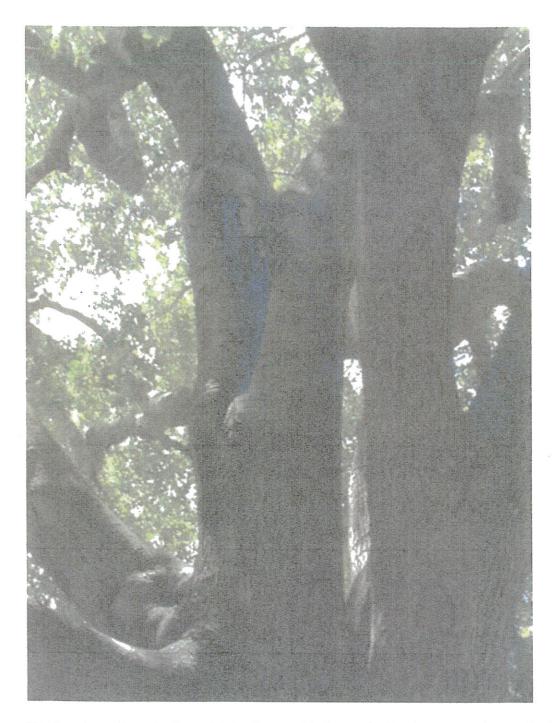
The tree has a large hollow at 12', where a third, equally dominant, poorly attached leader split from the other leaders. The hole is about 3' long and is the heartwood (dense, non-living xylem that gives trees structural strength and stability) has rotted out of the center. The remaining outer portions of these conjoined leaders are structurally weak without the heartwood and could split from each other or break from the lower tree at any time. Failure of this portion of the tree would likely cause more leaders to fail below it as it fell.
