**TO:** Design Review Commission  
**FROM:** Sierra Davis, Assistant Planner  
**SUBJECT:** 16-SC-24 – 300 Cuesta Drive

Approve design review application 16-SC-24 subject to the listed findings and conditions

This is a design review application for a new two-story house. The project includes 2,506 square feet on the first story and 1,381 square feet on the second story. The following table summarizes the project's technical details:

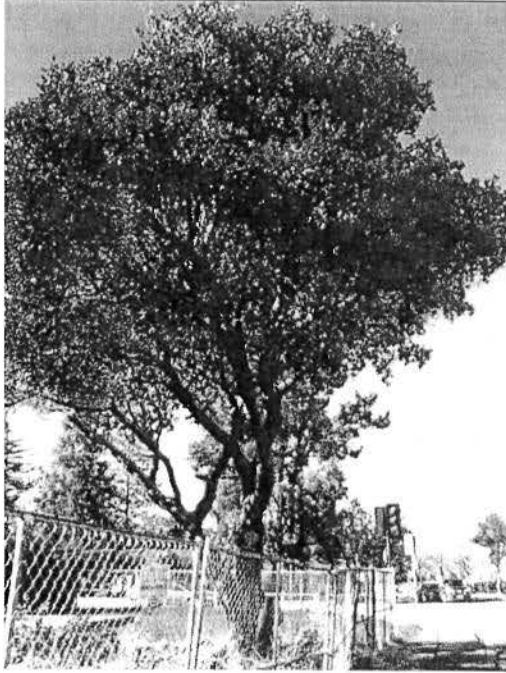
Oak #1 profile

On scales of zero to 100% each, this tree rates out with a health of 75% and a structure of 60%, for an overall condition rating of 70% or "good", after recent severe pruning was performed.

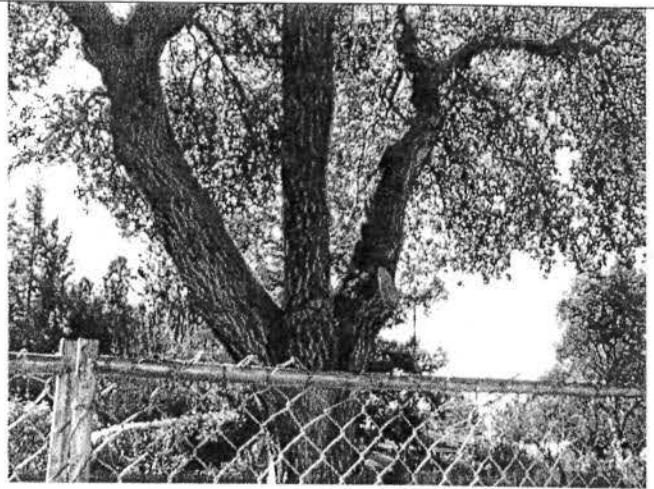
Pruning cuts visible in oak #1

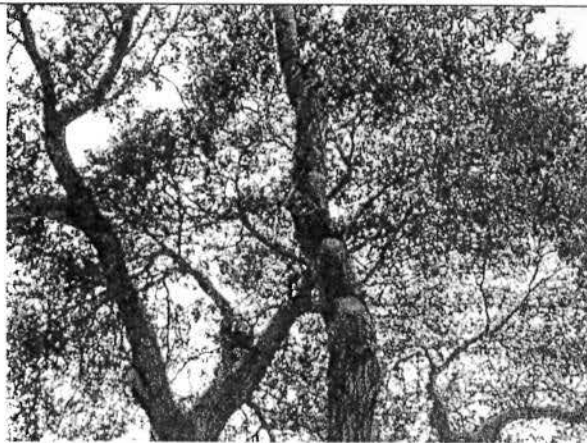
Oak #1 pruning cut close-up view.

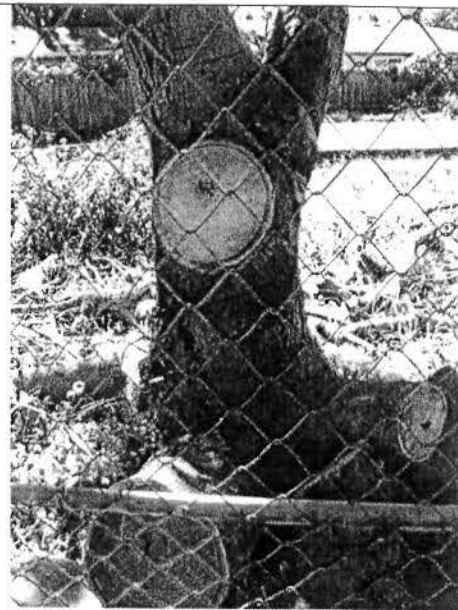
Oak #2 large diameter pruning cut.

**Tree #2** is a coast live oak measuring 27.2 inches diameter. The tree stands 30 feet with a spread of 35 feet. On scales of zero to 100% each, the tree rates out with a health of 70% and a structure of 50%, for an overall condition rating of 63% or "fair", after recent severe pruning was performed.

Approximately eight cuts were made during recent pruning, removing limbs measuring between 4" and 16" diameter each. The overall effect of this pruning was significant loss of above ground biomass and reduction of the health and structure ratings as detailed above. The pruning, although severe, probably does not endanger the life of the tree, given that we have received very good natural rainfall this season which has boosted soil moisture to normal levels.

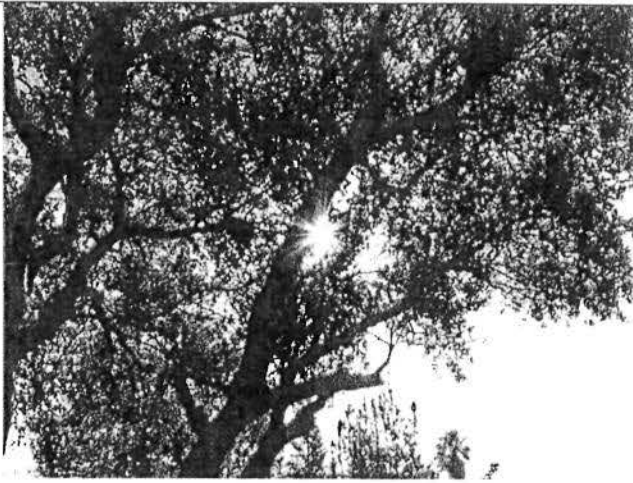
Canopy view of oak #2, showing some moderately large diameter pruning cuts on scaffold limbs.

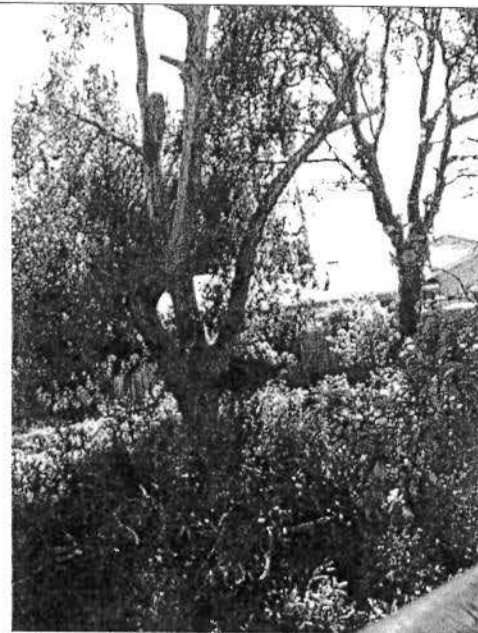
Center of image: oak #3 lower area.

**Tree #3** is a coast live oak measuring 26.8 inches diameter. This tree stands 30 feet with a spread of 20 feet. On scales of zero to 100% each, the tree rates out with a health of 30% and a structure of 30%, for an overall condition rating of 30% or "poor", after recent severe pruning.

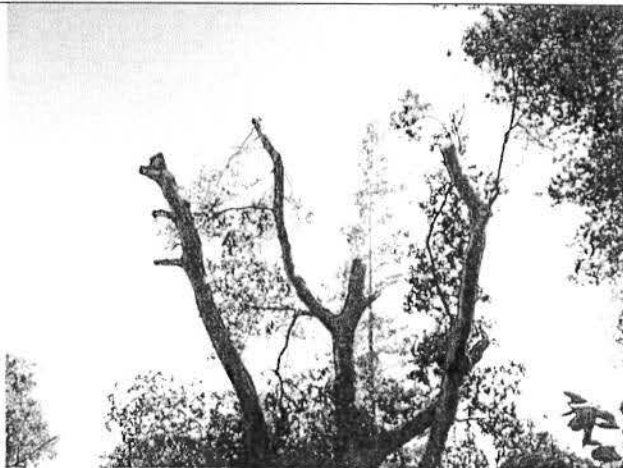
Upper canopy area of oak #3's remaining above ground biomass, showing the topping cuts that were made throughout the entire canopy. The tree will have to be managed by a very good pruner over time to periodically prune selected sprouts arising from near the cut areas, to restructure a new canopy by using those selected sprouts to form a "new canopy".

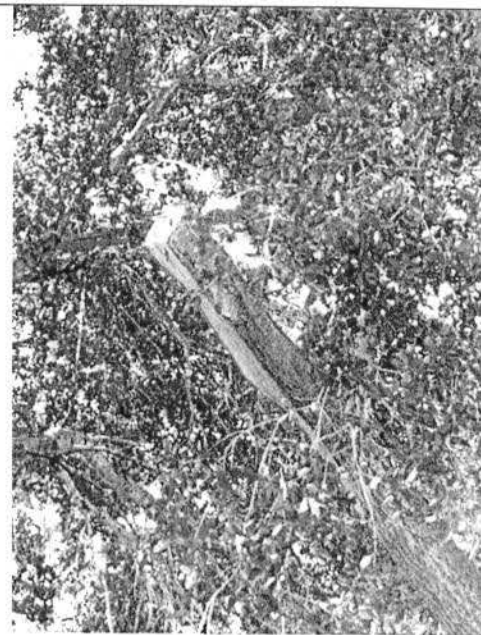
An eight inch diameter limb on oak #3 that sustained a six foot long (approx.) stripped out area where bark peeled off from the pruning cut as the cut portion of the limb fell. This area will have to be removed.

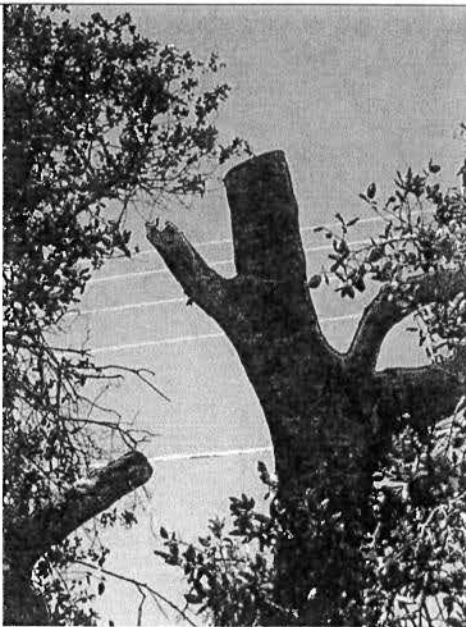
Close-up of another stripped bark area on a smaller diameter stem on oak #3 (center of image) that will have to be removed to avoid tissue dieback.
