**TO:** Design Review Commission  
**FROM:** Steve Golden, Senior  
**SUBJECT:** 18-V-05 and 18-SC-14 – 901 Madonna Way

This application includes variances to allow for a daylight plane encroachment and reduced second story side yard setback for a new two-story house. The project includes a variance to encroach into the right-side daylight plane and a second story side yard setback of 12 feet where a 17.5-foot setback is required on the right side, and design review for a new two-story residence that includes 2,018 square feet at the first story and 2,235 square feet at the second story. The following table summarizes the project's technical details:

**Variance Justification Letter for 901 Madonna Way Los Altos  
Regarding 2<sup>nd</sup> floor 17.5ft side setback encroachment**

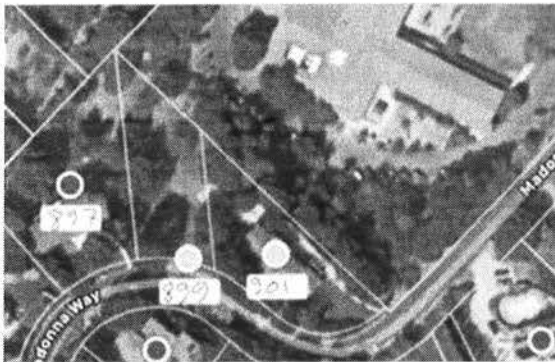
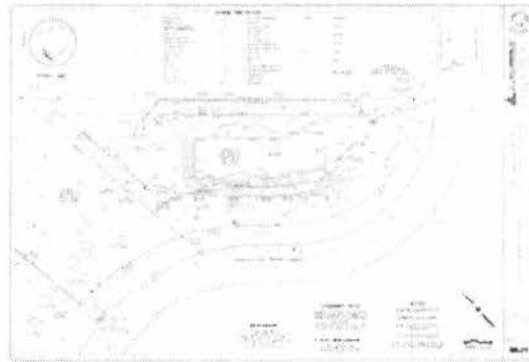
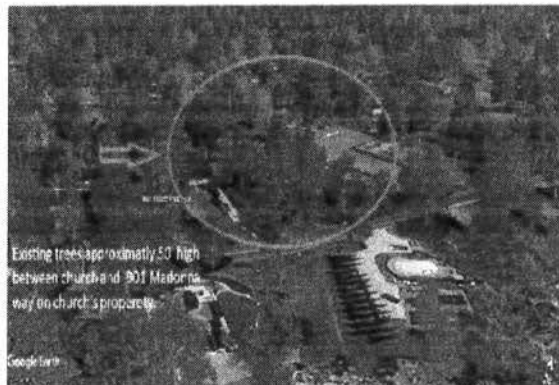
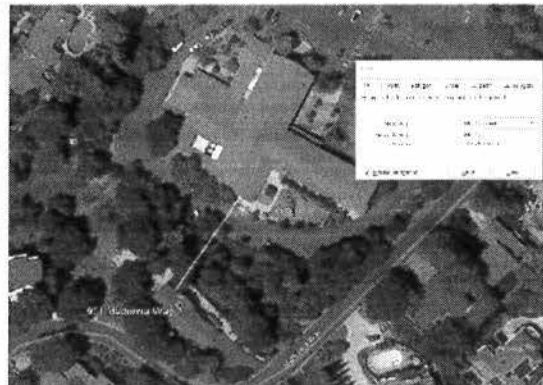
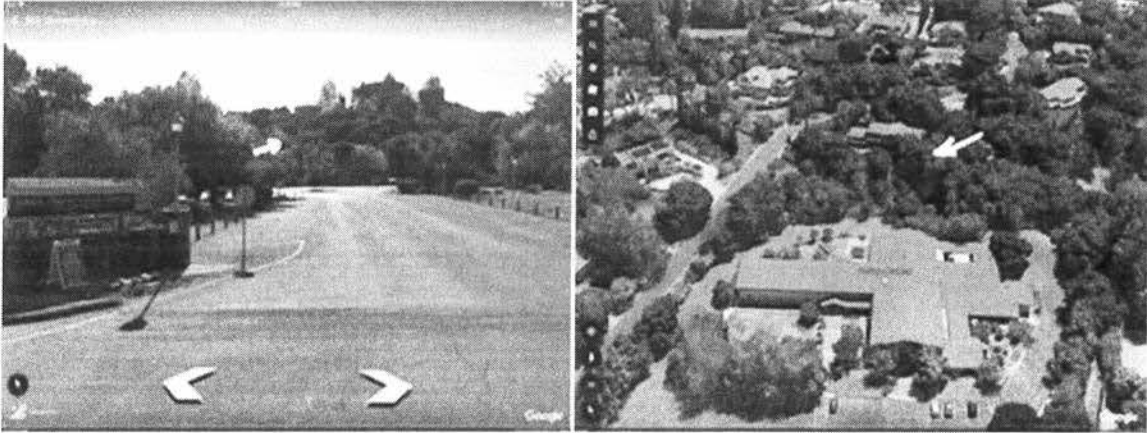
901 Madonna Way in Los Altos has an odd shape lot. The front setback extends to the left side of the property all the way to the neighbors property at 899 Madonna Way. The shape of this lot is eventually replacing the 1<sup>st</sup> floor side setback from 10ft to 25ft. This pushes the new structure to the right side by 15ft. Due to this condition, we would like to get a 2<sup>nd</sup> story side setback variance on the right side to encroach into the 17.5ft 2<sup>nd</sup> story side setback for the kitchen wall and the overhang on the balcony per plans. There are no structures immediately next to this side of the property. The closest structure to this side is a school/Church which is more than 140ft away from 901 Madonna Way, plus there are many tall trees between the two properties which are on the Churches property.

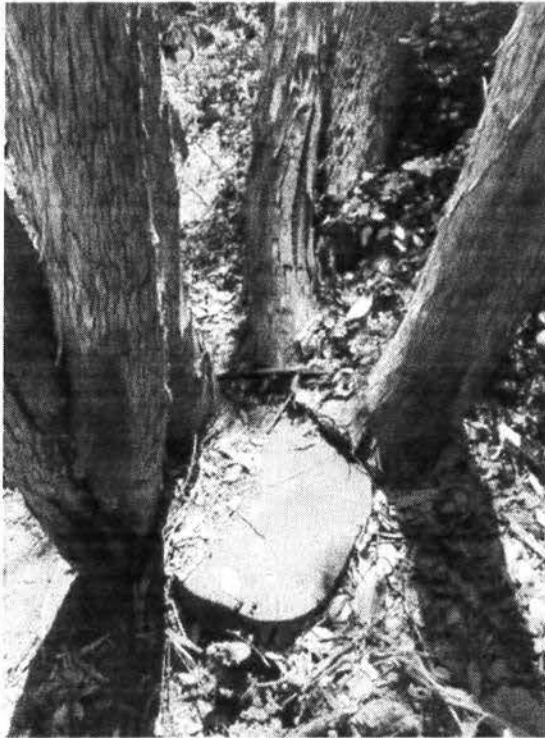
**Showing evidence of past tree removal**

Silver dollar eucalyptus trees #3 and #4 are both in poor condition. These trees are stump re-sprouts from trees that were previously cut down. The stumps were likely not poisoned, so the trees were able to send up new shoots that have now developed into medium sized trees. The old trunks have decayed, making the trees hazardous. The form of the existing trees is poor as they are multi leader at grade. The trunks are all competing for apical dominance (not the natural form of the tree). Included bark in the future is likely. Also, eucalyptus trees tend to be a fire hazard. In comparing wildfire parameters in eucalyptus stands versus native oak woodland (a comparable native habitat structure) fuel loads are significantly greater. Eucalyptus stands can accumulate significantly higher fuel loads than native woodlands. One study found fuel loads of 31 tons/acre in eucalyptus stands as compared to 12 tons/acre in native coast live oak woodlands (National Park Service 2006). These trees are hazardous because of their poor form, therefore removal is recommended. These trees are not of a protected size.

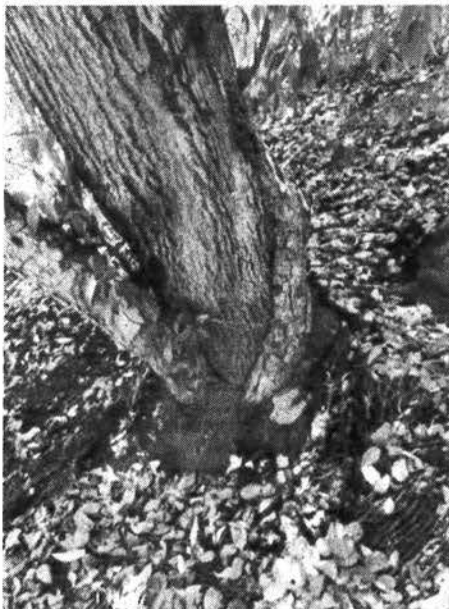
**Showing xylosma trees at risk of girdling oak tree**

Many xylosma trees were observed within the stand of oak trees. These trees are not aesthetically pleasing. The majority of the xylosma trees are heavily suppressed within the oak trees on the lot. These trees do offer a minimal amount of screening. The overall look of the oak trees with the xylosma trees removed would be improved as the trunks would be more visible. None of the xylosma trees are of a protected size. A better choice for planting underneath the oak trees would be toyon trees (*Heteromeles arbutifolia*), as this species natural occurs within an oak woodland habitat. A xylosma tree is in the process of girdling oak tree #10. This xylosma tree should be removed as soon as possible.

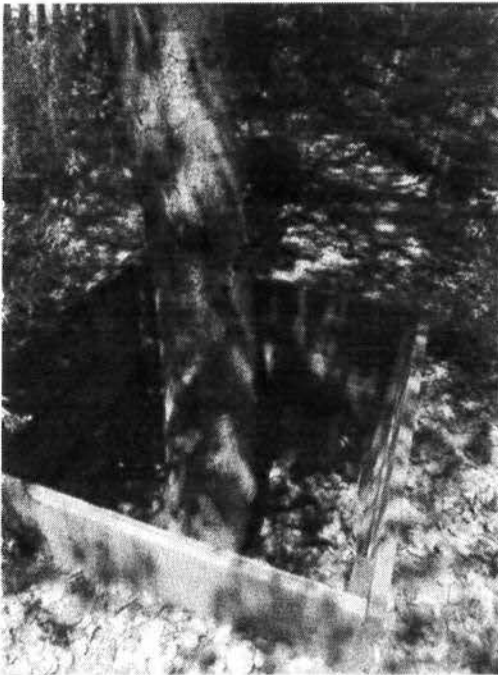
**Showing oak in tree well**

Coast live oak trees #22 and #23 are both located in deep tree wells. The root crown of these trees is at least 3 feet under grade. The tree wells were likely constructed a long time ago when development on the property first occurred as the grade was likely needed to be raised to create a flat area. The trees are exhibiting good vigor, and fair form. These tree wells are critical for the trees survival. The root crowns have been buried by leaf debris and should be exposed by removing the debris as buried root crowns can lead to root rot diseases. In the future problems are likely to occur as one day the trunks will be in contact with the wall of the tree wells and will be at risk of being girdled or buried by leaf debris. At that time a larger tree well will be needed. The tree wells can also be hazardous as people can fall into them if not aware of the deep hole in the ground. It may be a viable option to remove these trees and replant on top of grade to eliminate the tree wells from the property. These trees are under the protected size for the city of Los Altos. The following tree protection plan will help insure the health of the existing trees to be retained.
