COVER SHEET

RESIDENCE
Y RESIDENCE 137 SYLVIAN WAY, LOS ALTOS

ZHENG-ZHONG
NEW SINGLE FAMILY

NEW SINGLE FAMILY RESIDENCE

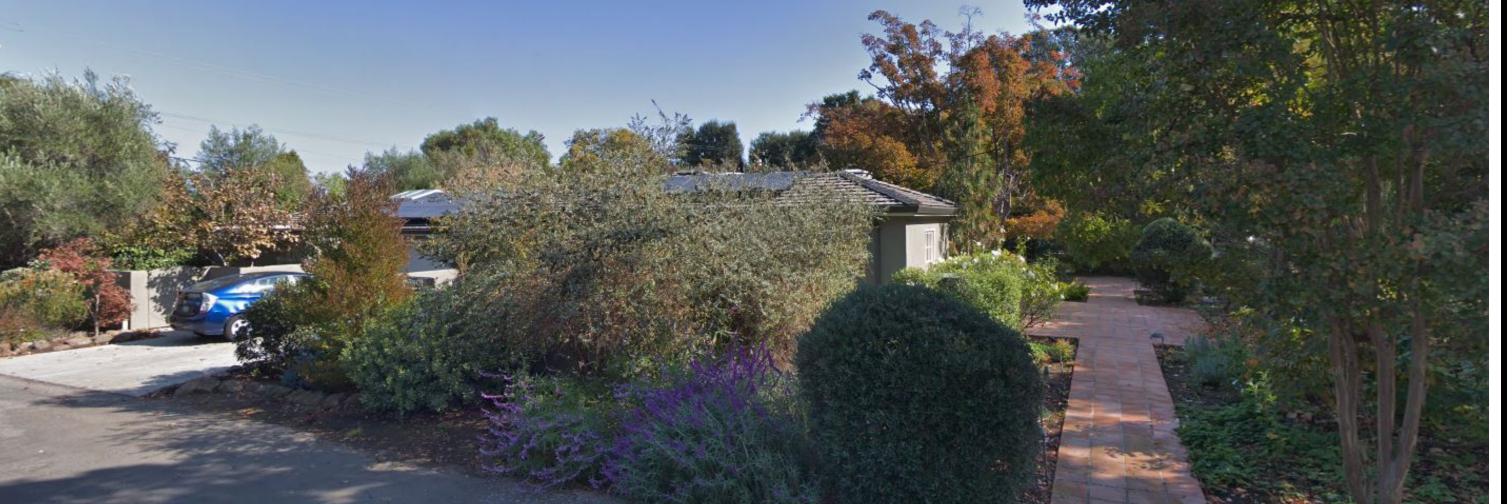
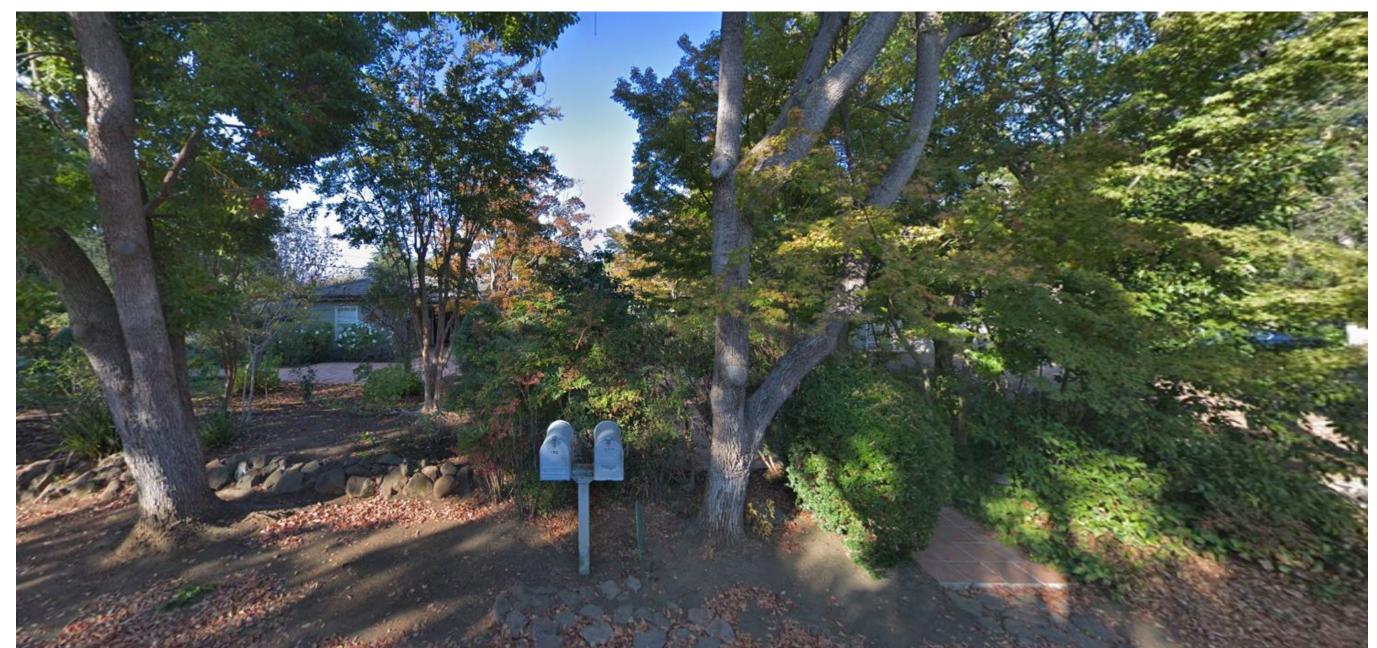
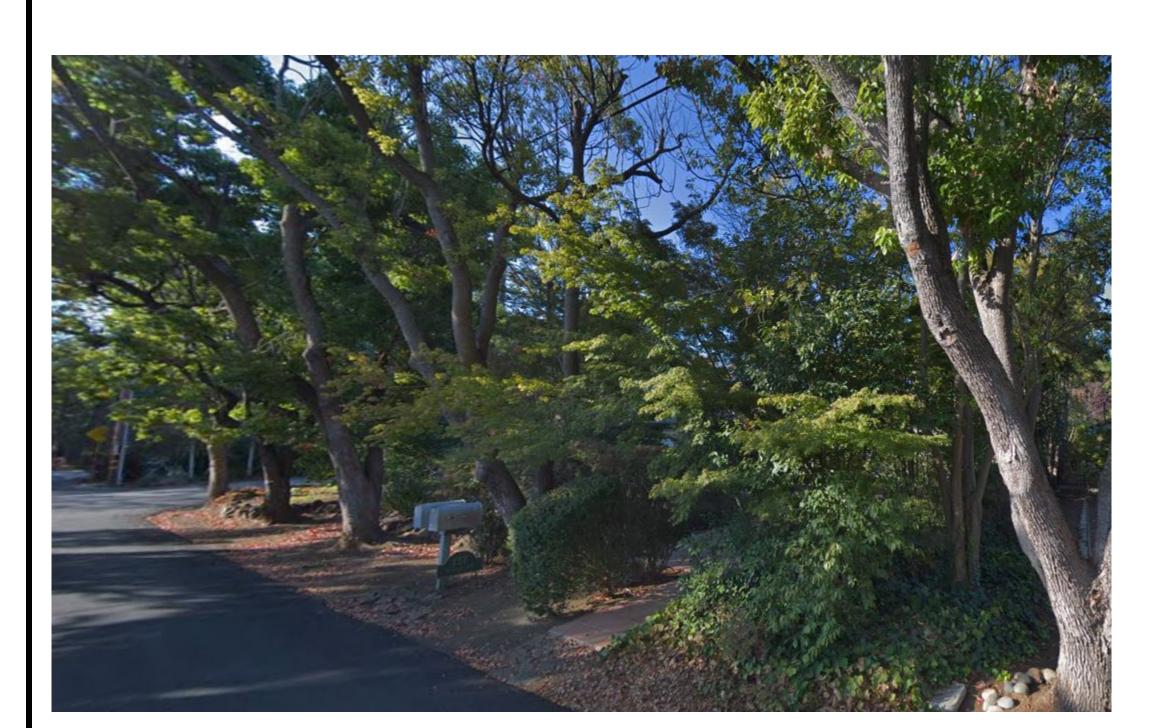
MAP AND EXISTING EXTERIOR SIDE ELEVATIONS

EXISTING ELEVATIONS

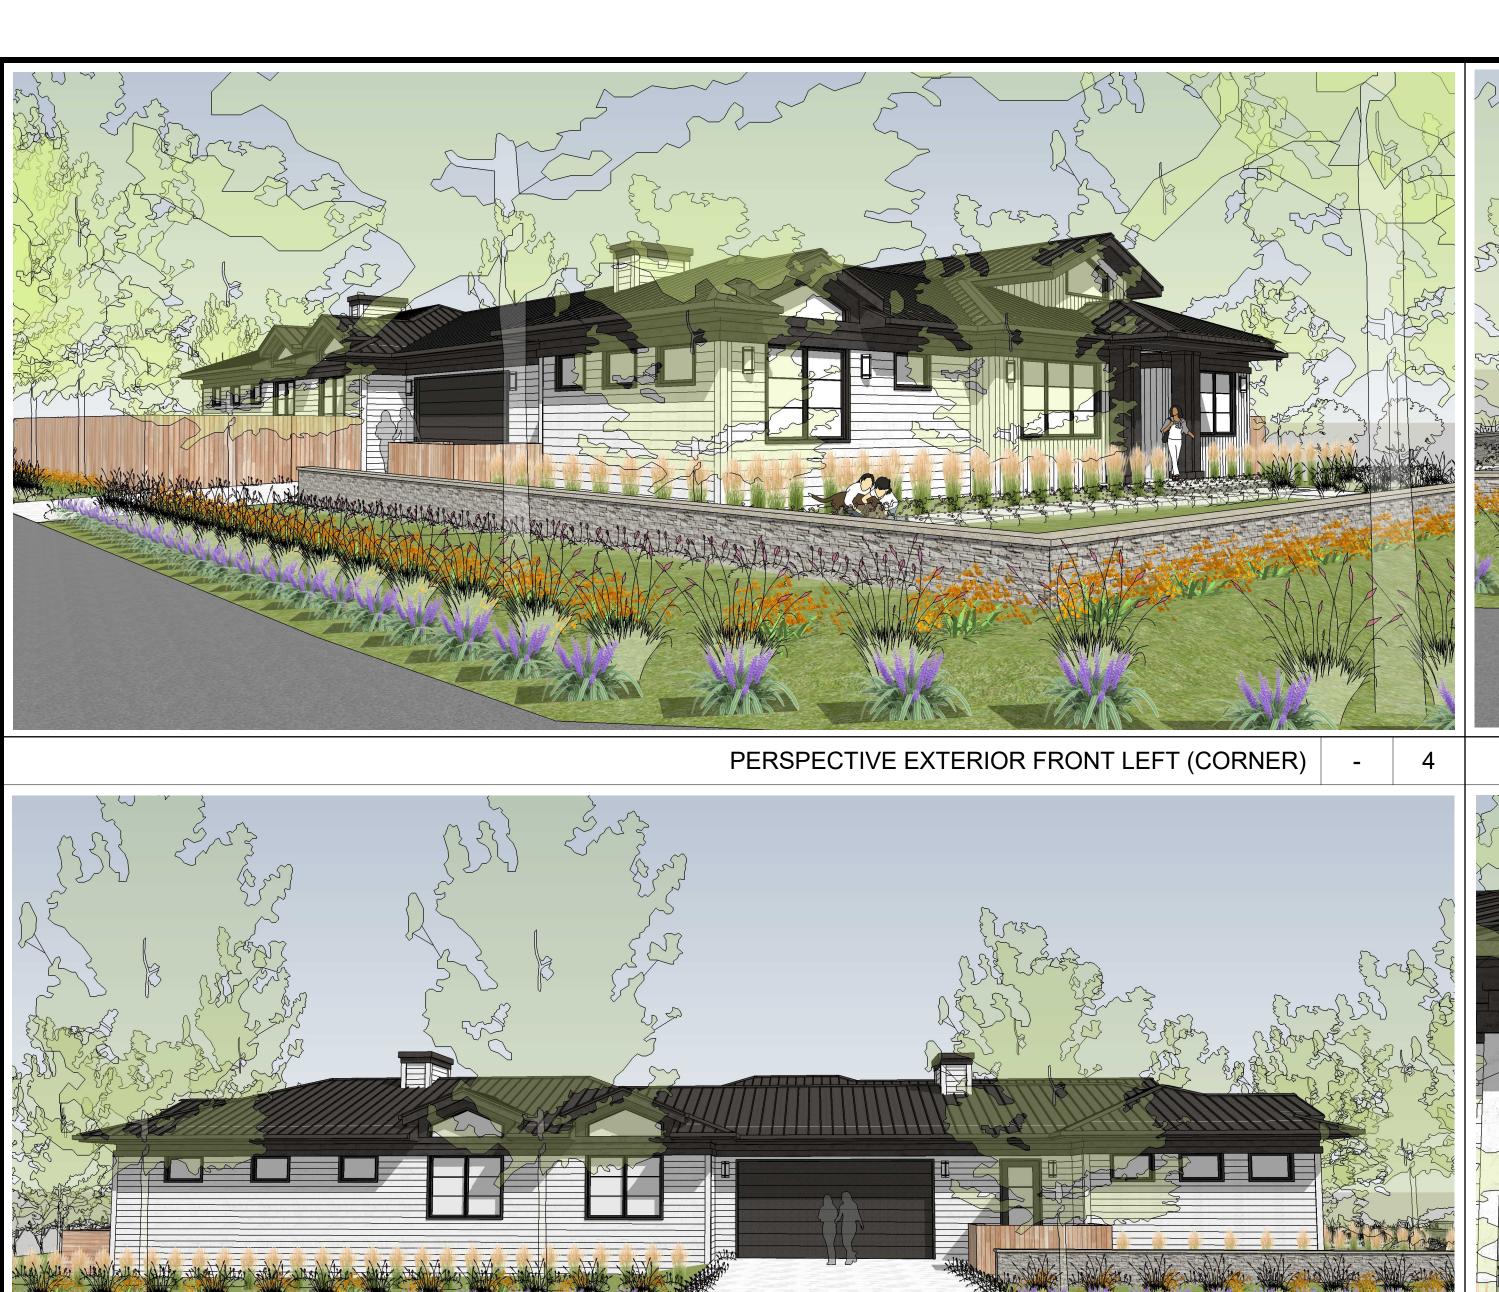
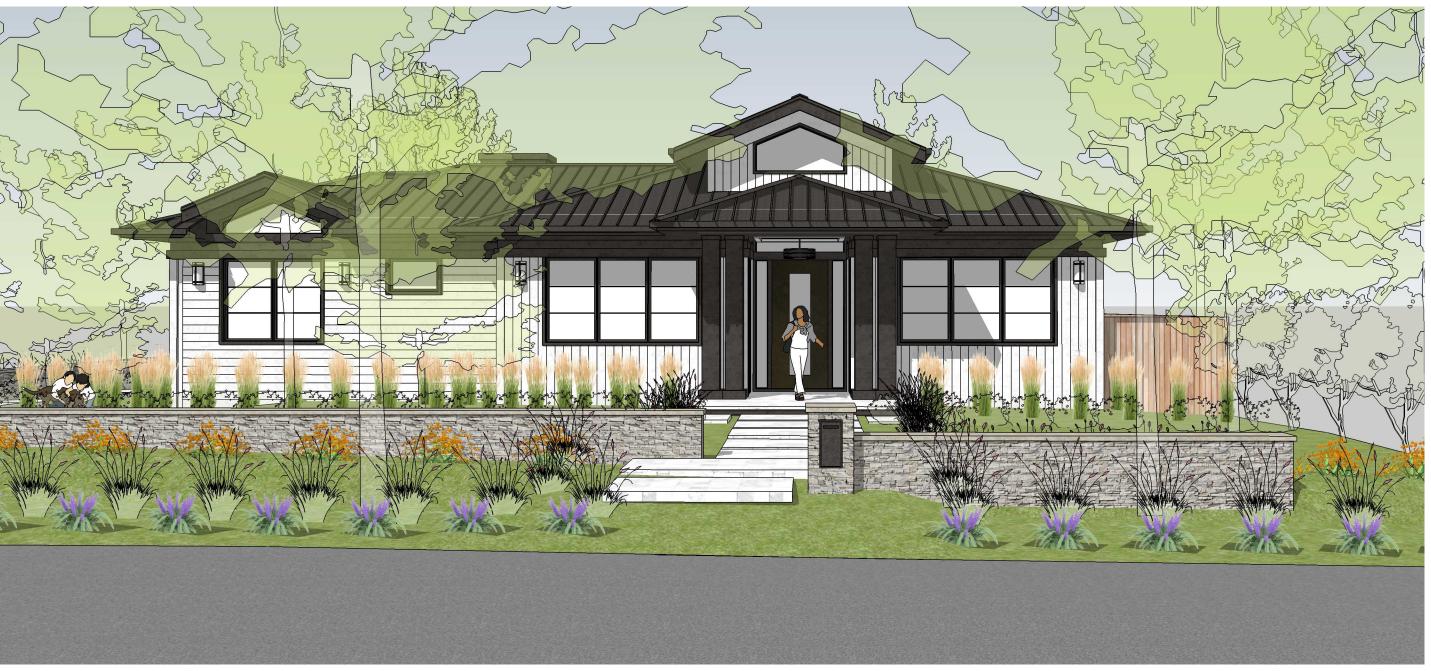
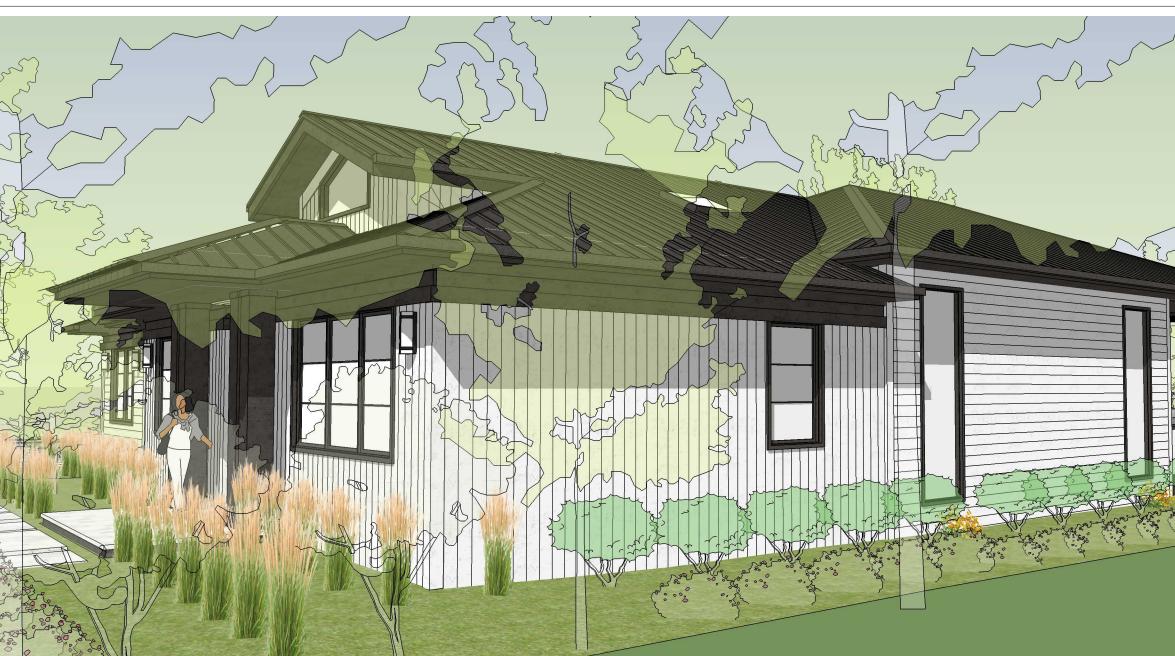
PERSPECTIVES

PERSPECTIVE EXTERIOR FRONT

PERSPECTIVE EXTERIOR LEFT

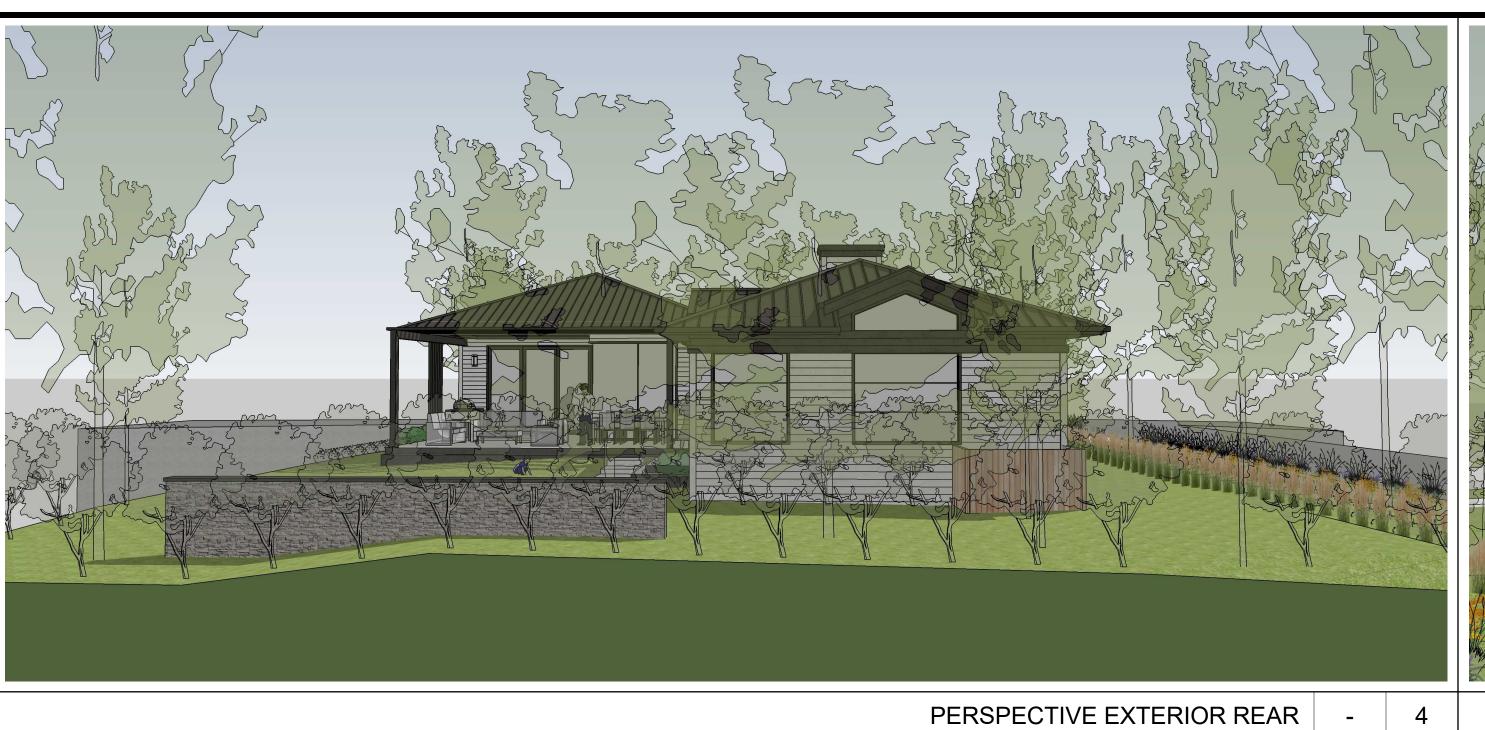
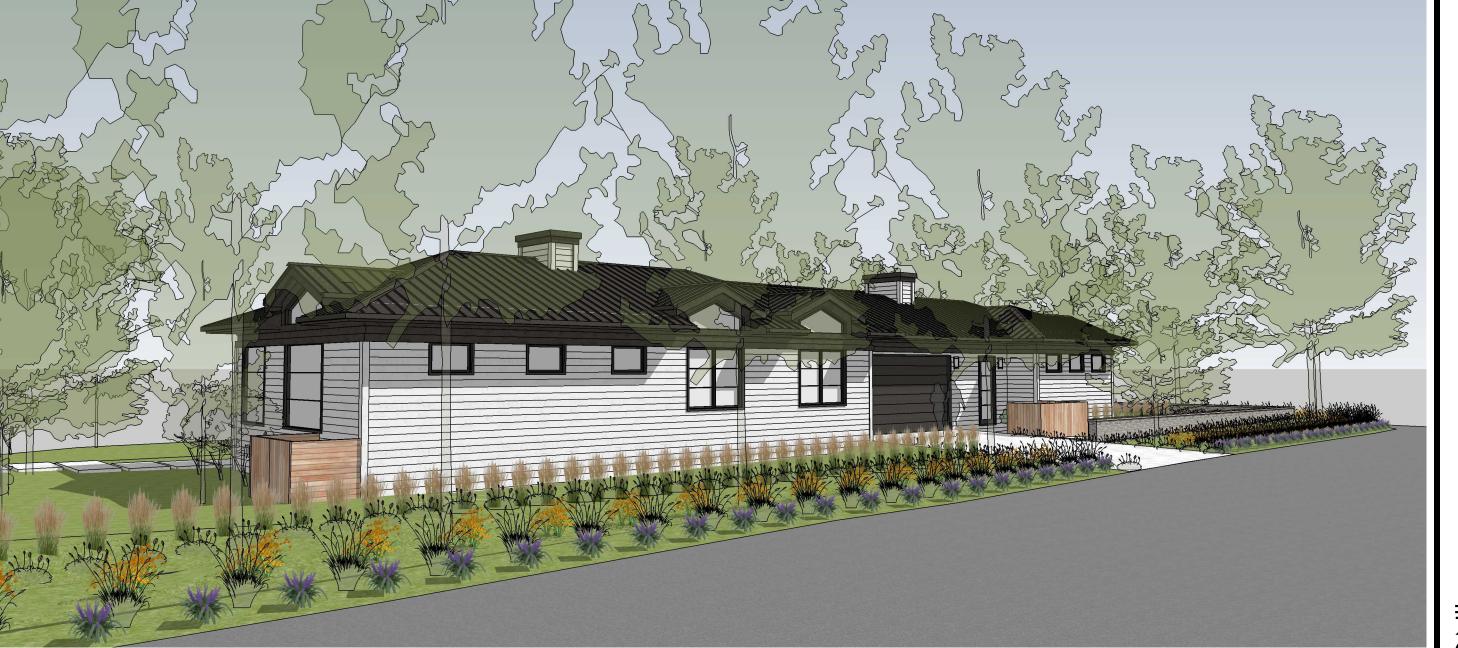
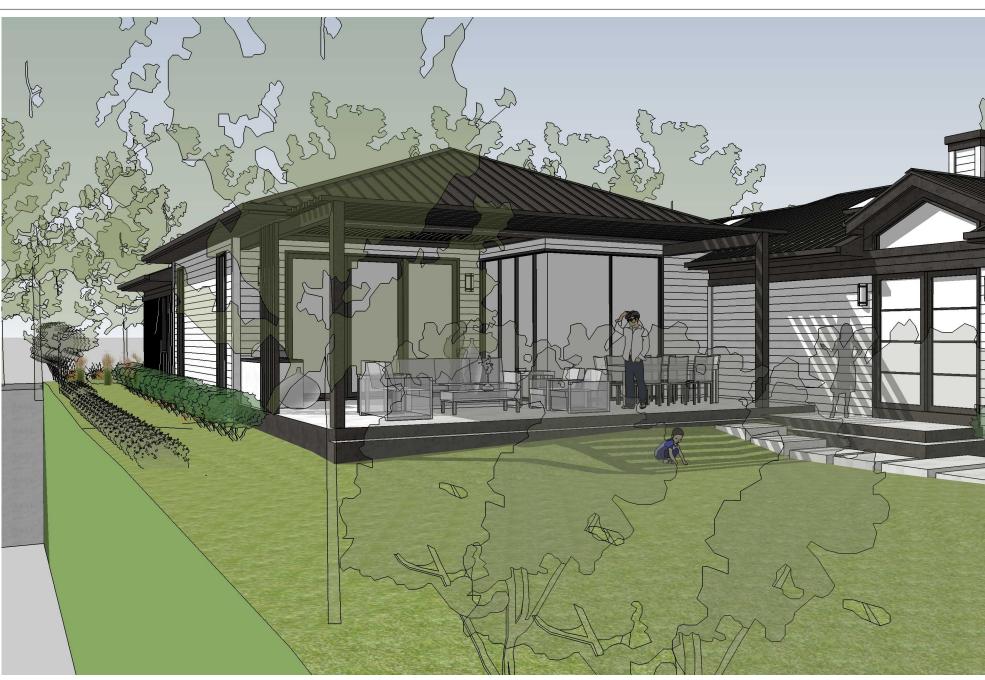
EXTERIOR PERSPECTIVES

PERSPECTIVE EXTERIOR FRONT HIGH (CORNER)

PERSPECTIVE EXTERIOR FRONT RIGHT -

PERSPECTIVE EXTERIOR LEFT REAR

PERSPECTIVE EXTERIOR RIGHT REAR

PERSPECTIVE EXTERIOR REAR
