DATE: June 5, 2019

TO: Design Review Commission
FROM: Steve Golden, Senior Planner
SUBJECT: 18-SC-04 – 446 South Clark Avenue

PROJECT DESCRIPTION

This is a design review application for a new two-story house that was continued from the April 3, 2019 Design Review Commission meeting. The project includes 2,081 square feet at the first story and 982 square feet at the second story. The following table summarizes the project's technical details:

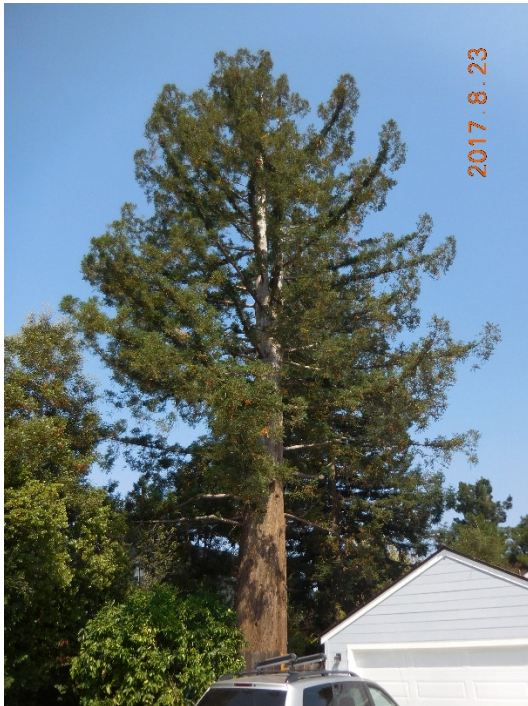
Redwood #7 with codominant leaders from a past

topping.

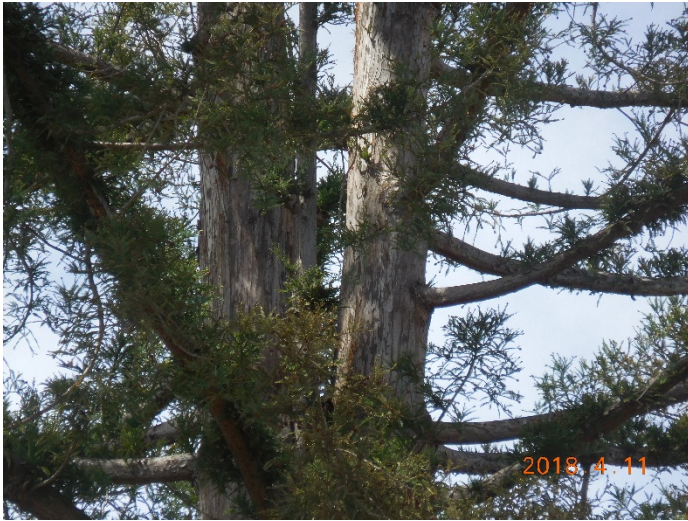
Redwood tree with codominant leaders and a third leader forming. The third leader will act as a fulcrum to help split the two large leaders.

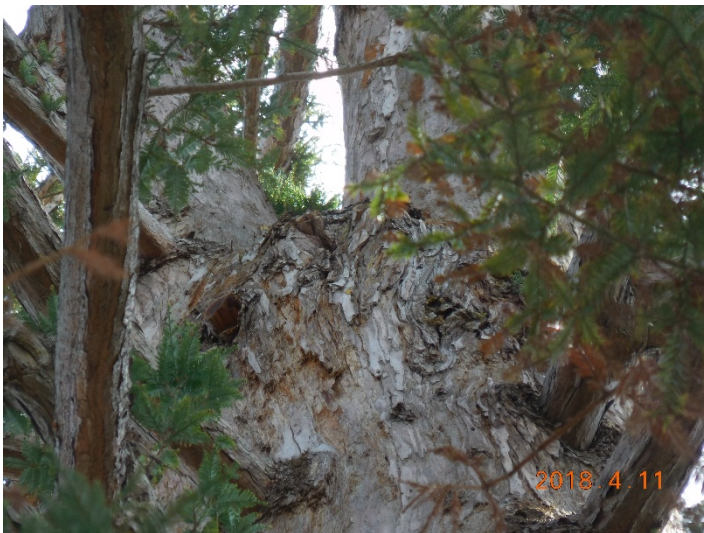
A climber's view of the poor crotch. Note the buildup of reaction wood signifying a split or crack in the crotch.

Codominant leaders with included bark is a common reason for failure in redwood trees. As the two tops enlarge the trunks of the tops (bark on bark) expand and push themselves apart.

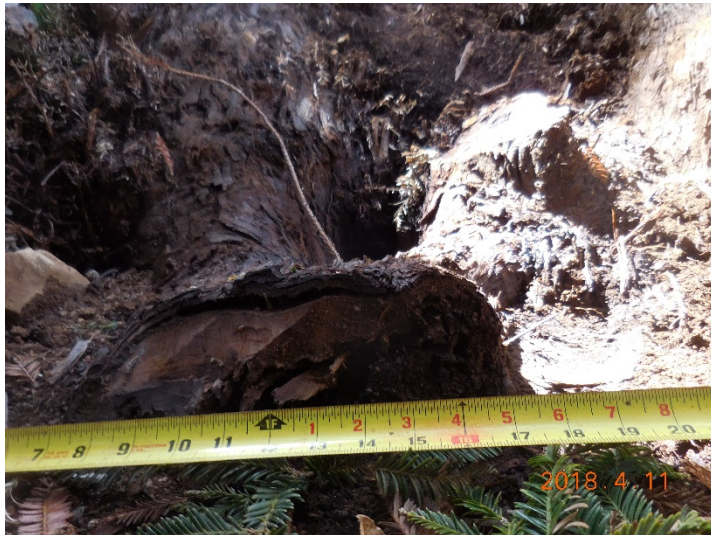
10 inch diameter buttress root cut by previous owner.

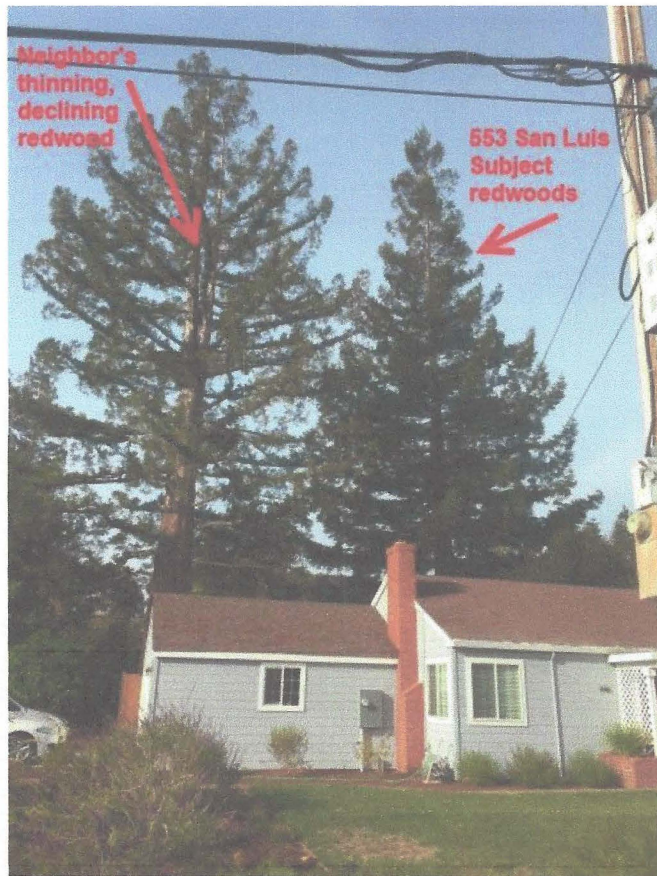
P-1 (above) Redwood trees to be impacted by construction project - shot from South Clark, looking over the existing roof of 446 South Clark Avenue.

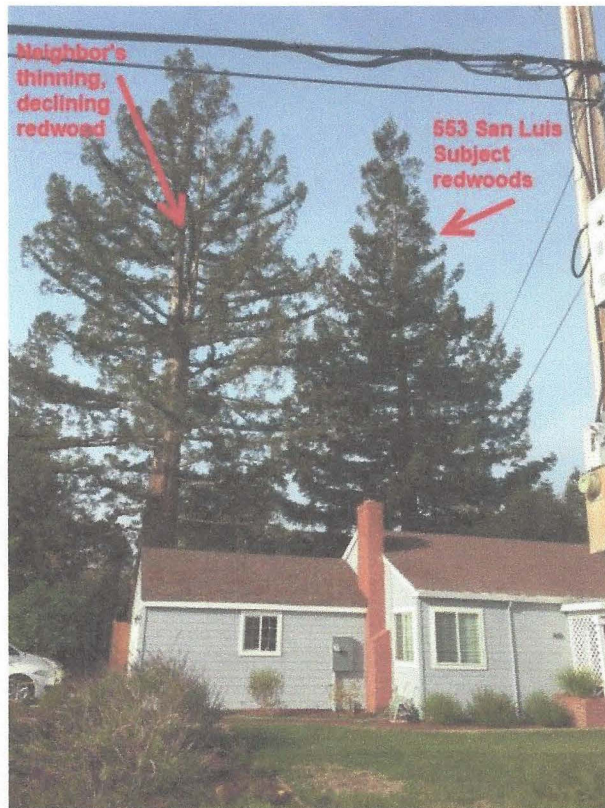
P-1 (above) (taken by me on December 2, 2017) Redwood trees impacted by construction project - shot from South Clark, looking over the existing roof of 446 South Clark Avenue.

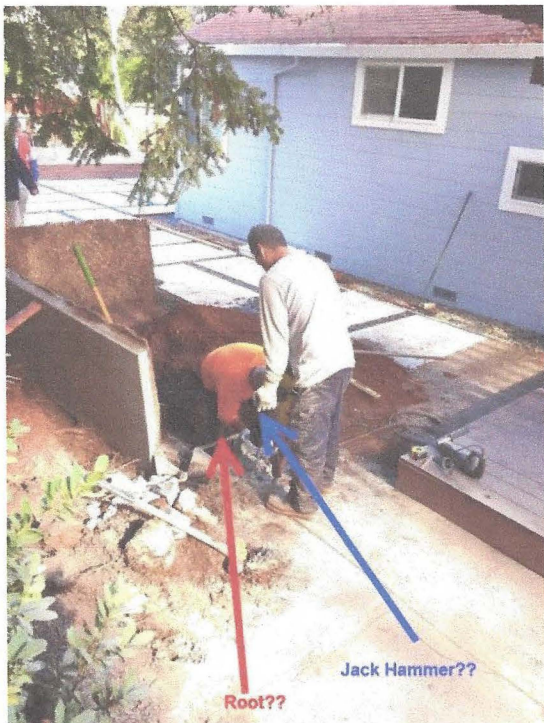
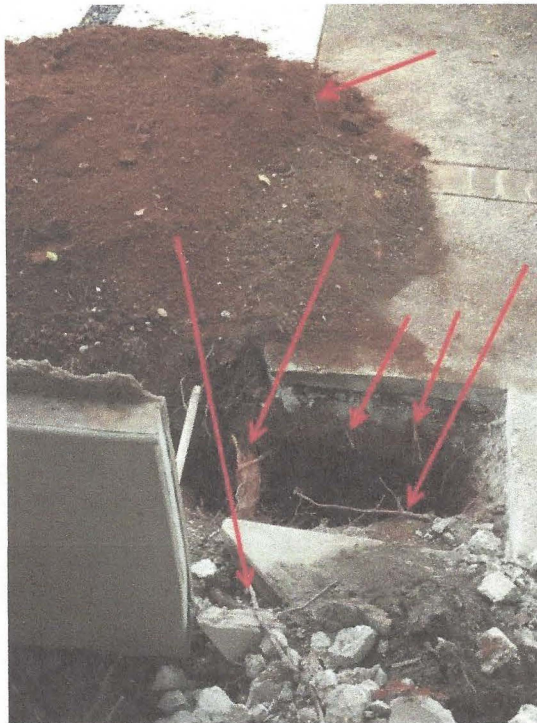
P-2 (above, left) excavation in progress

P-3 (above, right) roots & irrigation(?) line

I have included the most relevant images as P-2, P-3, P-4, and P-5 below.

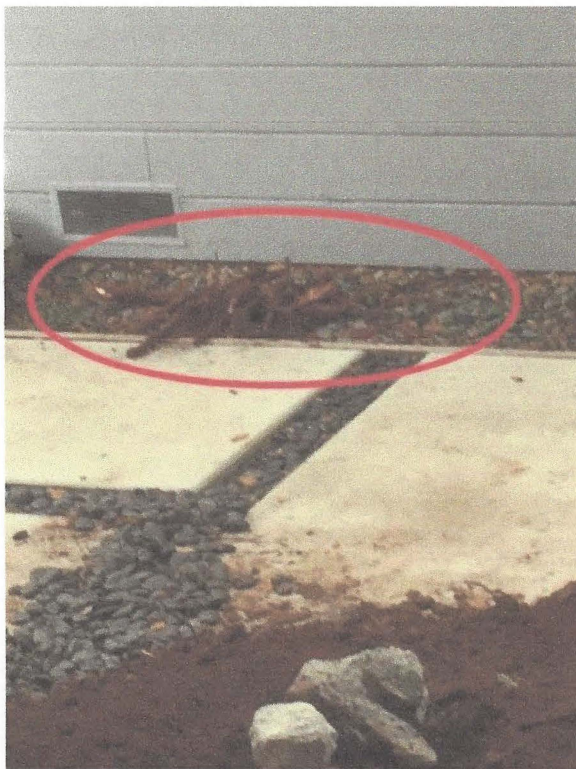
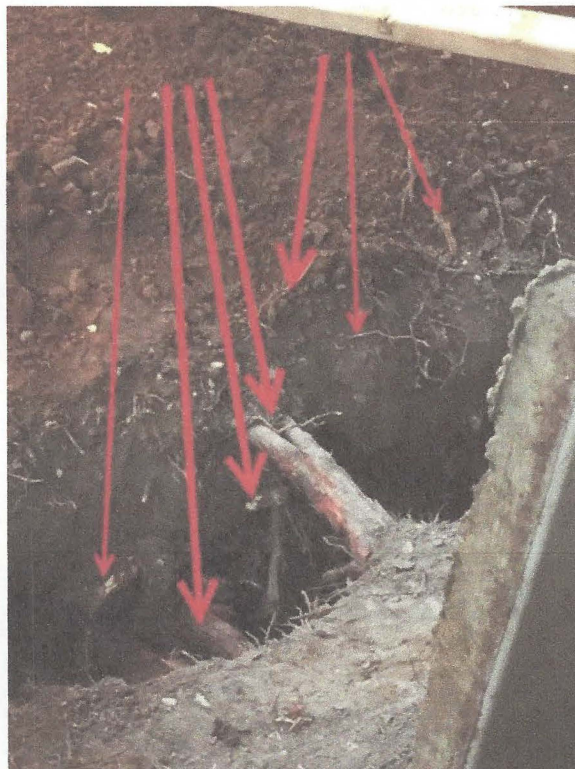
P-4 (below, left) pile of discarded roots

P-5 (below, right) likely redwood tree roots

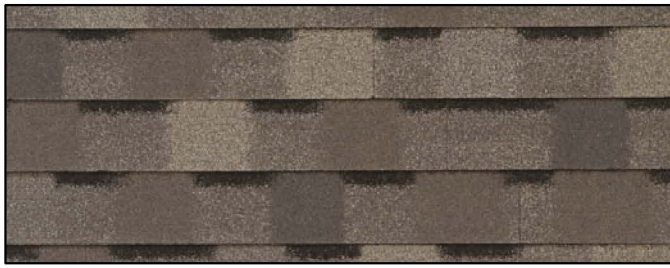
CERTAINTEED COMPOSITION SHINGLE ROO- LIGHT GRAY

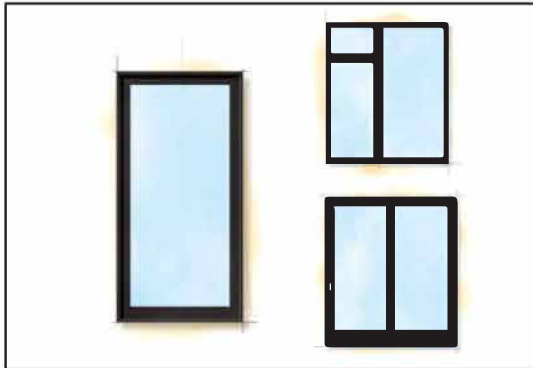
FIBRX COMPOSITE CLAD WINDOW
(ANDERSEN 400 OR EQUAL)

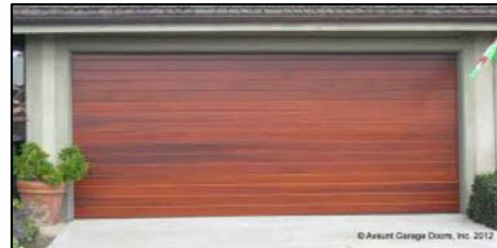
GARAGE DOOR w/ IPE SIDING

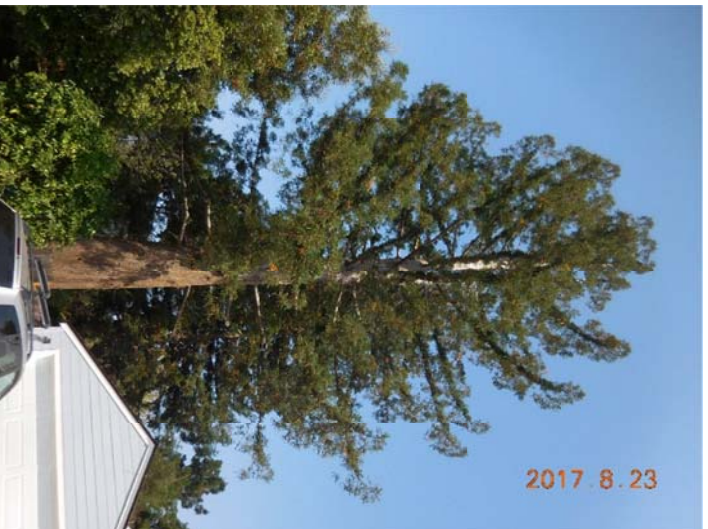
Redwood #7 with codominant leaders from a past topping.
