**TO:** Design Review Commission  
**FROM:** Calandra Niday, Assistant Planner  
**SUBJECT:** SC19-0010 – 126 Mount Hamilton Avenue

This is a design review application for a new two-story house. The proposed project includes 2,740 square feet on the first story, 1,206 square feet on the second story, and a 2,704 square-foot basement. The following table summarizes the project's technical details:

## ON-CHIEN RESIDENCE

126 MOUNT HAMILTON AVENUE, LOS ALTO.

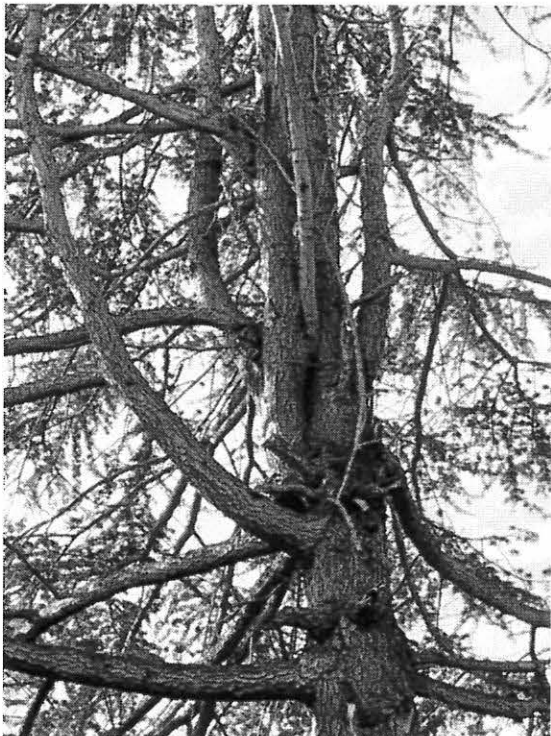
**Showing cedar tree #11**

Deodar cedar trees #10-11 are located on the west side of the property, at the property line, and have been poorly maintained in the past. Both trees have been topped in the past. Cedar tree #10 is codominant with 2 tops at 40 feet. Because the union at 40 feet looks to be wide set, the risk of failure due to the codominant tops is low. It is recommended to reduce the smaller of the 2 leaders and cable the leaders together. Cedar tree #11 is in poor condition due to being codominant at 40 feet with multiple new leaders creating areas of included bark. Included bark forms in the junctions of codominant stems where there is a narrow angle union, meaning the junction looks like a "V" rather than a "U." As the tree continues to grow the narrow unions will essentially fill with bark and create a growing area of structural weakness in the tree. When noticing a very narrow angle (creating a "V" at the junction of branches) it is likely that stress put on the either of the codominant stems can cause splitting, or even cause the stem to break off at the junction. As leaders grow they have the potential to push against each other often until the point of failure. Also each leader is heavy to the direction away from the trunks and creates more stress to the tree. This tree is recommended to be removed or heavily pruned beyond ANSI Standards to reduce the risk of a large leader failure.

The project is proposing to retain all trees with the exception of three trees, including the Oleander hedge (tree #9), the Deodar cedar tree (tree #11), and the dead Loquat tree (tree #16). The Oleander hedge and Loquat tree are not large enough to be considered a protected tree under the City's Tree Protection Regulations (Municipal Code Chapter 11.08). The Deodar cedar tree (tree #11) is shown to be in poor condition and has formed codominant stems that has resulted in splitting. An arborist report was prepared by Kevin Kielty (Kielty Arborist Services) which further details the current conditions of the existing trees and is included in Attachment D. The arborist report also outlines a tree protection plan for the remaining healthy trees on the site. The last page of the arborist report includes an evaluation of the new pool location. Staff worked with the applicant to relocate the pool to be outside the tree driplines of the existing large deodar cedar trees towards the rear property line.

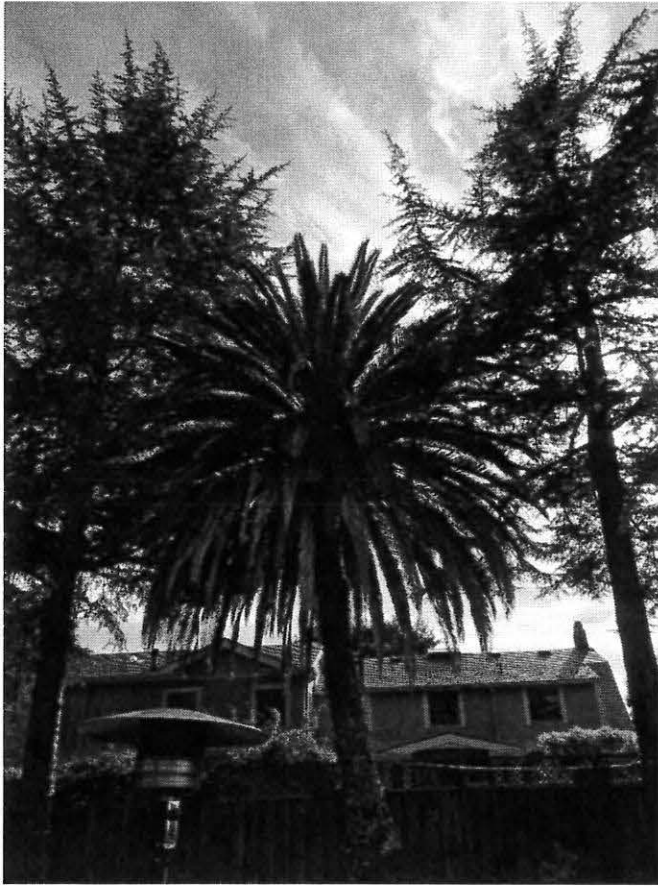
#### **Showing trees #12-14**

Deodar cedar trees #12 and #14 are in good condition and have been well maintained in the past. Both trees offer a good amount of screening for the property. Canary Island palm tree #13 is located between the two cedar trees.
