SUBJECT: 16-SC-23 – 1093 Los Altos Avenue

Approve design review application 16-SC-23 subject to the listed findings and conditions

PROJECT DESCRIPTION

Kielty Arborist Services

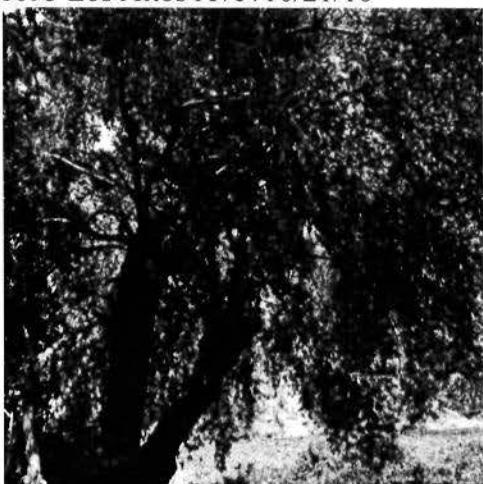
Protected olive tree #4 is in poor condition. This tree has been severely topped in the past. New growth consist of watersprout growth. Watersprouts do not develop proper branch to trunk unions and as a result tend to fail in normal weather conditions. Neighbors oak tree #7 is heavily suppressing this tree and has not allowed for much vertical height. This olive tree is the fruiting variety and has created a mess beneath the trees canopy. This tree is recommended for removal as it has received poor maintenance in the past that has compromised the structural integrity of the tree.

Showing topped limbs on olive tree

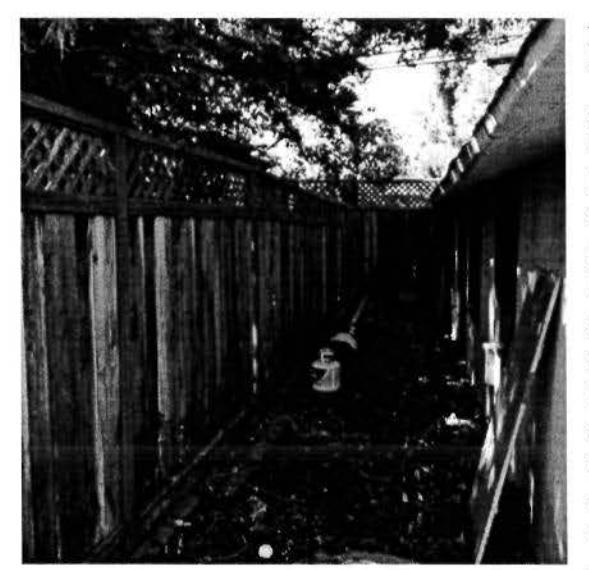
Showing area to be fenced off

Neighbor's redwood tree #6 is in fair condition. This tree is a very large mature tree with an estimated diameter of 50 inches. The tree is located at an estimated 3 feet from the property line. The tree is exhibiting some drought stressed symptoms and the top of the tree looks poor when compared to the rest of the tree. The tree is located 8 feet away from an existing accessory structure located on the property. When this structure is to be removed great care must be taken in order to reduce impacts to the neighbor's redwood tree as much as possible. It is recommended that tree protection fencing extend out from the property line fence near the tree and out to the foundation of the existing accessory structure. The width of the fencing should encompass the entire dripline of the tree. Before demolition of this structure takes place a

landscape barrier should be placed at a distance of 10 feet from the structure in all directions, this will reduce the risk of compaction in this area from heavy machinery. The foundation of the accessory structure must be removed carefully, in order to not damage any roots that have grown against the foundation or underneath the foundation. All equipment must work away from the tree. The site arborist will need to be on site during the demolition of this structure in order to inspect, document and to offer mitigation measures as seen fit. Impacts to the neighbor's redwood tree are expected to be minor to nonexistent if the above recommendations are carried out with care.

A pool is proposed in the same area as the accessory structure near neighbors redwood #6. The accessory structure foundation likely acted as a root barrier discouraging root growth in this area. Most roots are expected to be running along the foundation. It is recommended that once the accessory structure has been demolished that an exploratory trench be completed with the use of an airspade to a depth of 3 feet deep in order to expose all roots and leave them damage free. At this time the site arborist must make a site visit to document and inspect roots in this area. All roots over 2 inches in diameter to be cut must first be given the site arborist consent. Roots to be cut must be cut cleanly using a hand saw or loppers. If roots are to be exposed for longer than 6 hours, they must be wrapped with burlap and kept moist by spraying the burlap with water 4 times a day. Impacts from the proposed pool are expected to be minor as root loss is expected to be minimum as the existing structure likely acted as a root barrier. Mitigations for the minor root cutting will consist of an irrigation plan. A soaker hose shall be placed at the property line near this tree and be turned on every 2 weeks for 4 hours at a time. During the winter when rainfall is sufficient irrigation can be temporarily suspended. All hardscapes around the pool must be hand dug and require the least amount of excavation as possible. The site arborist must be on site during all excavation near this tree. It is the contractors responsibility to contact the site arborist 48 hours in advance when there is to be work done near this tree. Kielty Arborist Services can be reached at 650 515 9783 or 650 532 4418. We can also be reached by email at kkarbor0476@gmail.com.
