**TO:** Complete Streets Commission  
**FROM:** Jaime O. Rodriguez, Consultant  
**SUBJECT:** Citywide Pedestrian Activated Flashing Beacon System Maintenance

Sample  
Industry Standard Best-Practice Beacon System  
El Monte Ave & Mills Ave, Los Altos, CA

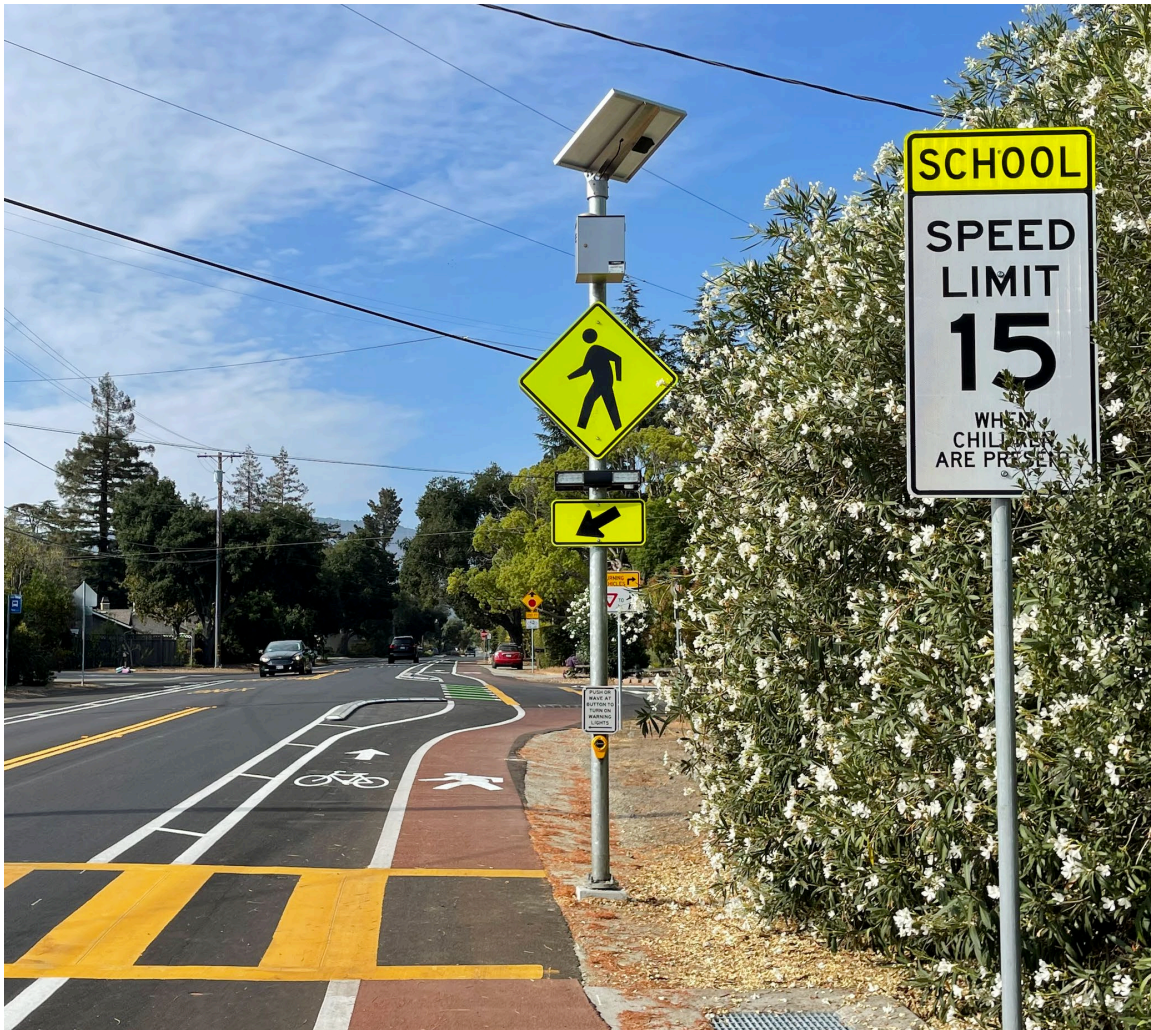
TAPCO Rectangular Rapid Flashing Beacon (RRFB) System

- Two RRFB units on each pole, back-to-back so motorists see lights on both sides of street
- Push or Wave button activation
- Larger solar panel with larger batteries for longer use
- Standard static signs for easy maintenance

The City's last pedestrian-activated flashing beacon site installation, El Monte Avenue & Mills Avenue, includes the most current industry standard best-practice equipment deployment including:

- TAPCO Manufacturer
- Rectangular Rapid Flashing Beacons
- Accessible Pedestrian Signals with audible, manual push, and waive motion activation
- Static Signs
- Solar Panels
