Facility Condition Assessment

**For
City of Los Altos
Municipal Service Center - Shed
707 Fremont Ave
Los Altos,
California 94024-5408**

Date of Report: October 12, 2016

Faithful+Gould, Inc.

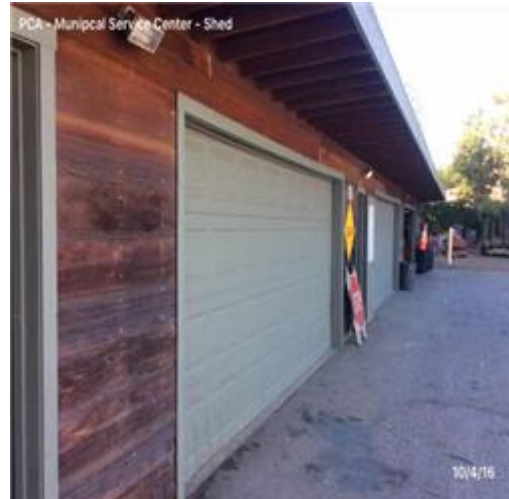
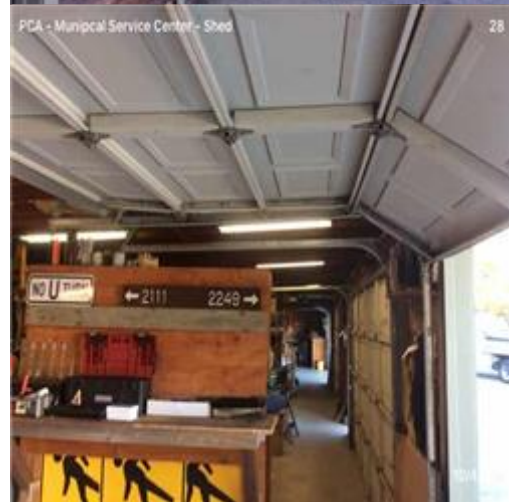
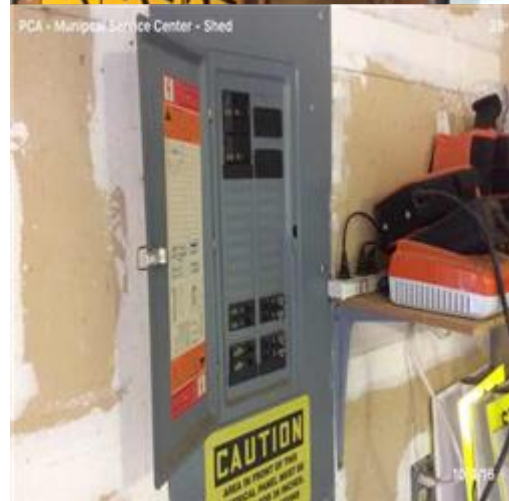
The building has a reinforced concrete slab loading bay area and asphalt road surfaces. The exterior surfaces are in fair condition overall. There no site emergency power generator.

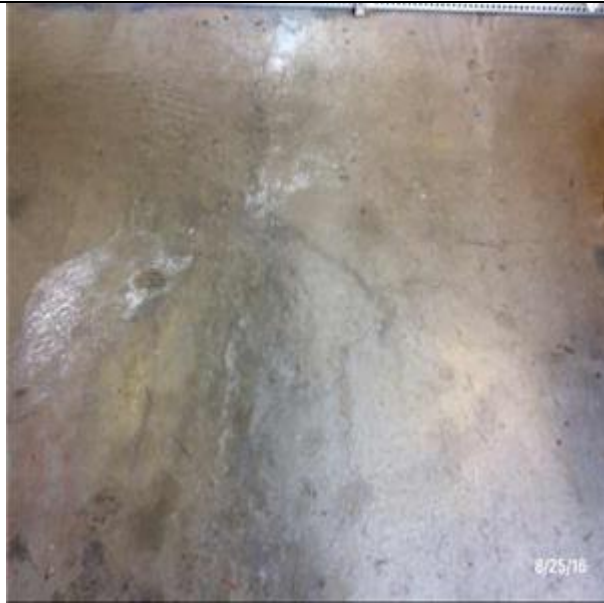
Overall the floor slab was observed to be in fair to good condition and no actions are anticipated during the study period.

A1031 Standard Slab on Grade:- View of Slab-on-Grade Reinforced Concrete

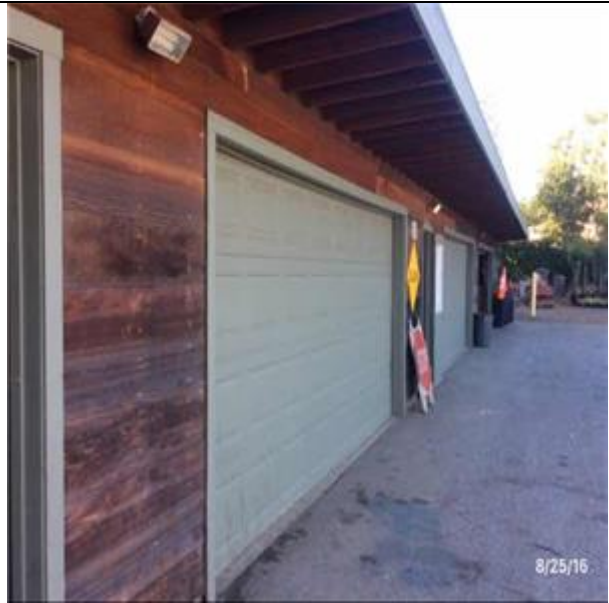
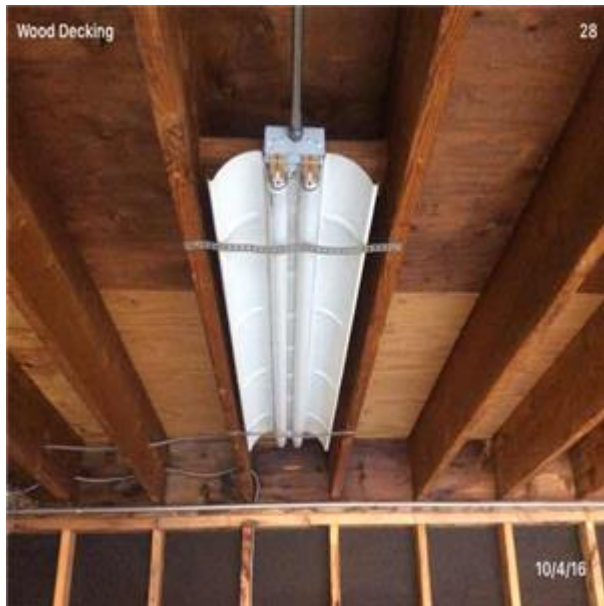
The wood roof structure was observed to be in fair to good condition with no obvious defects or deflections.

B1021 Flat Roof Construction:- View of Wood Decking

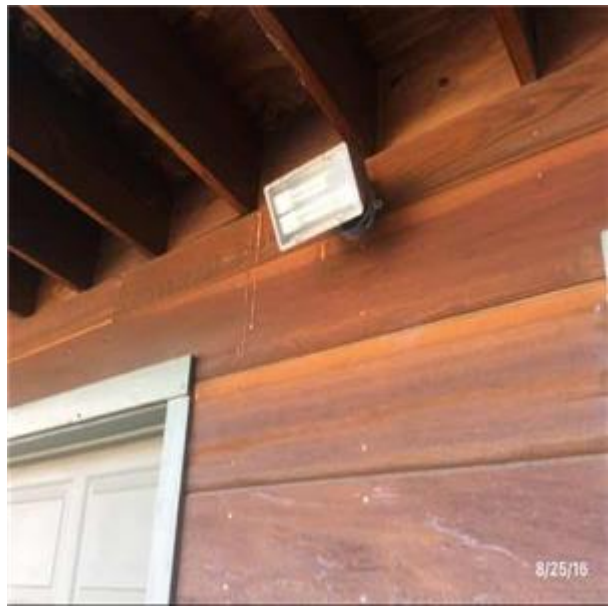
The exterior walls were observed to be in fair condition. Based on EUL and observed condition, replacement of the exterior wood siding can be anticipated later in the study period.

B2011 Exterior Wall Construction:- View of Wood Clapboard Siding

ID	Type	Recommendation	Priority	Year	Expenditures
153942	B2010	Replace Wood Clapboard Siding	Priority 3	2022	\$56,736

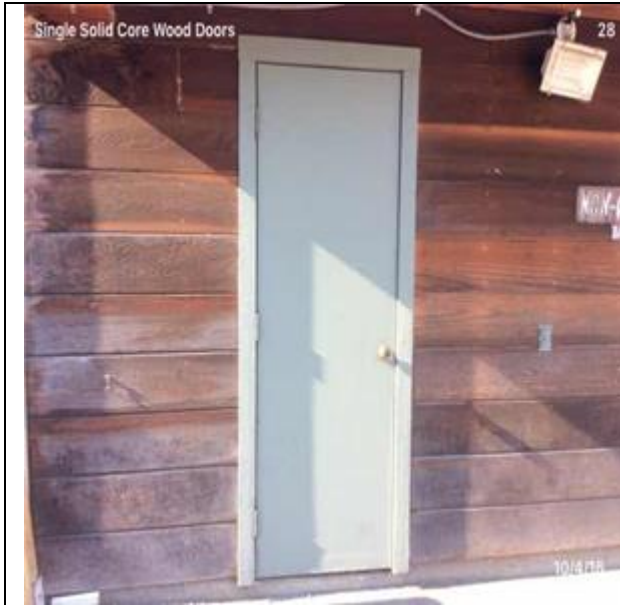
The exterior door was found to be in fair to good condition with no observed deficiencies in either the door or the door hardware and no actions are anticipated within the study period.

B2032 Solid Exterior Doors:- View of Single Solid Core Wood Doors

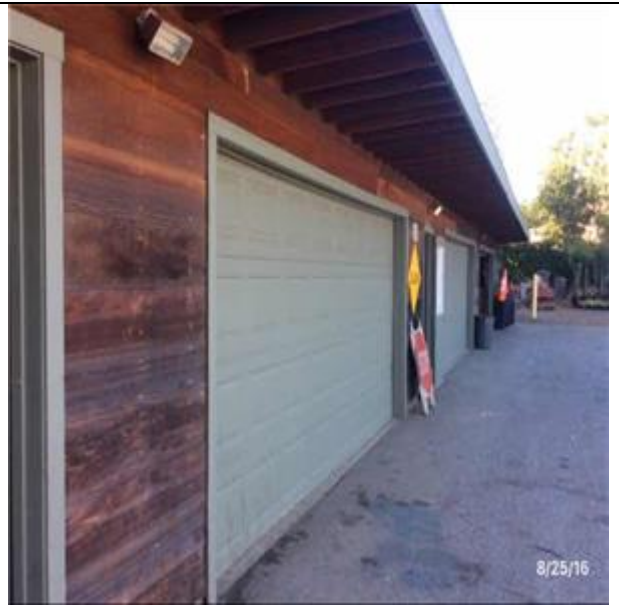
The overhead doors were observed to be in fair to good condition. With regular maintenance no actions are anticipated within the study period.

B2034 Overhead Doors:- View of Overhead Doors

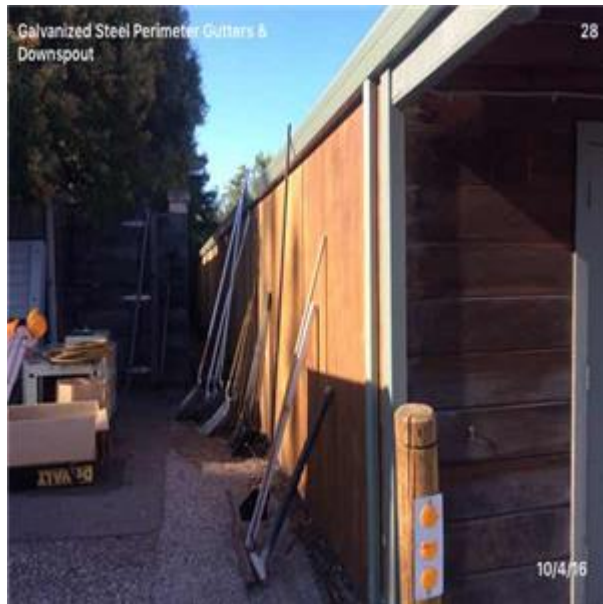
The rainwater drainage system was observed to be in fair to good condition and no actions are anticipated during the study period.

B3016 Gutters and Downspouts:- View of Galvanized Steel Perimeter Gutters & Downspout

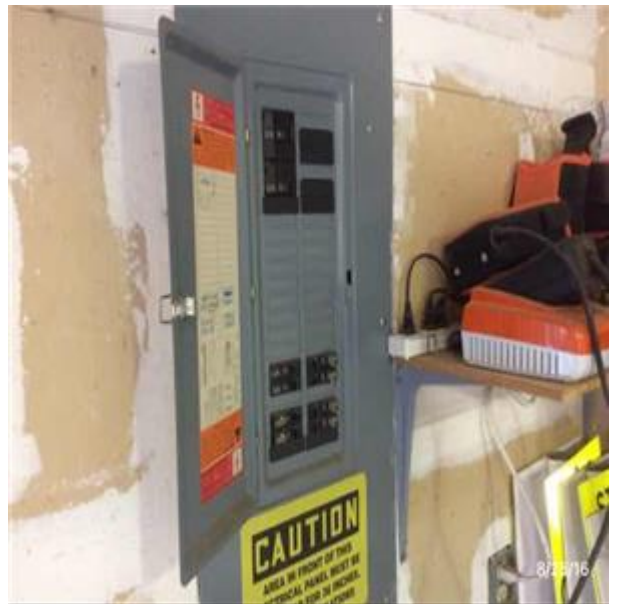
The panelboard was observed to be in fair condition and based on EUL, replacement can be anticipated early in the study period.

D5012 Low Tension Service & Dist:- View of Panelboard - 120/240volts, 60 to 2000amp

ID	Type	Recommendation	Priority	Year	Expenditures
153943	D5010	Replace Panelboard - 120/240volts, 60 to 2000amp	Priority 3	2018	\$3,260
153944	D5020	Replace Exterior Wall Pack Light Fixtures	Priority 3	2022	\$2,205

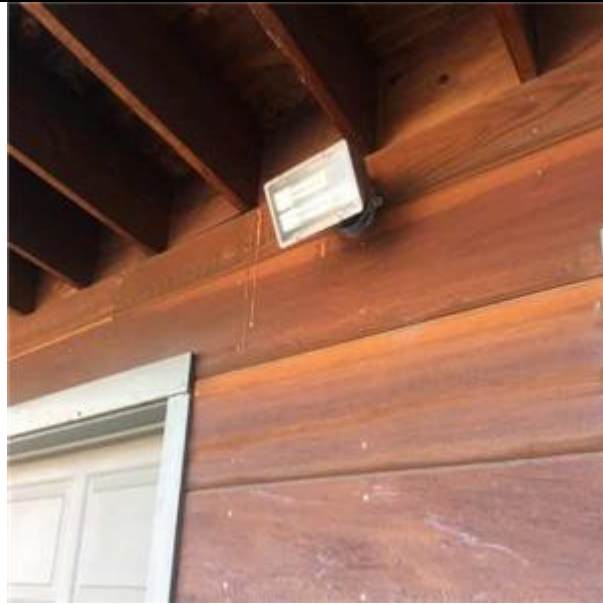
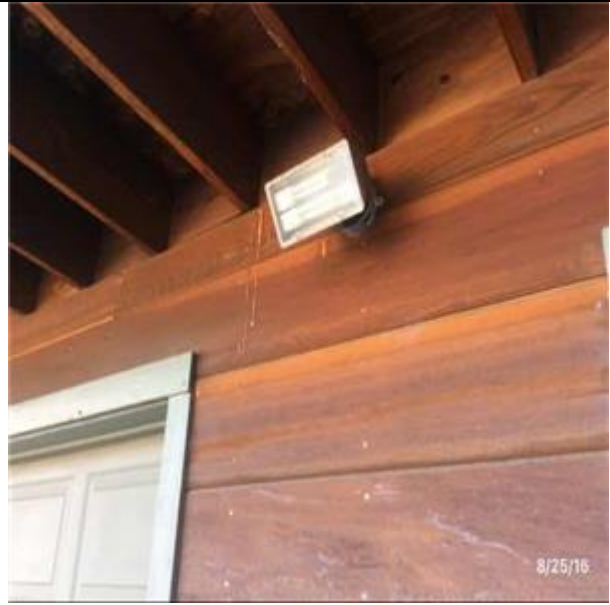
The wall packs were observed to be in fair condition. Based on EUL and condition, replacement is anticipated mid-term in the study period.

D5022 Lighting Equipment:- View of Exterior Wall Pack Light Fixtures

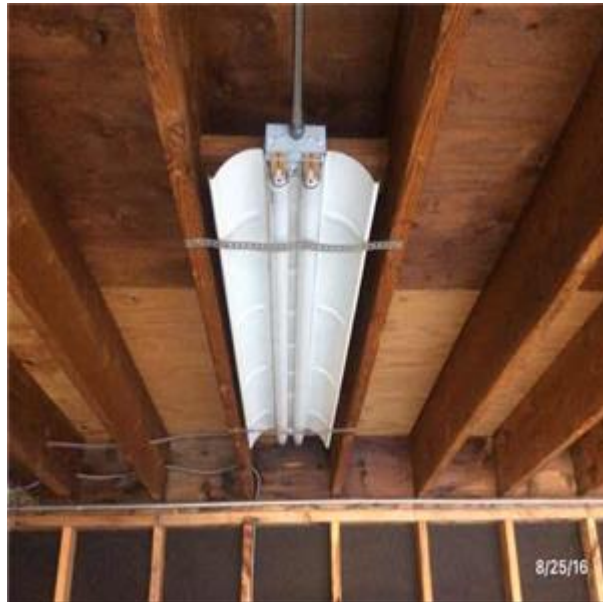
The interior light fixtures were observed to be in fair condition and no actions are anticipated during the study period.

D5022 Lighting Equipment:- View of Fluorescent Light Fixtures
