HISTORIC STRUCTURE REPORT

Halsey House

City of Los Altos | December 2019

Architectural
Resources Group

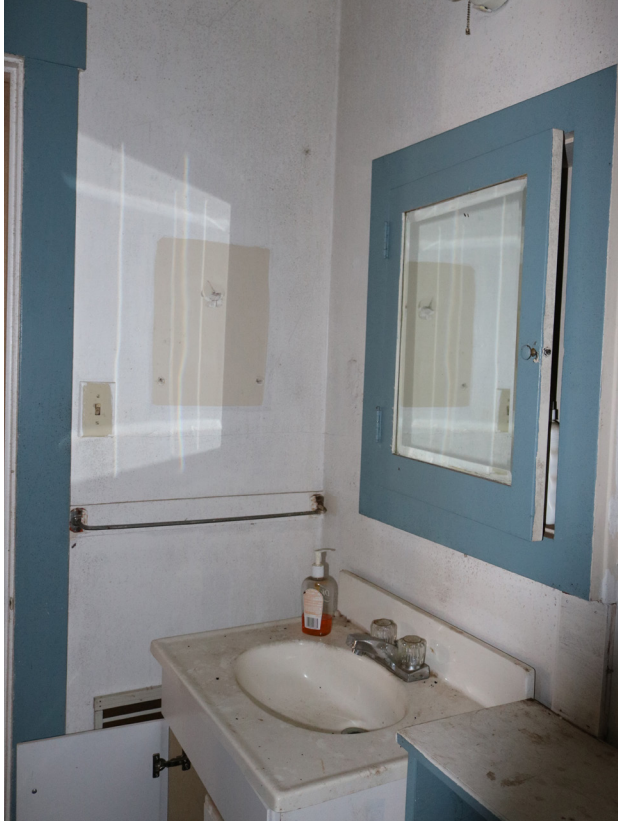
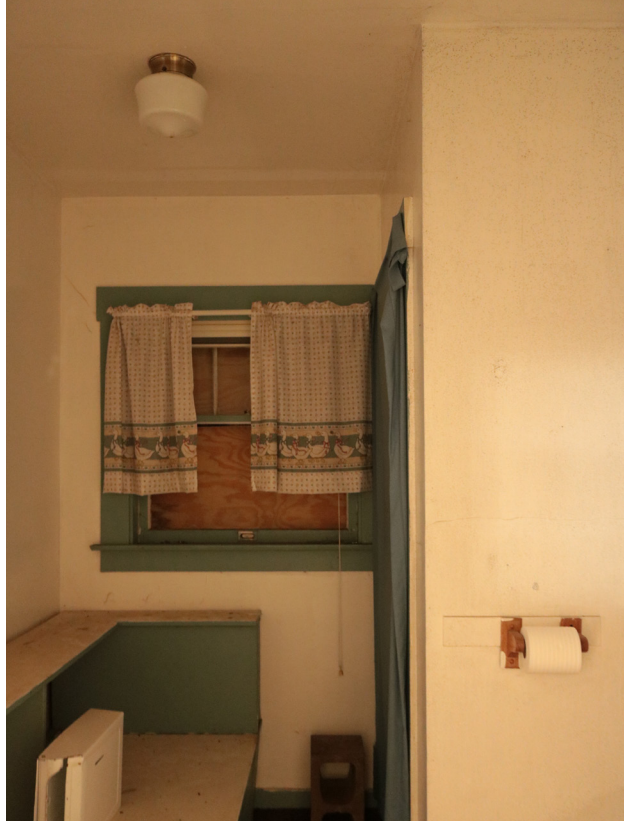
Interior views of restroom near the southern end of the west wing.

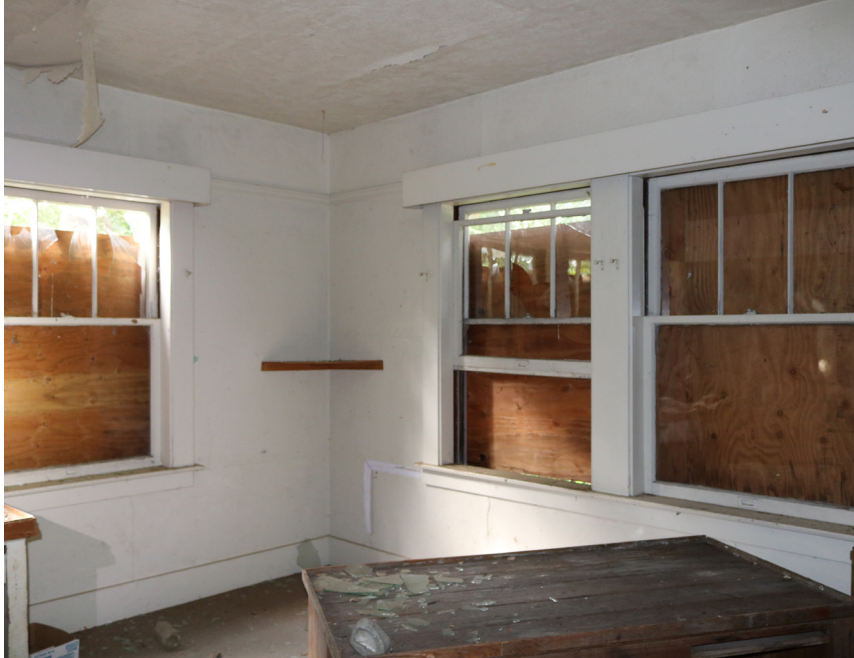
View looking south inside Discovery Lab.

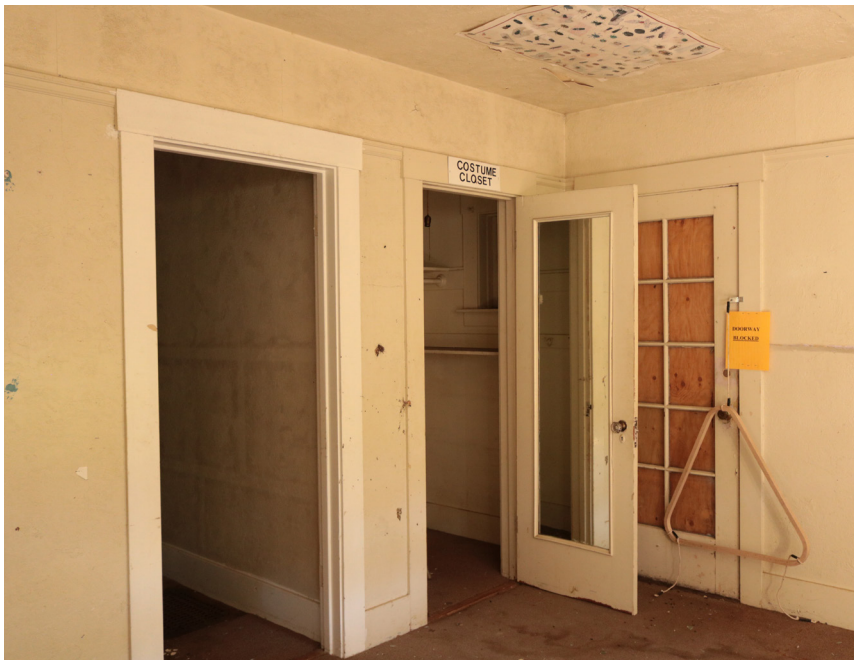
Looking north in Discovery Lab.

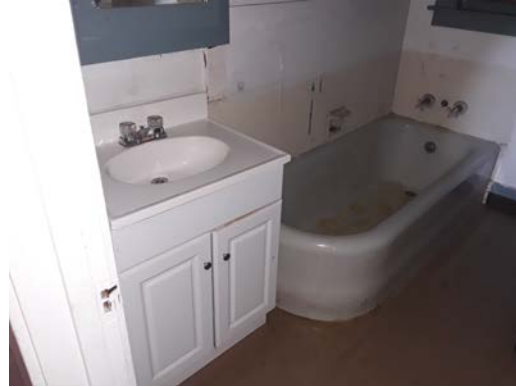
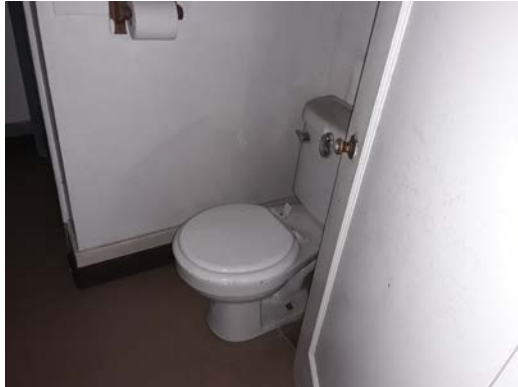
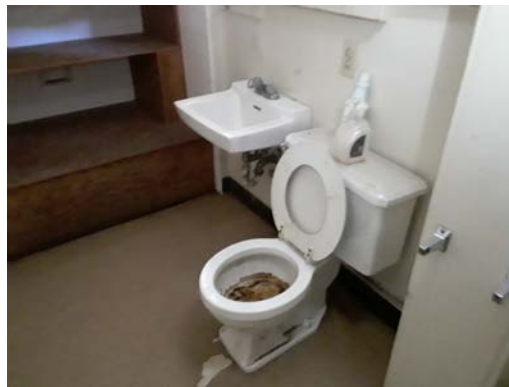
7. West wing bathroom - tub and valving is in poor condition. Non-ADA, non-low flow water closet and lavatory is in fair condition. Shower stall water valves are old and not pressure temperature compensating. Exhibit P5.1, 5.2, 5.3

1. If the building is to be made usable as a private residence, the entire plumbing system, including piping and fixtures, needs to be replaced.
2. If the building is to be restored to exhibit status, concealed piping can be abandoned in place, and fixtures refurbished and marked 'not in use'.
3. If the building is to be re-purposed as a destination venue, the entire plumbing system needs to be replaced to meet current CPC and ADA requirements.

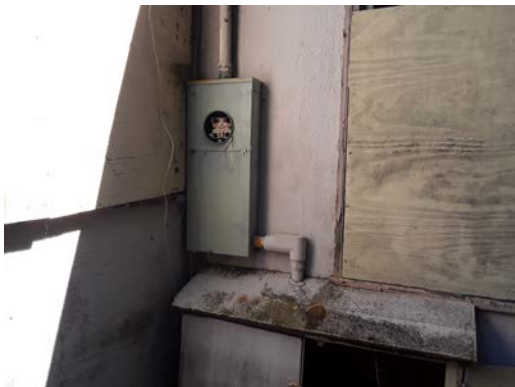
1. The electrical service is disconnected. The PG&E meter has been removed. Exhibit E1
2. Electrical circuit breaker panel is present.
3. Original 'knob and tube' and more recent Romex wiring is observed. Without power to the building, it is not possible to determine if the original wiring is still in use.
4. GFCI outlets not observed.
5. Telephone service and wiring is in very poor condition.
6. Lighting fixtures and related wiring are old, poor condition and not per code. Exhibit E2

1. The entire electrical service and distribution needs to be replaced and brought up to the current California Electrical Code.
2. If building is to be made usable in any capacity, all lighting needs to be replaced.
