AGENDA REPORT

TO: Historical Commission
FROM: Sean Gallegos, Staff Liaison
SUBJECT: Halsey House Update

CIP Project, CF-01004 Halsey House Renovation/Replacement

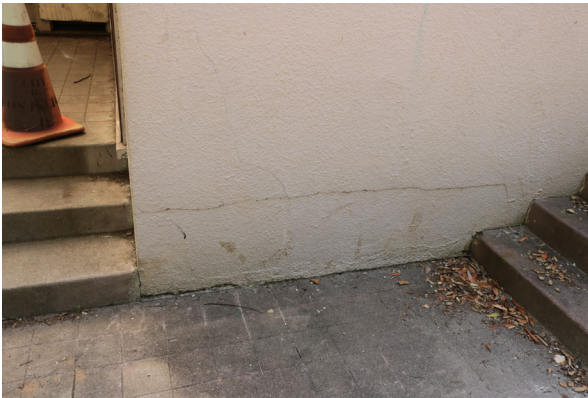
Crack along the base of the north elevation at the Main Entry (ARG, 2019).

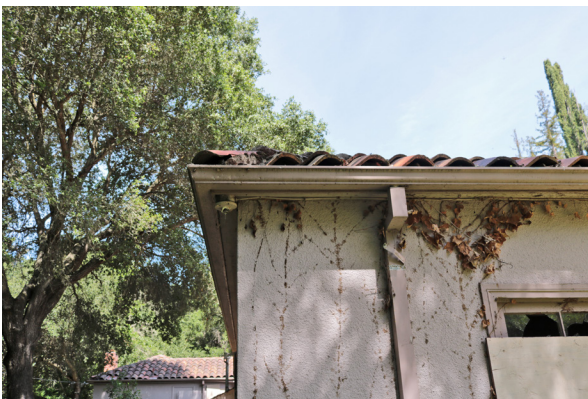
Remains of ivy growth along the south elevation (ARG, 2019).

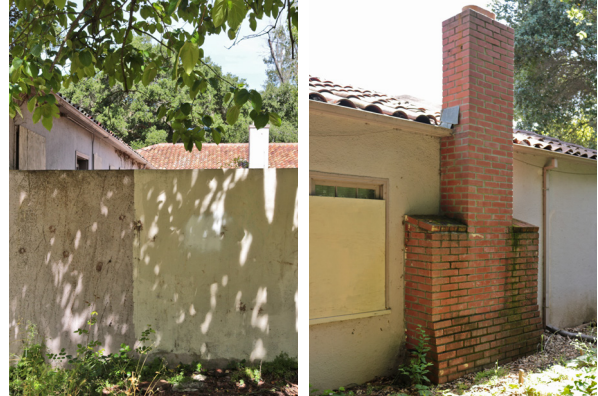
Dissimilar paint colors along the south elevation (left); biological growth at the west chimney (right); (ARG, 2019).

Along the south elevation, the top of the low wall of the courtyard is covered in heavy biological growth due to moisture accumulation and shade produced by a mature overhanging tree. The paint coating along the south elevation is inconsistent with a dissimilar yellow paint coating a portion of the western section. Additionally, the arched wood door at the south wall of the Courtyard is significantly rotted at the base.

The brick chimney at the west appears to be in fair condition overall at the exterior. There is significant biological growth at the base and along the horizontal surfaces. The mortar appears to be in good condition overall and there are no loose or decaying bricks.

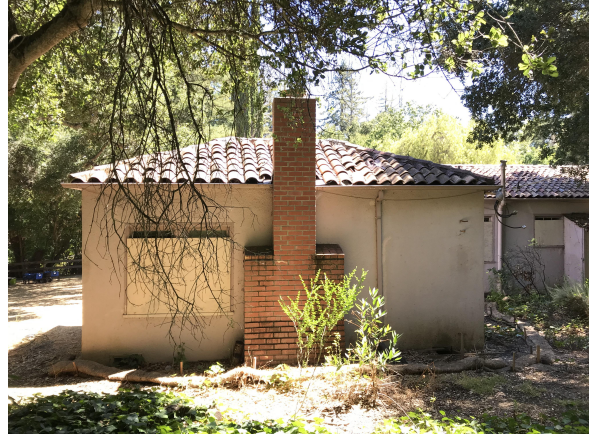
Photo #2 - West Elevation of the Northwest Appendage of the Building

There are two chimneys that extend above the roof, one is located on the south exterior wall of the north wing and the other is located on the west exterior wall of the northwest appendage of the building. The chimney at the northwest appendage is clearly an unreinforced brick (see Photo #2). The chimney located on the south exterior wall of the north wing is clad in stucco and it is unclear if the chimney is constructed with unreinforced brick (see Photo #7).

1. Strengthen the existing wood shear walls and add new wood shear walls in the longitudinal and transverse direction at the first floor to resist ASCE 41-13 design earthquake lateral forces.
2. Add sill bolts from the shear wall sill plates to the top of the concrete foundation walls to resist ASCE 41-13 design earthquake lateral forces.
3. Strengthen the roof diaphragm to resist ASCE 41-13 design earthquake lateral forces.
4. Add positive connections between the wood beams and wood posts in the crawl space.
5. Add positive connections between the wood posts and isolated concrete footings in the crawl space.
6. Provide continuous ties at the roof diaphragm chords of the building.
7. Provide positive anchorage of the unreinforced brick chimneys to the roof diaphragm and brace the top of the chimneys above the roof to the roof diaphragm.

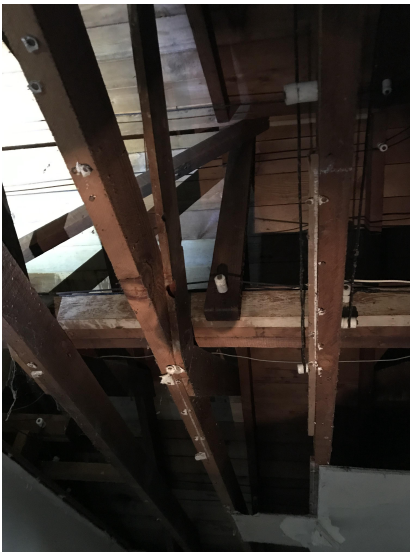
Photo #13: Roof Framing and Ridge Board at East Wing of the Building

The roof framing was observed in the east wing and west wing of the building. The roof framing at the east wing of the building consisted of 1x straight roof sheathing over 2" x 5 1/2" roof rafters spaced at 18" on center with a 2" ridge board at the mid-span and supported by the perimeter wood framed bearing walls at the side walls. See Photo #11 and Photo #12. The roof framing at the west wing of the building consists 1x straight rood sheathing over 2" x 5 1/2" roof rafters spaced at 16" on center with a 1" ridge board at the mid-span and supported by the perimeter wood framed bearing walls at the side walls. See Photo #13 and Photo #14.

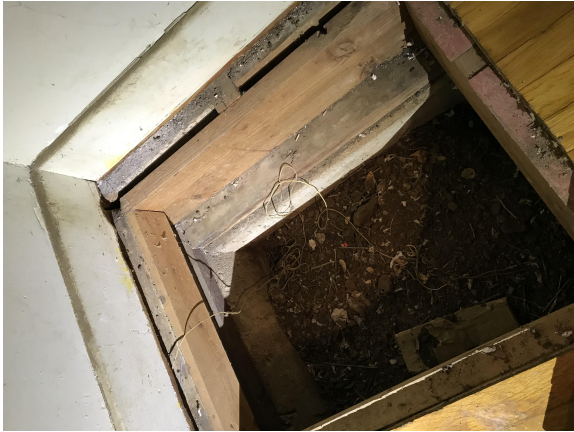
Photo #15: Crawl Space Access Opening in Floor Framing at East Wing

The floor framing was observed in a crawl space access hatch in the southwest corner of the east wing. See Photo #15. The floor framing at the east wing consists of 1x finished wood floor and 1x diagonal sheathing over 2" x 7 1/2" joists spaced at 16 inches on center that span to the perimeter foundation walls and a single line of interior wood beams. See Photo #16. The perimeter foundation consists of a continuous concrete foundation and the interior wood beams are supported on isolated concrete footings. Note that the interior beams and isolated concrete footings were not measured due to the approximately 12" crawl space height to the underside of the floor joists, but the Duquette structural drawings noted the interior beams were 4x6 and the isolated concrete footings were 1'-6" square. The building code requires 12" minimum clearance

between the underside of interior beams and exposed grade and 18" minimum clearance between the underside of floor joists and exposed grade in a crawl space. The floor framing over the crawl space in the remaining sections of the house were not observed.
