# STORM WATER MANAGEMENT MASTER PLAN

City of Los Altos

May 2010

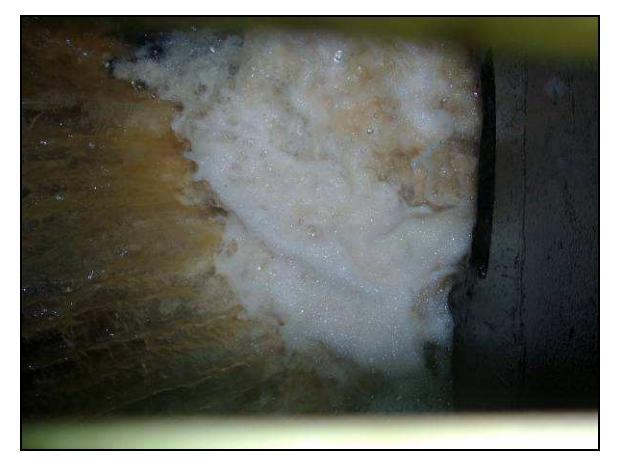
- There is a series of upstream check dams on the creek that are in poor condition (Photo 3.1).
- Storm water flow enters into the pipe channel and there is no debris/trash rack (Photo 3.2).
- Discussions with a local resident indicated that in the past a large tree branch had become lodged inside the pipe creating a surcharged flow condition. Backwater began to flood the low-lying areas adjacent to the townhomes (Photo 3.3).
- Physical features of the structures appeared to be new, without defects and were determined to be in good structural condition.
- Not all of the features were identified on the maps and there were slight discrepancies with the actual locations. Size information for this line was omitted from the maps, understating the size and importance of the line, which carries a large amount of flow from creeks.
- There is poor and limited access to the manhole structures.

Photo 3.2. Turbulence at inlet transition from box culvert to circular conduit

- Consider installing a trash rack on the inlet to the storm water pipe. Otherwise, continued maintenance and cleaning of this line is suggested.
- Locate and expose all access points on the line and update maps with their actual locations.

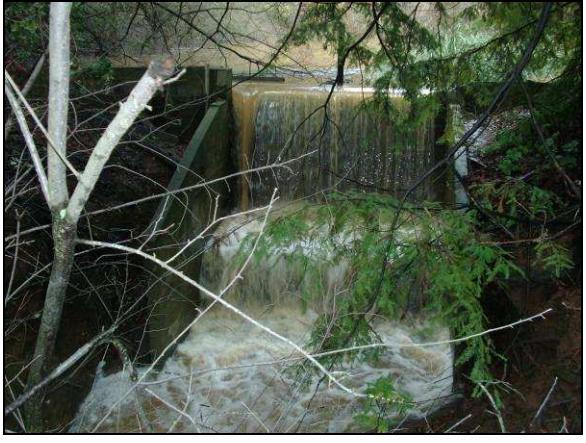
Photo 3.1. Upstream check dam

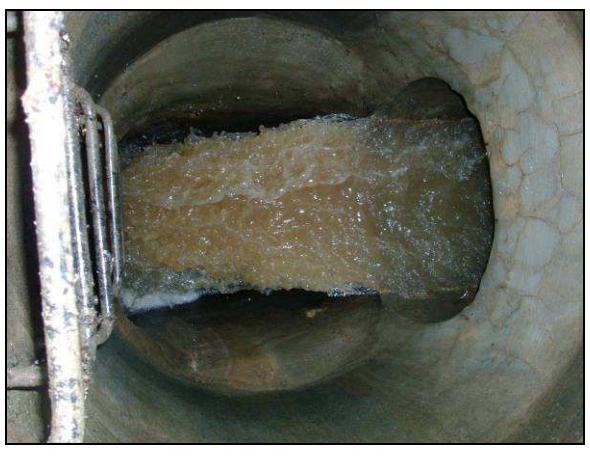
Photo 3.3. Drop inlet at MD6-119 where tree branch was reported to have become lodged

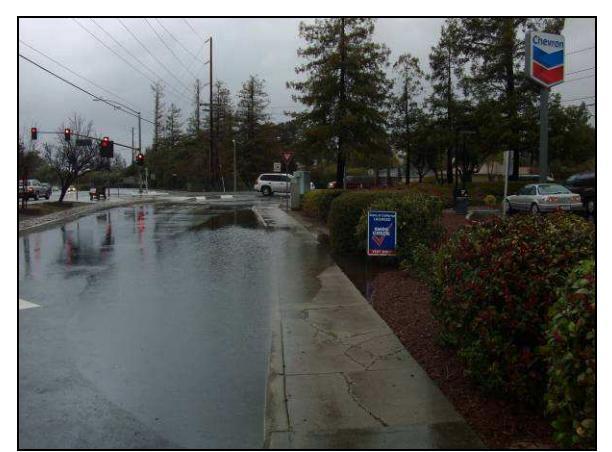
- There is a low area in the offramp from Foothill Expressway near the Chevron gas station that floods due to lack of drainage or road grade (Photo 3.4).
- Water continues to pond until the height exceeds the street curb. The water then flows over the sidewalk, across the landscaping to the catch basin located at the apex of the curve for the right hand turn (Photo 3.6).
- The catch basin (Unknown J) at the south curb edge of Foothill Expressway at El Sereno Avenue does not appear on the maps (Photo 3.5).

Photo 3.4. Flooding at Foothill Expressway offramp

Install a curb cut, add an additional catch basin alongside the road, and/or correct the road grade to allow for proper drainage.

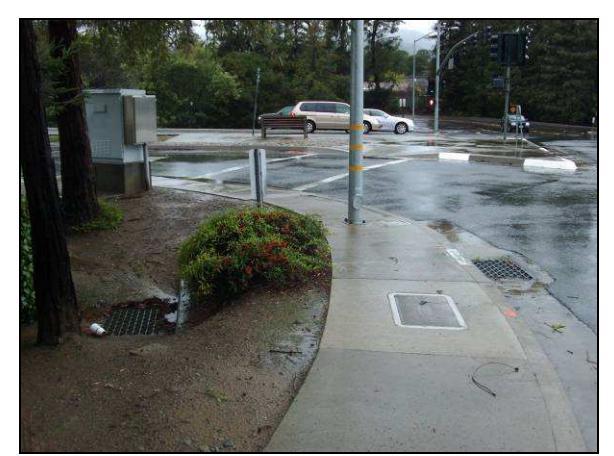
Photo 3.5. Unidentified catch basins (Unknown J) at the apex of the right hand turn onto Homestead

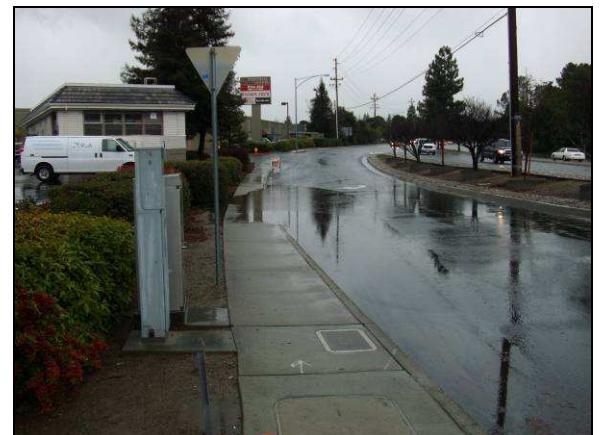
Photo 3.6. Looking south at flooded area

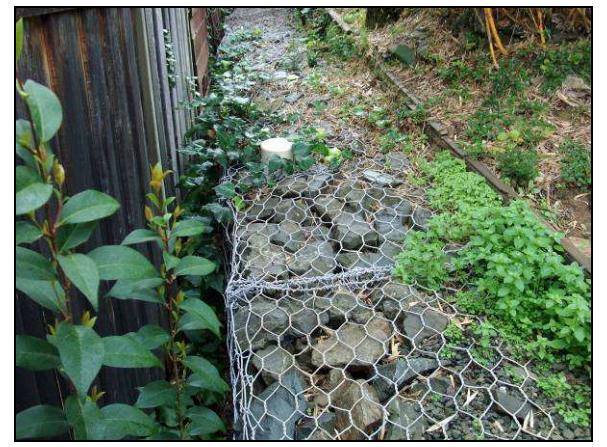
- The upper portion of the ditch is a cage-wrapped rock retaining wall (Photo 3.10). Drainage issues were not reported in this area.
- Portions of homeowner-made retaining wall improvements are collapsing (Photo 3.11).
- Dirt from the backyard hillsides and landscaping debris blocks the water flow through the concrete ditch. Temporary piping is in place to restore drainage (Photo 3.12).

Photo 3.10. Cage-wrapped rock retaining wall

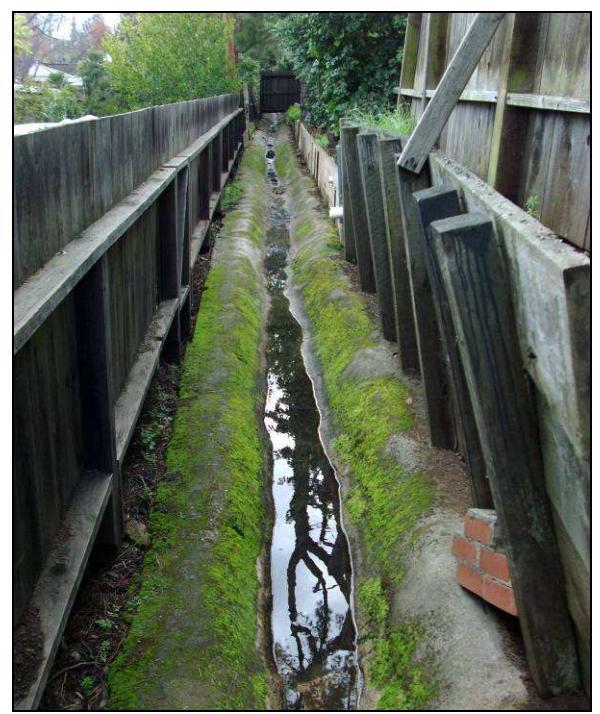
Photo 3.11. Collapsing retaining walls along drainage ditch

- Consider CCTV inspection of the corrugated metal pipe to assess condition.
- Continue rock wall long the length of the pipe or equivalent structural storm drainage chambers to keep the hillside dirt from sliding and obstructing the drainage.

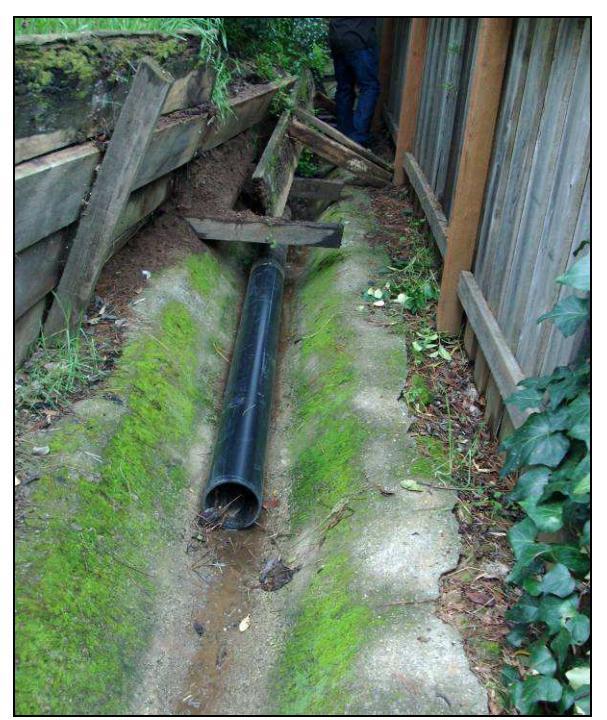
Photo 3.12. Temporary piping to restore drainage under debris

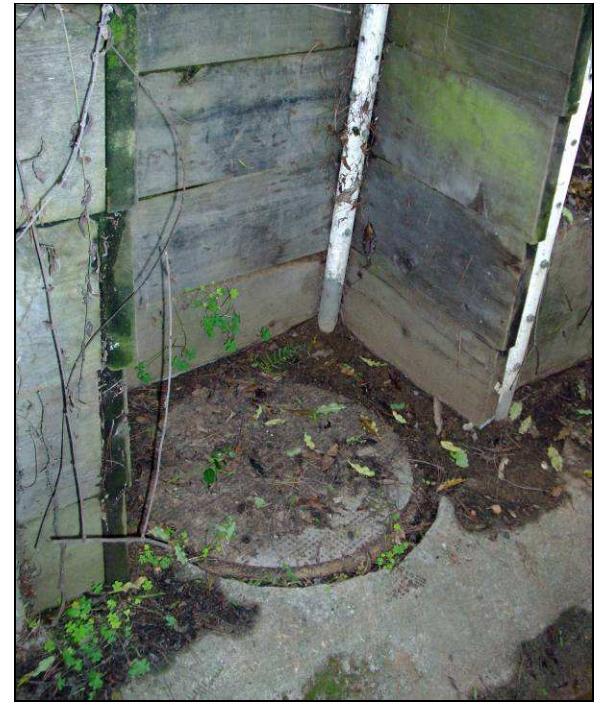
- The easement also serves as access for a sanitary sewer manhole directly adjacent to the concrete ditch (Photo 3.13).
- The outlet of the ditch enters a corrugated metal pipe and the inlet to the pipe is partially obstructed (Photo 3.14).

Photo 3.13. Sanitary sewer manhole in concrete ditch, shared easement

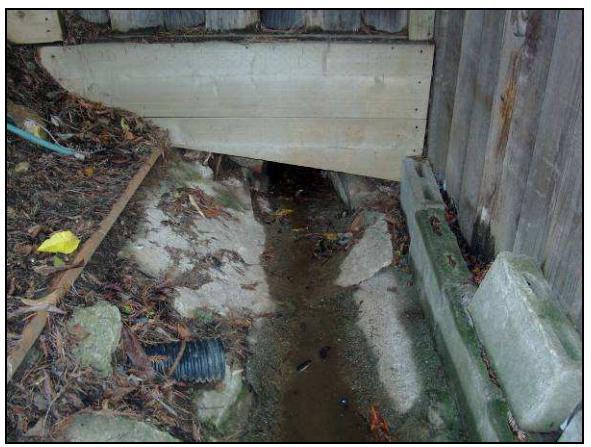
- Structural Rating = N/A (No structural component)
- O&M Rating = 4 (Very poor access)

Photo 3.14. Outlet to corrugated metal pipe partially obstructed

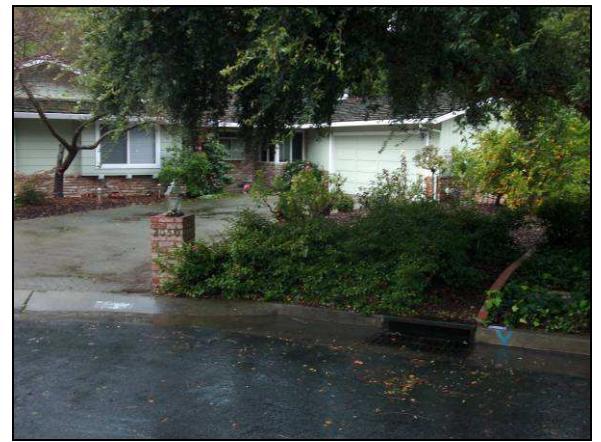
- Appears to have greater flow to Catch Basin L4C-607 from hillside drainage from St. Joseph Ave. towards Madelaine Court (Photos 3.15 and 3.16).
- One feature, L4D-606, in easement could not be located between the cul-de-sac and Permanente Creek.

Photo 3.15. L4C-607 catch basin

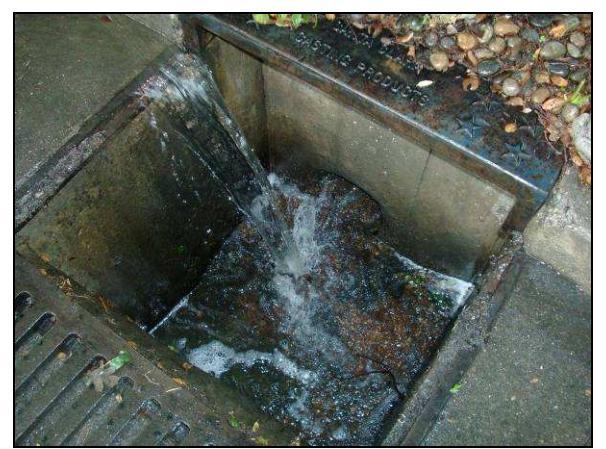
Photo 3.16. Storm water flow entering L4C-607 catch basin

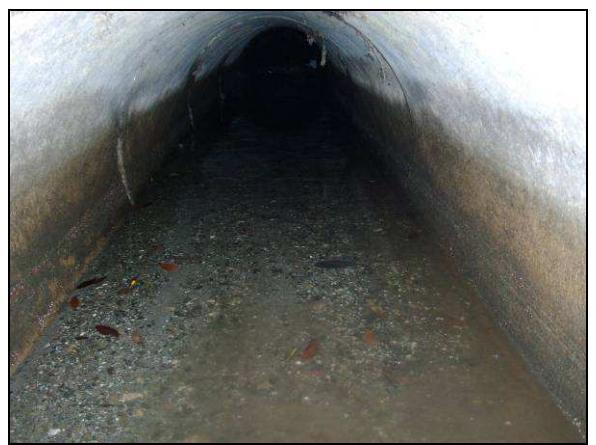
- There are parallel lines along Robinhood Court, a 33-inch trunk line and a smaller local storm water collection system, both draining to Permanente Creek.
- There was some sediment buildup in the smaller 21-inch line. This appears to be due to shallower slopes of the storm pipes in this area (Photos 3.17 and 3.18).
- One feature, L5D-104, in easement could not to be located.

Photo 3.17. Sediment buildup in 21-inch pipe

- Locate Storm Drainage Feature L5D-104.
- Clean the 21-inch line between Catch Basins L5C-108 and L5C-106.

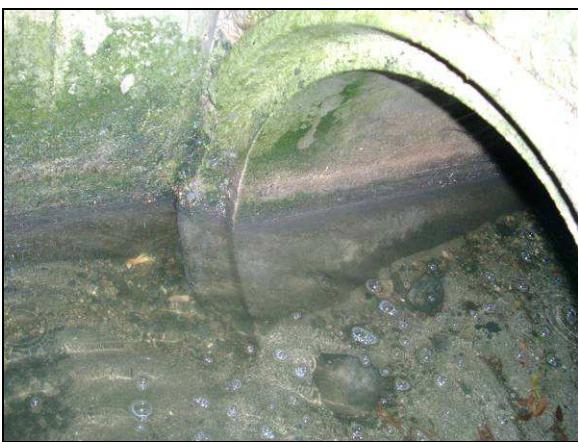
Photo 3.18. Shallow slope causes sediment buildup and restricts flow capacity

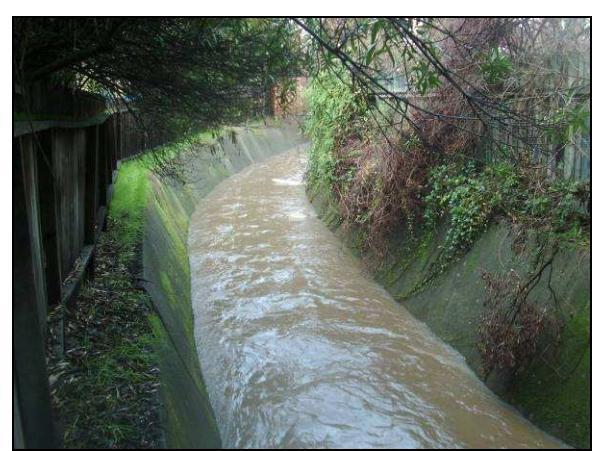
- Hale Creek upstream of Covington Rd. is a natural creek bed. Hale Creek crosses under Covington Rd. and flows out into a concrete-lined channel. The box channel under Covington Rd. appears to be undersized to handle the creek flow (Photos 3.19 and 3.20).
- The flow is scouring around the outside edges of the upstream approach to the Covington box channel (Photo 3.21).
- Storm water outfall pipes protrude into the creek bed creating possible areas for debris to collect, potentially causing obstructions to flow.

Photo 3.20. Hale Creek downstream

Box channel may need to be upsized or an additional parallel channel constructed to alleviate the flow restriction.

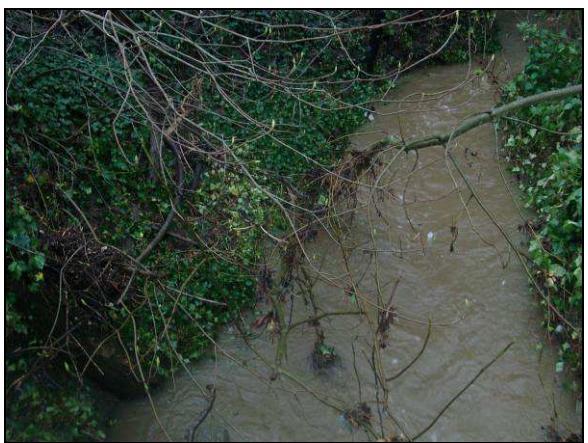
Photo 3.19. Hale Creek downstream

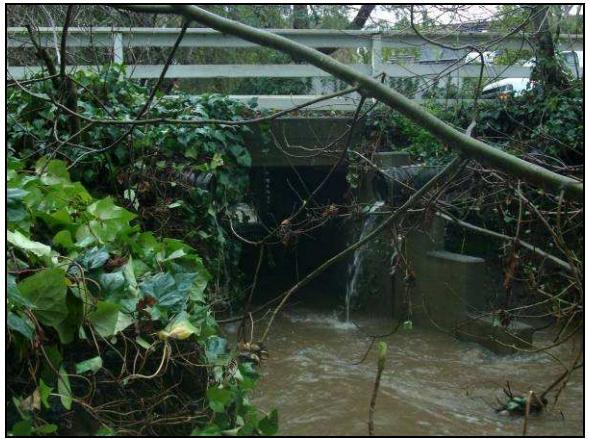
Photo 3.21. Upstream structure, undermined along sides of channel – protruding outfalls

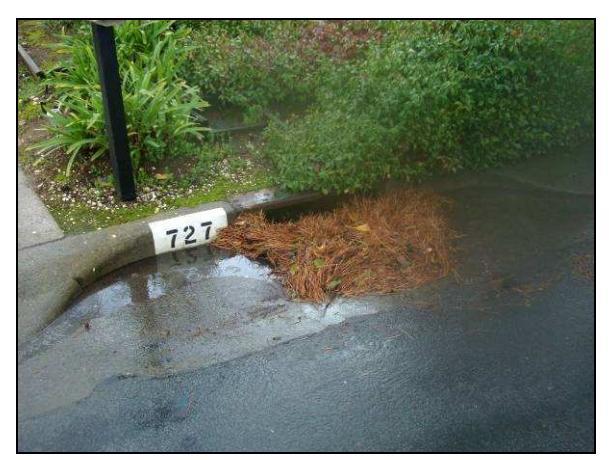
- Catch Basin G2C-609 was observed to have been covered with pine needles (Photo 3.22).
- View of the downstream pipe indicates that some debris may be obstructing the flow (Photo 3.23).

Photo 3.22. Catch Basin G2C-609 obstructed by pine needles

Cleaning is recommended on the pipe between G2C-609 and G2D-610.

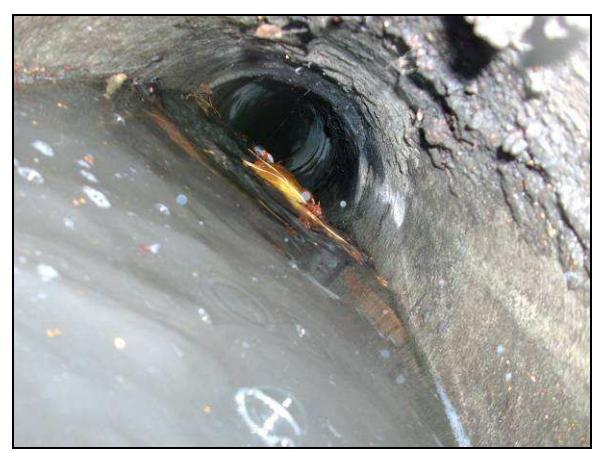
Photo 3.23. Downstream pipe partially obstructed with debris

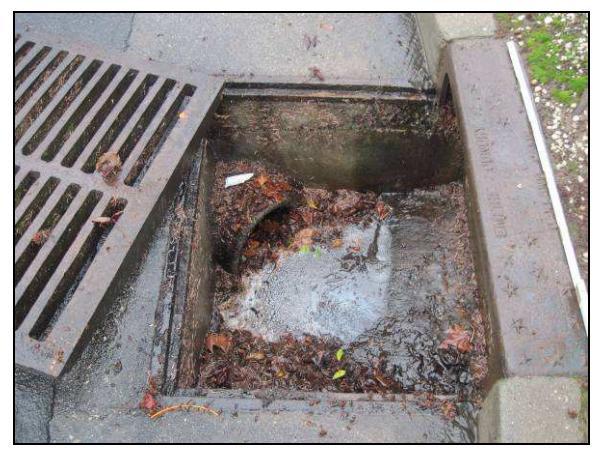
- Structural Rating = 1 (Vanda concrete condition = 1; outlet configuration restricts flow)
- O&M Rating = 1 (some light debris)

Photo 3.24. Catch Basin C2C-315, poor transition to outlet pipe

- Catch Basin C2C-315: cut or chip out outlet pipe edges. Use mortar to round edges into a smooth transition to pipe outlet from the catch basin.
- Slight ponding in front of Catalina Court could be alleviated by installing a catch basin and utilizing what appears to be a previously abandoned 12-inch pipe.

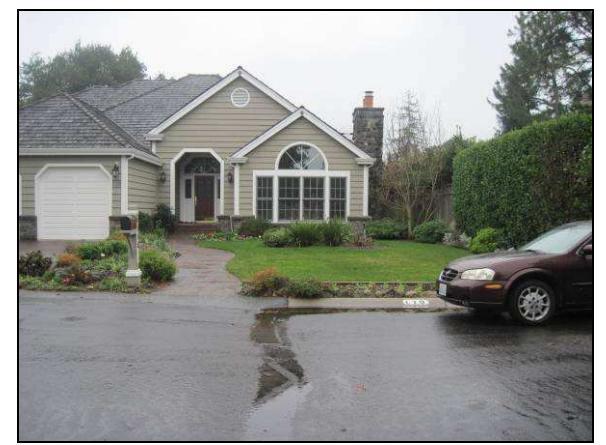
Photo 3.25. Slight street surface ponding in front of 110 Catalina Court

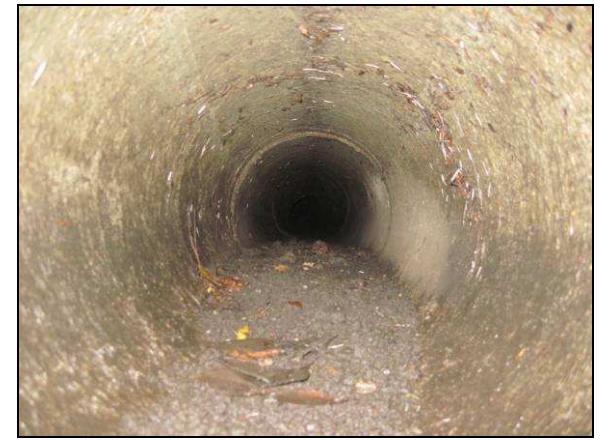
Photo 3.26. 12-inch dry pipe with some sediment looking upstream south – not shown on maps

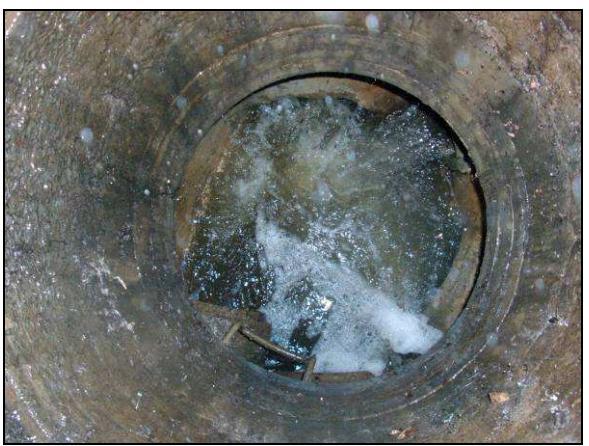
- Structural Rating = 2 (Vanda concrete condition = 1; poor design, configuration of too many inlets creates turbulence and outlet configuration restricts flow)
- ✤ O&M Rating = 1

Photo 3.27. Manhole M6D-614 with multiple inlets, turbulent flows, potentially piping

- Downstream piping may need to be upsized or the storm system expanded to accommodate the flow in this drainage area.
- The outlet to the drainage creek needs to be modified by possibly trenching the creek bed deeper and wider so that the flow is not restricted.

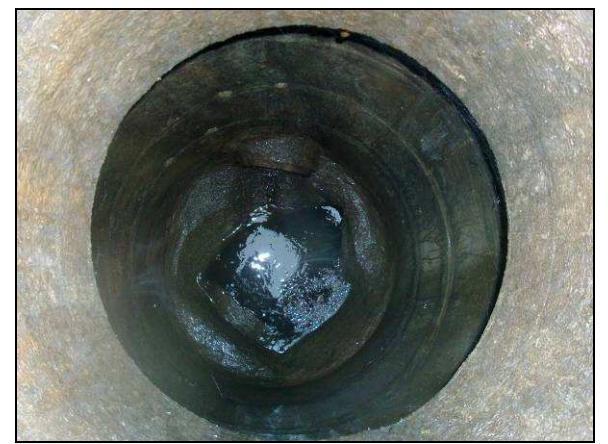
Photo 3.28. Manhole M6D-617 with additional pipe from south, which appears abandoned and is not shown on the maps

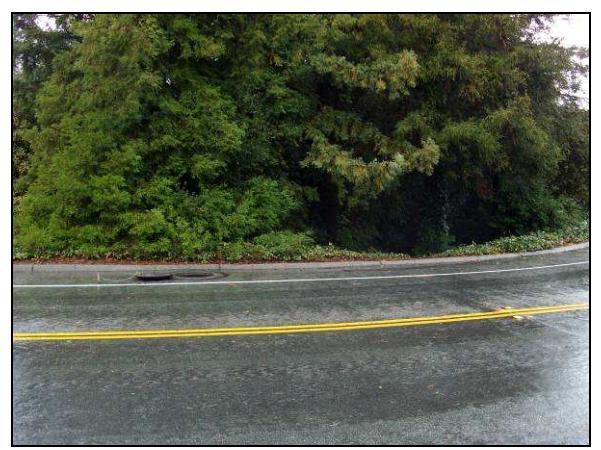
Photo 3.29. Unidentified manhole (Unknown G) downstream of M6D-617 with outlet drainage to creek

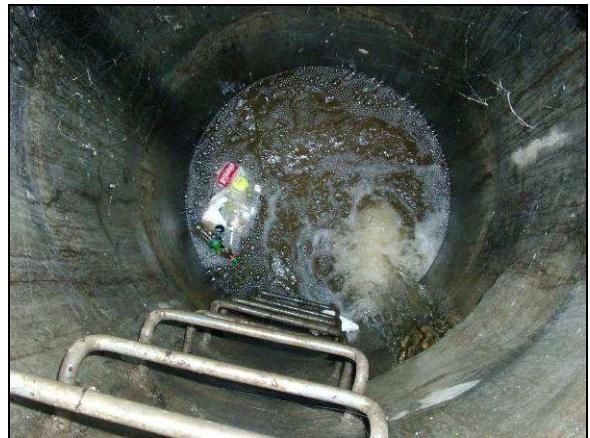
Photo 3.30. Manhole downstream of M6D-617 which is surcharged due to poor outlet configuration to drainage creek bed

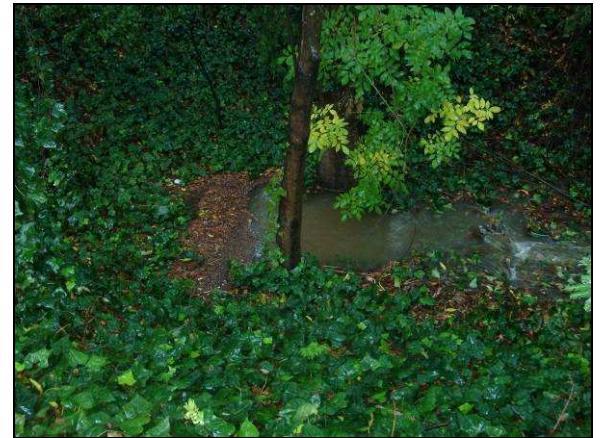
Photo 3.31. Outlet to creek is completely submerged

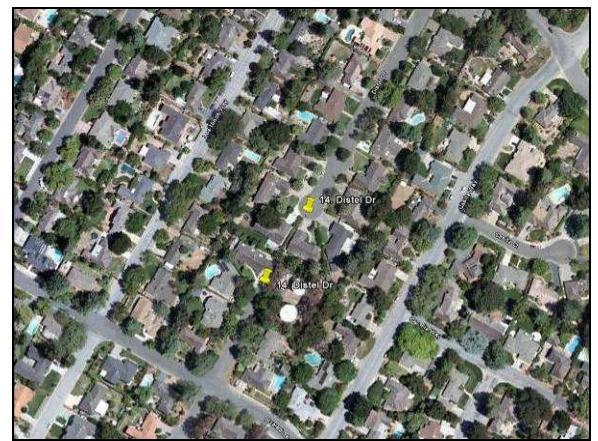
Figure 3.11. Distel Drive

This area was identified as plugging periodically due to debris (Figure 3.11).

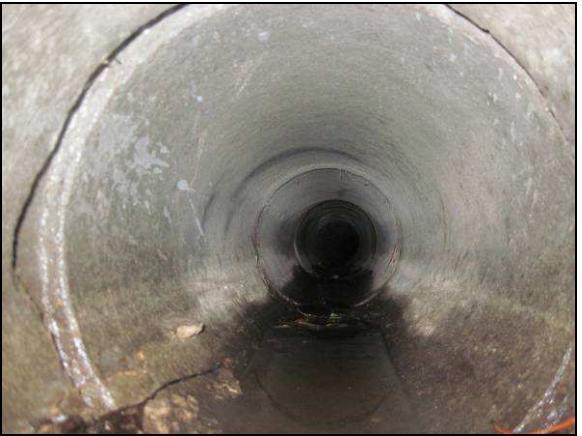
- The pipe downstream of Catch Basin C3C-501 had cracks at a joint.
- Structure C3C-502 had a small mortar dam at the invert of the inlet pipe, which backed up water into the upstream pipe. The catch basin had slight debris and there was some sediment buildup downstream.

- Structural Rating = 1 (Vanda concrete condition = 1)
- O&M Rating = 1 (Mortar obstruction causes some debris build up)

Photo 3.32. Catch Basin C3C-501, downstream pipe with cracks

- Clean downstream pipe.
- Remove mortar dam at inlet to C3C-502.

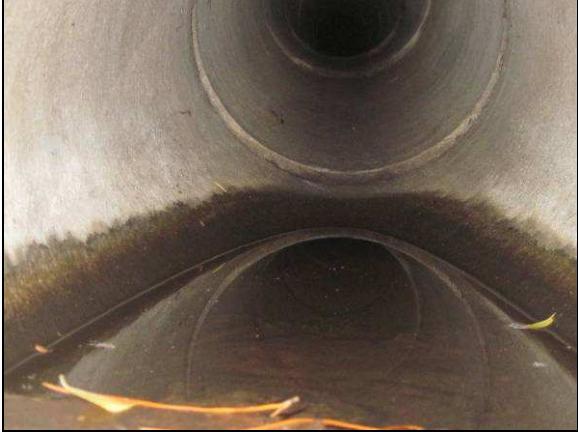
Photo 3.33. Catch Basin C3C-502, mortar dam and backup in inlet

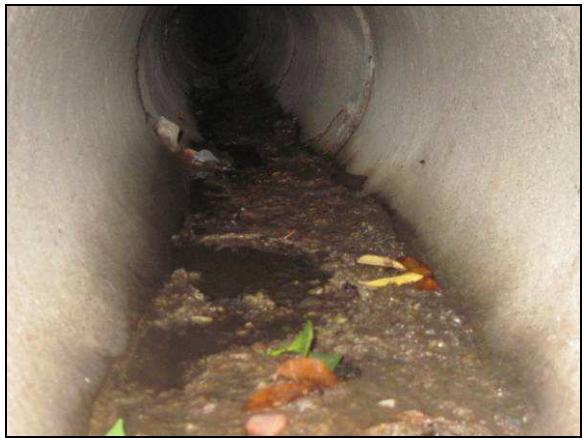
Photo 3.34. Catch Basin C3C-502, sediment in downstream pipe

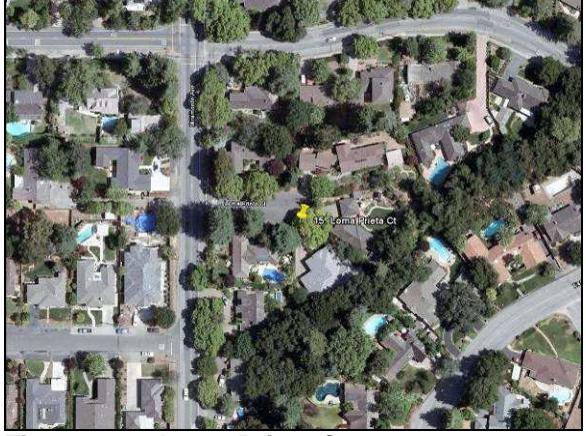
Figure 3.12. Loma Prieta Court

This area was identified as having poor drainage because the storm inlet is too high (Figure 3.12).

Lower the inlet grating of Catch Basin H5F-404 below the surrounding gutters. This may not be feasible without lowering the outlet line since the catch basin is very shallow.

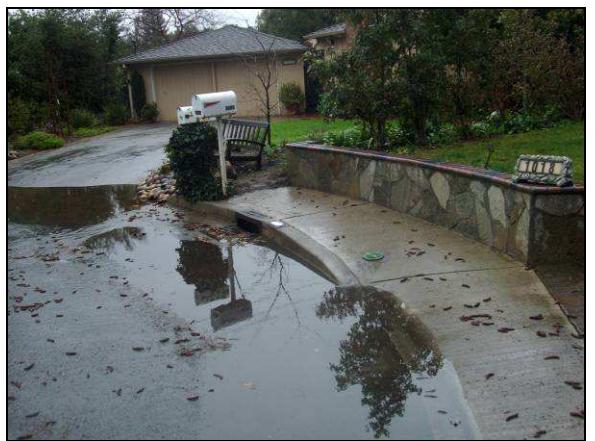
Photo 3.35. Catch Basin H5F-404 surrounded by ponding

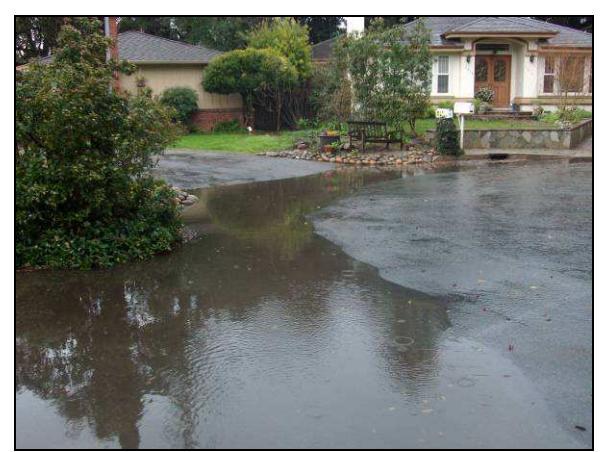
Photo 3.36. Large puddle at end of Loma Prieta Court

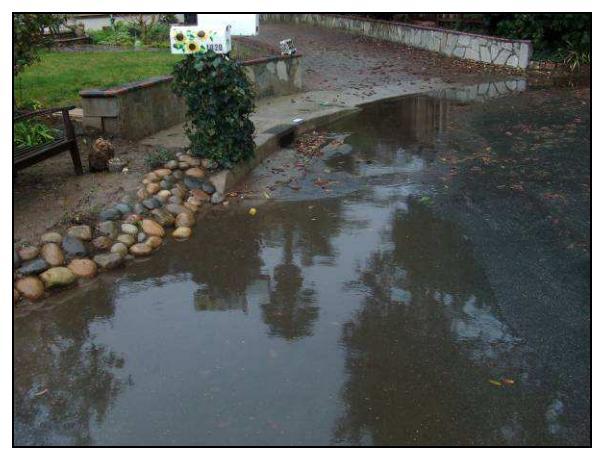
Photo 3.37. Puddles approach but cannot enter Catch Basin H5F-404

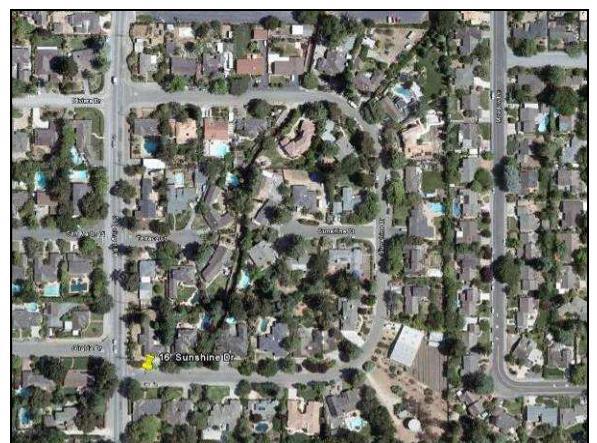
Figure 3.13. Sunshine Drive

This area was identified as plugging periodically on the north side (Figure 3.13).

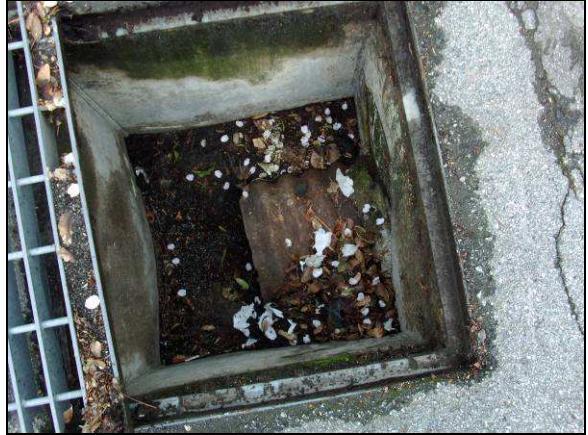
- Catch Basins F4F-212, F4F-204 and F4F-201 have inadequately sized grates and are half full of sediment (Photos 3.38 through Photo 3.44).
- Catch basins F4F-212 and F4F-201 have corrugated metal pipes. The pipes appear to be in good condition but the inlets from the catch basin are poorly constructed (Photos 3.38 through Photo 3.42).
- The pipe from catch basin F4F-204 is half full of sediment and directed upstream to discharge in to Hale Creek. When flows are elevated the creek could flow into this pipe and deposit sediment (Photos 3.43 to Photo 3.44).
- The access ramp to Hale Creek is directed upstream. When flows are elevated, the creek can begin to rise along side the access ramp and flow over the street (Photo 3.45).

Photo 3.38. Catch Basin F4F-212 undersized with protruding corrugated metal pipe outlet creating obstruction for sediment

- Reconstruct Catch Basins F4F-212, F4F-204 and F4F-201 to improve the flow to the outlet pipe.
- Clean pipes from F4F-212, F4F-204 and F4F-201 to remove sediment.

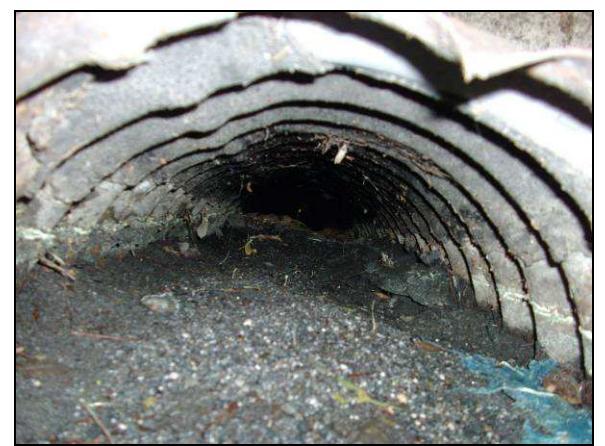
Photo 3.39. Catch Basin F4F-212 corrugated metal pipe outlet half full of sediment

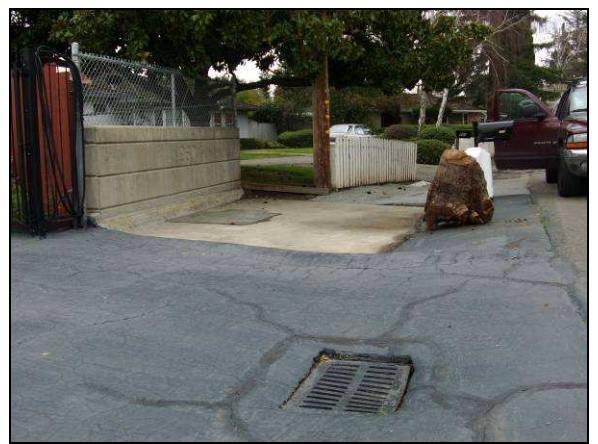
Photo 3.40. Catch Basin F4F-201 undersized

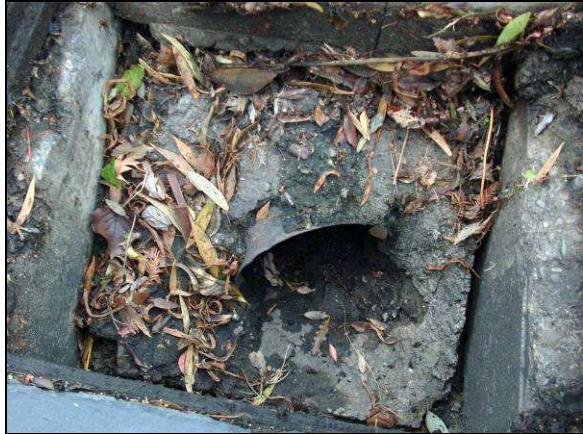
Photo 3.41. Catch Basin F4F-201 poorly constructed inlet

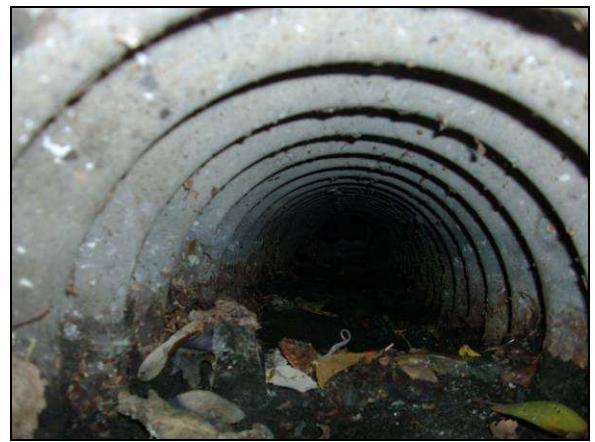
Photo 3.42. Catch Basin F4F-201 corrugated metal pipe outlet half full of sediment

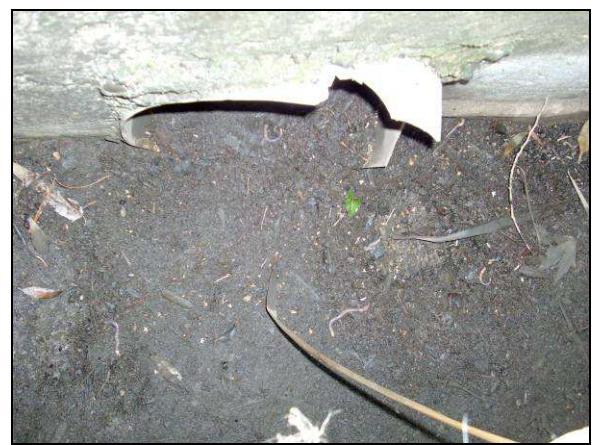
Photo 3.43. Catch Basin F4F-204 half full of sediment

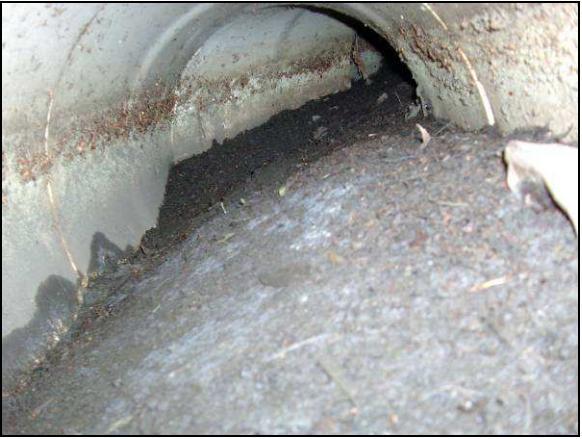
Photo 3.44. Catch Basin F4F-204 flows upstream into Hale Creek

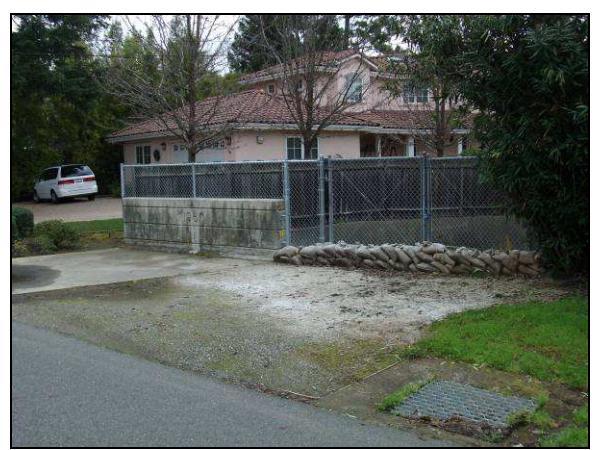
Photo 3.45. Access ramp to Hale Creek near F4F-204. Creek flows over ramp (Sandbags)

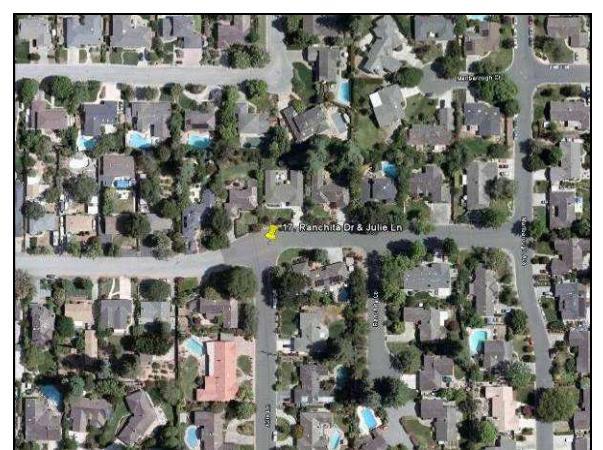
Figure 3.14. Ranchita Drive at Julie Lane

This area was identified as having drainage issues due to crowned road (Figure 3.14).

- Add a sump to Structure J6C-225 to collect debris.
- Add storm inlets along Ranchita Drive east of Ranchita Court.

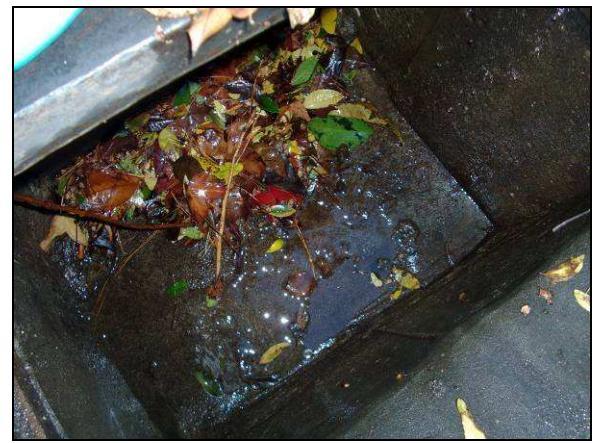
Photo 3.46. Catch Basin J6C-225 with leaves obstructing outlet

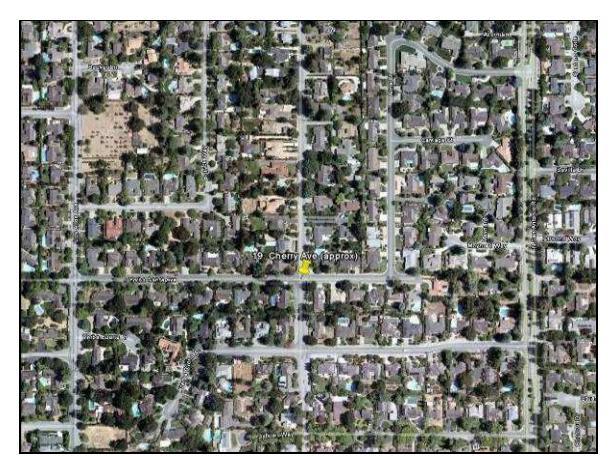
Figure 3.15. Cherry Avenue

This area was identified as having redwood tree roots in the storm drains (Figure 3.15).

- Structural Rating = 1 (Vanda concrete condition = 1)
- O&M Rating = 1 (No evidence of roots at the time of the evaluation)

Continue cleaning program to prevent roots.

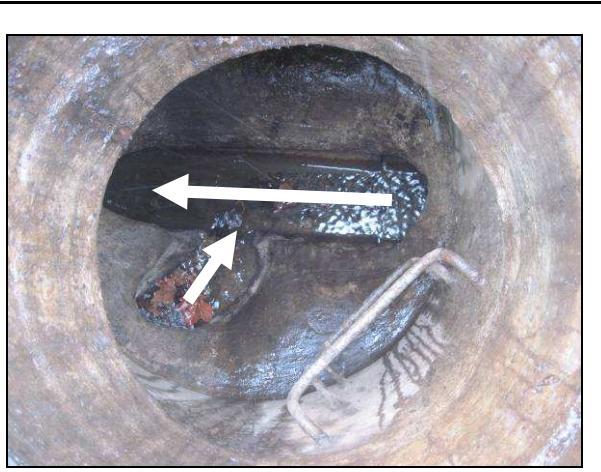
- The inlet to Manhole C3D-102 from C3C-103 enters the manhole facing upstream (Photo 3.47).
- The lines entering and leaving Manhole C3D-102 have about 1 inch of sediment (Photo 3.48).
- Catch Basin C3C-104 has about 3 inches of hard sediment or concrete at the outlet. This backs up flow in the catch basin but may allow debris to settle out (Photo 3.49).

Photo 3.47. Manhole C3D-102 with inlet from C3C-103 entering in upstream direction

- Reconfigure Manhole C3D-102 so that the inlets all flow in the downstream direction.
- Clean hard debris to allow better flow through the pipes

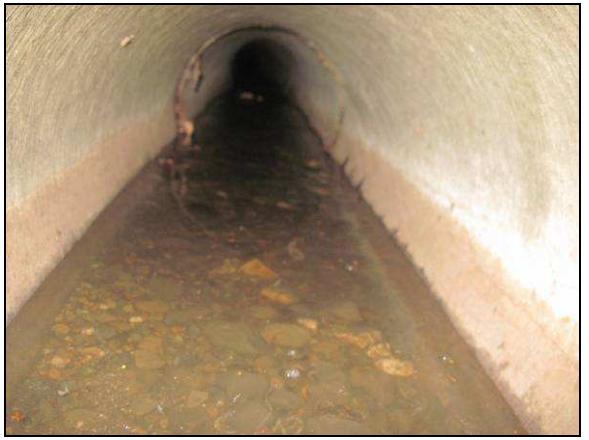
Photo 3.48. Outlet from Manhole C3D-102 with gravel deposits

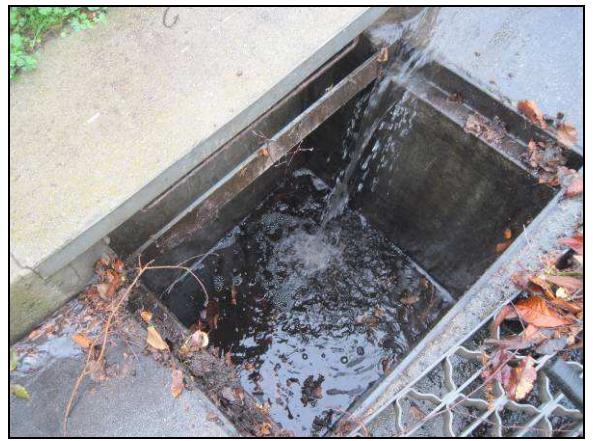
Photo 3.49. Catch Basin C3C-104 with flow backed up

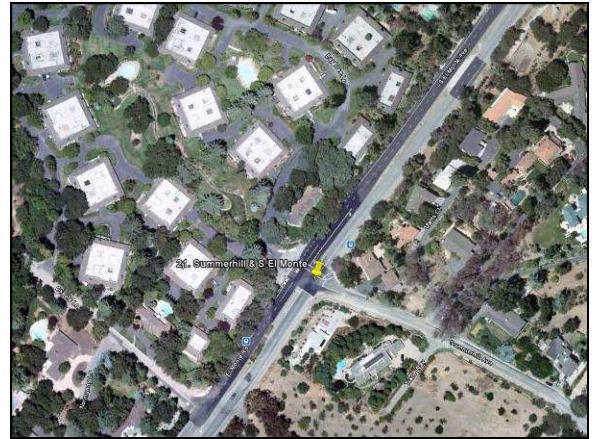
Figure 3.17. Summerhill Avenue at South El Monte Avenue

This area was identified as having rocks and debris obstructing drainage (Figure 3.17).

- Construct additional storm inlets at the south corner of the intersection. Surface flows from Summerhill could be intercepted before they reach the base of the incline, where the slope is flat and ponding occurs. Likewise, flows from the south along El Monte could be collected at points south of the intersection before encountering the low, flat area next to the roadway.
- Provide a larger inlet area to Catch Basin H2C-218 to reduce potential for clogging.
- Use CCTV to investigate the line between Catch Basins H2C-216 and H2D-217 to identify obstruction.

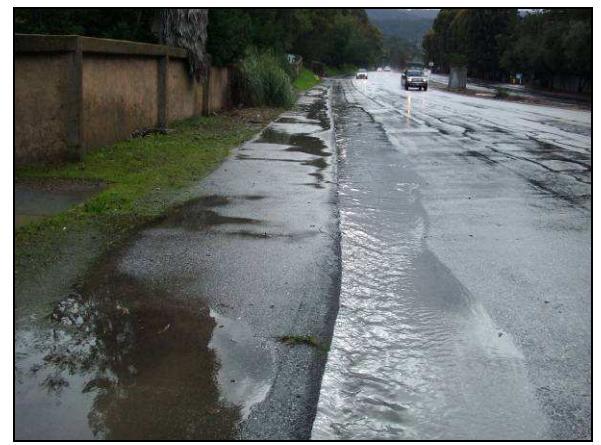
Photo 3.50. Large puddle along El Monte south of H2C-217 due to flat slope

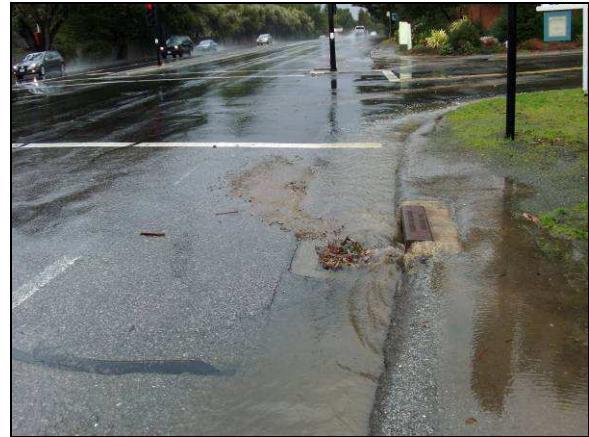
Photo 3.51. Ponding around H2C-217 in light rain with evidence of more severe ponding

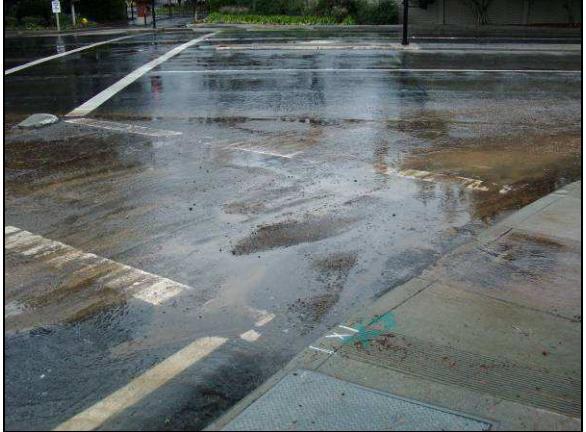
- Rocks and mud were found in the intersection adjacent to Catch Basin H2C-218, indicating potential overflow or back-up conditions at this catch basin (Photo 3.56).
- The line between Catch Basins H2C-216 and H2D-217 appears to have an obstruction or partial collapse which would restrict flow (Photo 3.57).

Photo 3.53. Corner adjacent to H2C-218 with evidence of flooding

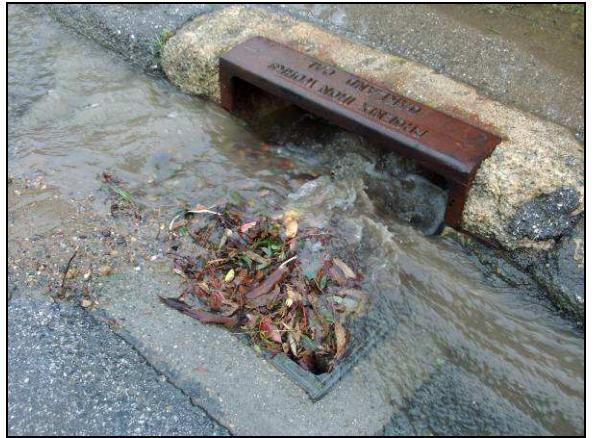
Photo 3.52. Inlet to H2C-217 with debris on grating with potential to obstruct flow

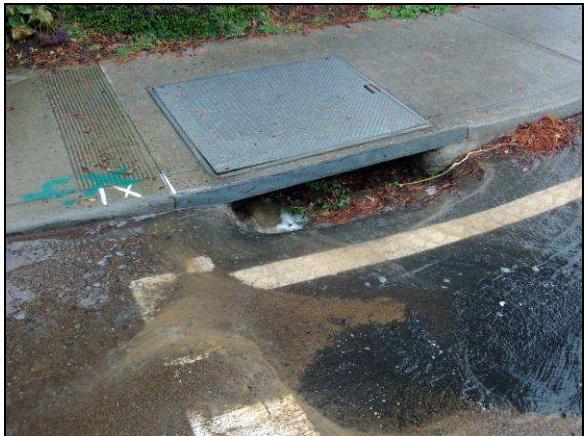
Photo 3.54. Inlet to H2C-218 with potential for debris to obstruct flow

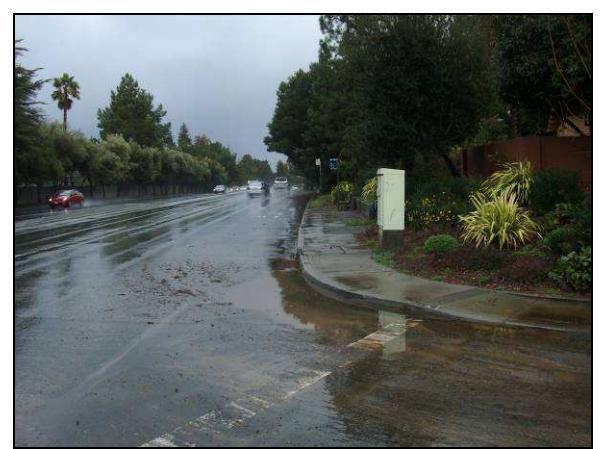
Photo 3.55. Puddling between Catch Basins H2C-218 and H2C-219

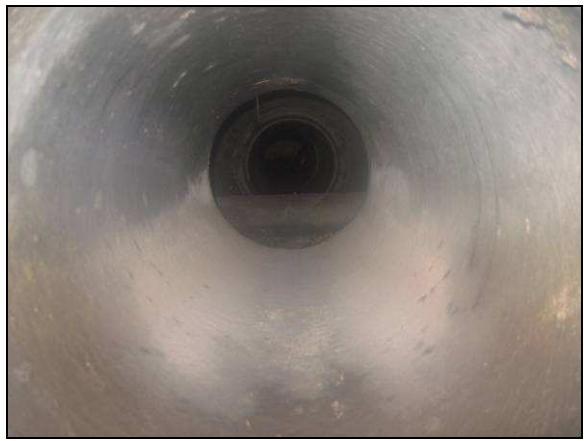
Photo 3.56. Pipe defect between H2C-216 and H2D-217 with obstruction at invert

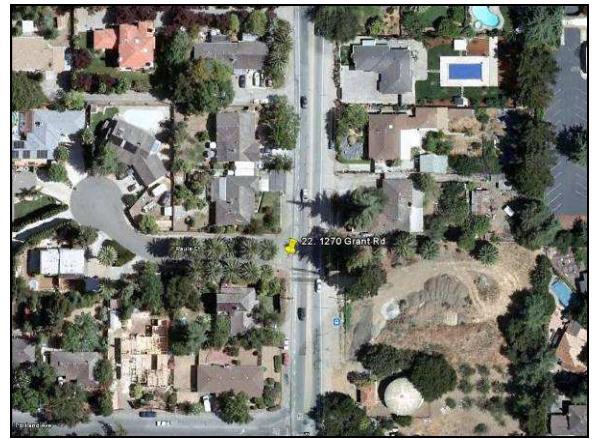
Figure 3.18. 1270 Grant Avenue at Paula Court

This area was identified as having poor surface drainage (Figure 3.18).

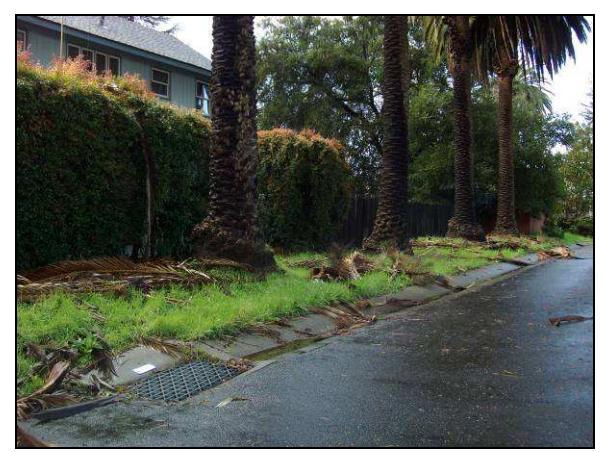
- Catch Basin I6F-401 is susceptible to being covered by debris (palm leaves from nearby trees). The catch basin has collected 3 to 4 inches of sediment and debris (Photo 3.58).
- Manhole I6D-402 has no apparent connection to I6F-401.
- Another additional manhole (Unknown F) not shown on the plans, with a cover labeled for the City of Mountain View, is present on the 24-inch line just south of I6D-402 (Photo 3.59).

Photo 3.57. Accumulation of palm leaves near Catch Basin I6F-401

Clean Catch Basin I6F-401.

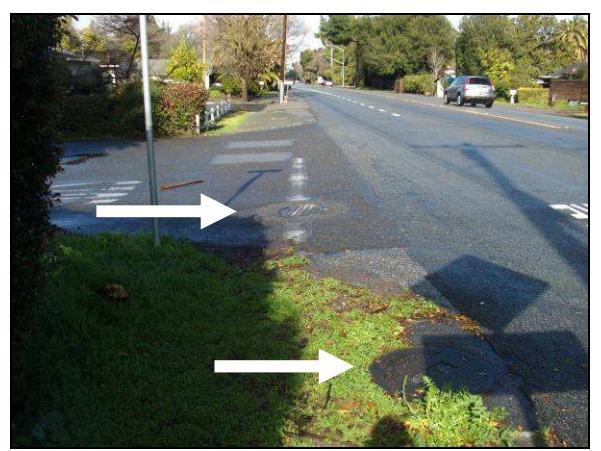
Photo 3.58. Pair of manholes at southwest corner of intersection (top—I6D-402; bottom—Unknown F)

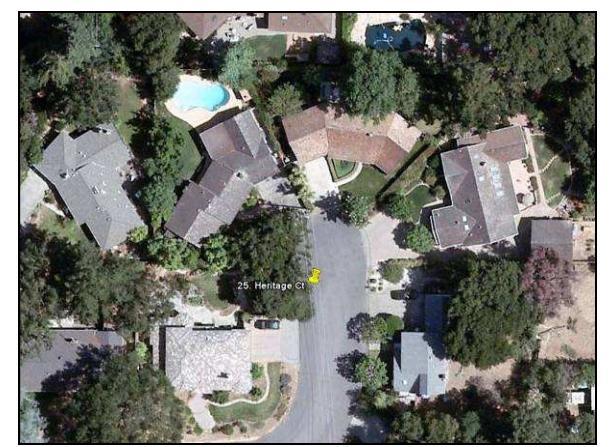
Figure 3.19. Heritage Court

This area was identified as having no curb and gutter (Figure 3.19).

- Conduct CCTV to locate J5F-303
- Clean lines from J5F-301 downstream through easement to Grant Rd.

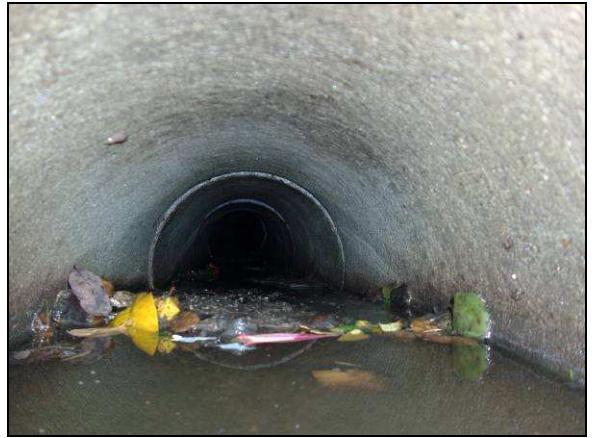
- Could not locate Feature J5F-303 (Photo 3.60)
- Pipe downstream from J5F-302 has some debris build up (Photo 3.61).

Photo 3.59. Catch Basin J5F-302 – Feature J5F-303 could not be located

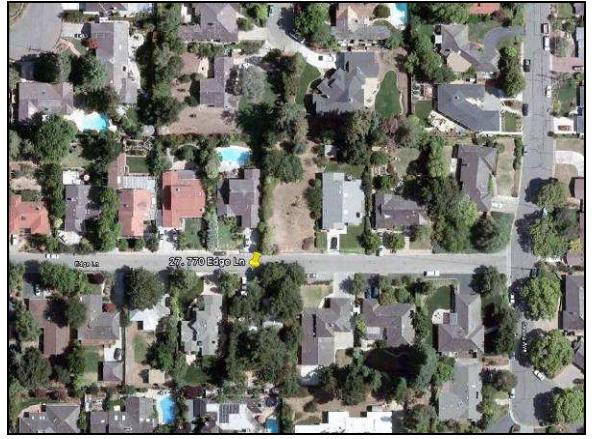
Figure 3.20. Edge Lane

No specific issues were identified (Figure 3.20).

None – V&A investigated catch basins on Alvina Court and Manhole I4D-203 on Edge Lane and did not detect any major deficiencies. The storm line is in an easement preventing access for maintenance.

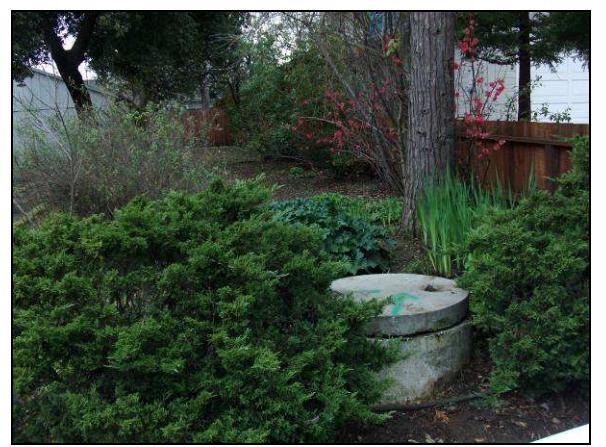
Structural Rating = 1 (Vanda concrete condition = 1)

Photo 3.61. Concrete cover for Manhole I4D-203

Replace the concrete manhole cover for I4D-203 with a standard cast iron lid.

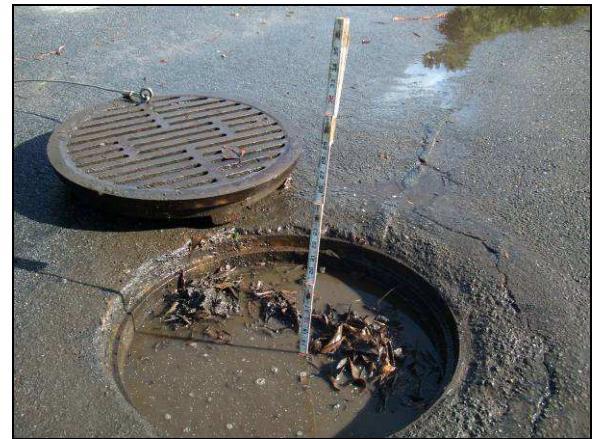
Slight ponding at the end of Dallas Court and an abandoned Manhole K6F-225 (Photo 3.63)

Photo 3.62. Abandoned Manhole K6F-225

Consider restoring storm water manhole and piping to Manhole K6F-225.

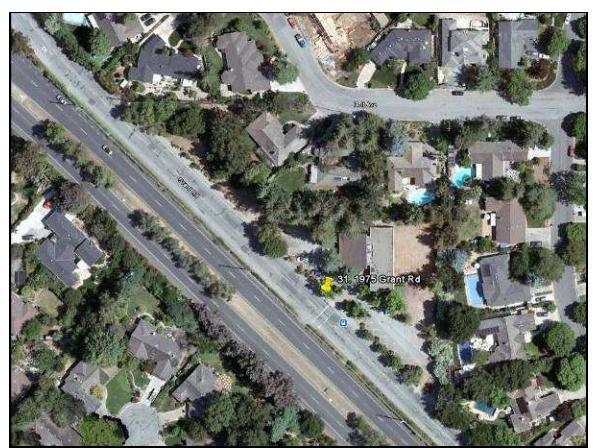
Figure 3.22. 1975 Grant Road at Woodland Library

• No specific issues were identified (Figure 3.22).

- Low spot for drainage along Foothill Expressway
- Catch basins were blocked with filter fabric due to construction at the library.
- Manhole L6F-117 was in good condition with only an inch of sediment. (Photo 3.64)
- ✤ Gutter Drain L6F-118 on northbound Foothill Expressway connects to Manhole L6F-117.

- Structural Rating = 1 (Vanda concrete condition = 1)
- O&M Rating = 1 (Some debris may be washed into storm pipe from ditch inlet in center of Foothill Expressway)

Consider additional inspection with CCTV camera.
