# STORM WATER MANAGEMENT MASTER PLAN

City of Los Altos

May 2010

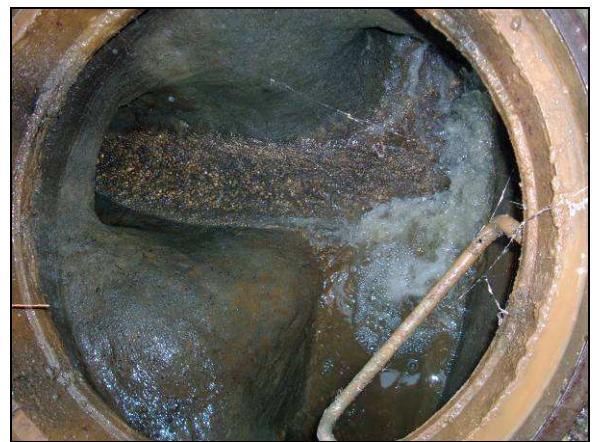
- Fast velocities and the 90-degree bend creates turbulence at the manhole downstream of N6D-502 (Unknown A, Photo 3.65).
- Sheet flow on the driveway is prevented from entering the next downstream inlet due to the cross-slope of the pavement and a small asphalt berm (Unknown B, Photo 3.64).

Photo 3.65. Turbulence at Unknown A

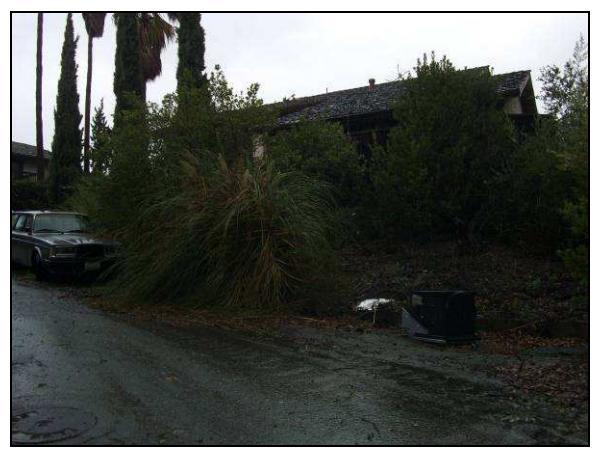
Photo 3.64. Catch Basin Unknown B

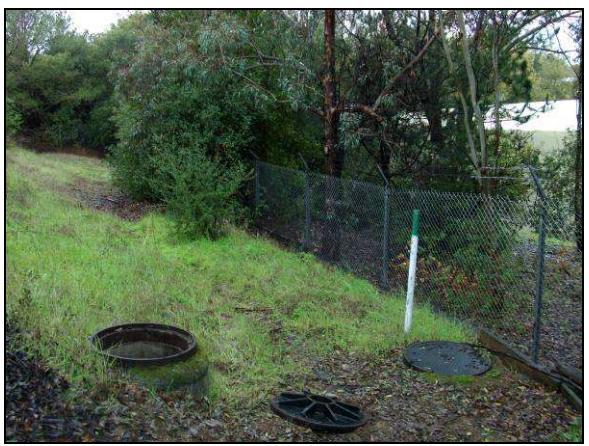
Photo 3.66. Unknown C located in utility easement alongside water tanks

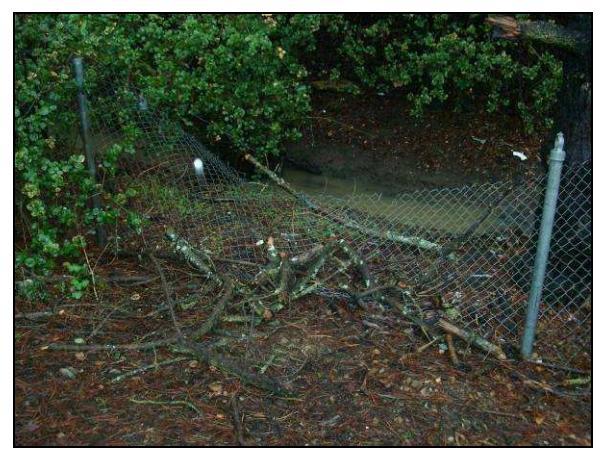
- At Unknown D the storm water appears to flow into a drainage ditch (Photo 3.67). The drainage ditch is covered with vegetation and debris (Photo 3.68).

Photo 3.67. Flow into drainage ditch

- Improve access to easement for maintenance.
- Clear catch basins of debris and improve inlet near drainage ditch.
- Inform agency with ownership over the water tanks regarding inadequate surface drainage.

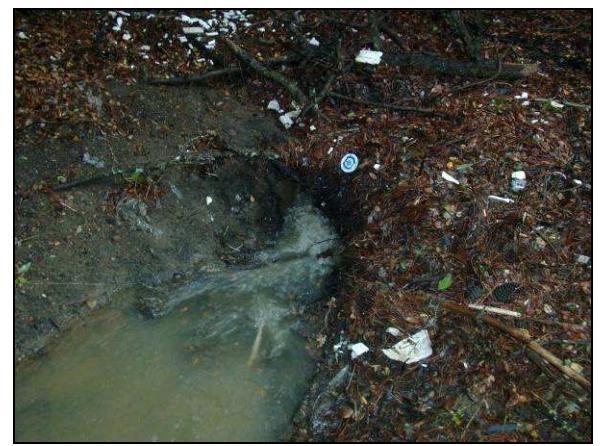
Photo 3.68. Drainage ditch with leaves and debris

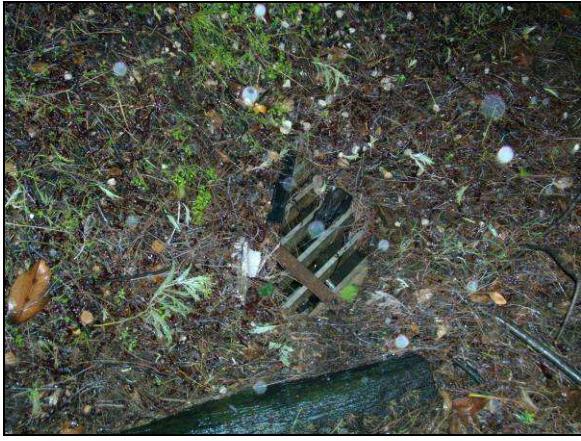
Photo 3.69. Catch basin not shown on maps parallel to Interstate 280 covered with leaves

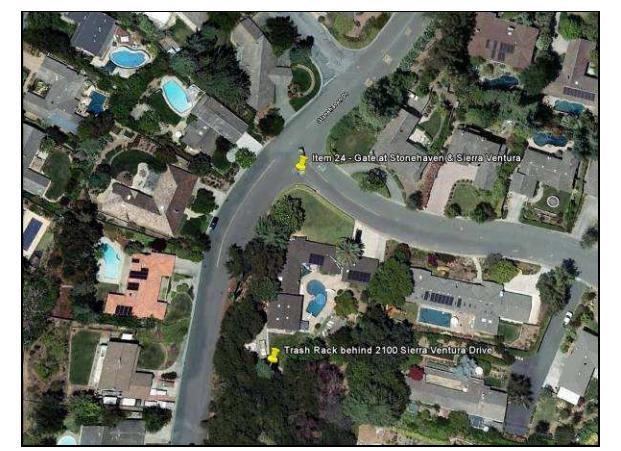
Figure 3.24. Gate at Stonehaven Drive and Sierra Ventura Drive

The City indicated that there were issues with debris getting stuck on the bar screen behind 2100 Sierra Ventura Drive. Also there is a gate structure located in the intersection of Stonehaven Drive and Sierra Ventura Drive which was paved over (Figure 3.24).

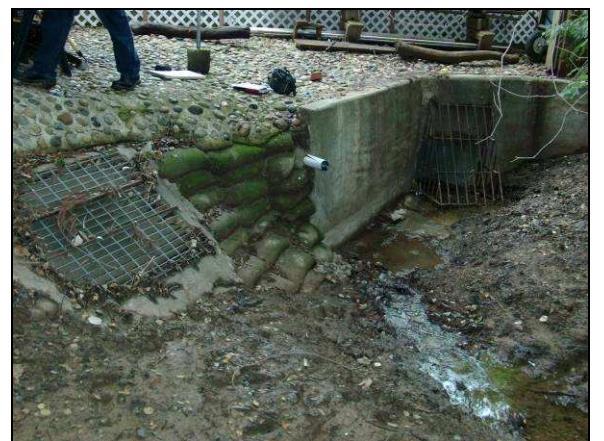
- The bar screen behind 2100 Sierra Ventura often gets blocked with debris. The homeowner routinely clears the debris from the bar screen to maintain his property (Photo 3.72).
- The creek flows through a gate which provides a structure for debris to collect (Photo 3.74).

Photo 3.71. Bar screen behind 2100 Sierra Ventura

- Improve creek channel approach to bar screens to alleviate debris from blocking the bar screen.
- Remove the asphalt over the Gate Structure M5D-207 and elevate the hatch to match road grade.
- Exercise the gate periodically to ensure it is operational.
- Based on the model prediction of storm water flows, the level of the gate structure may need to be repositioned to optimize storm water flows to each outlet.

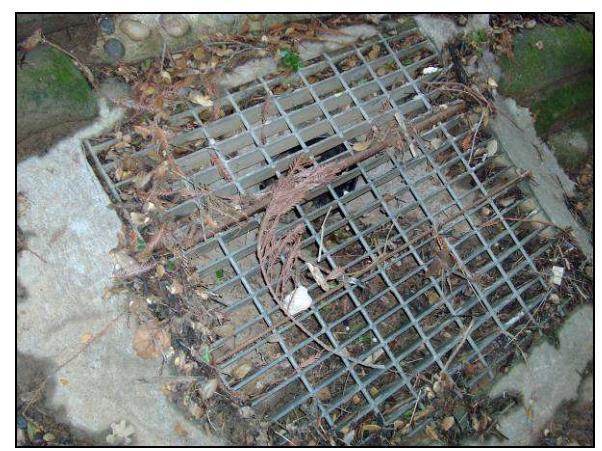
- Due to periods of elevated creek flows the homeowner added a 12-inch drainage pipe with grating from the creek to the front of the home (Photo 3.73).

Photo 3.72. Additional 12-inch drainage pipe and grating improvement

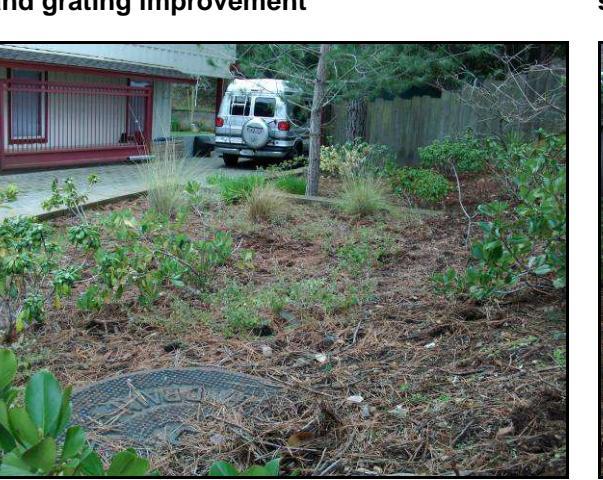
- Manhole M5D-216 is not located as shown on the maps. It is located alongside the driveway to 2100 Sierra Ventura Drive in the landscaped area (Photo 3.75 and Photo 3.76).

Photo 3.74. View of Manhole M5D-216 looking south

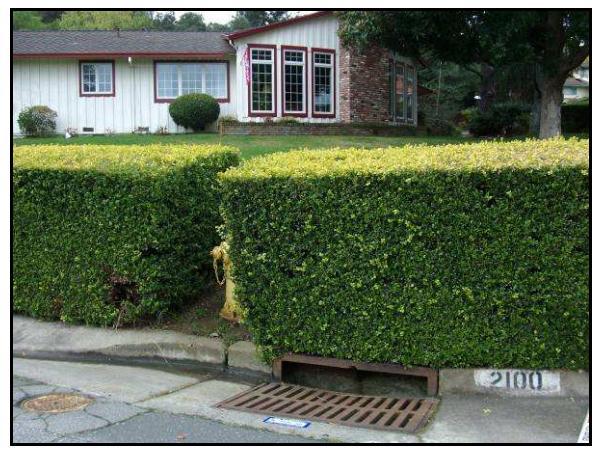
- The pipe added by the homeowner does not connect to the City's Catch Basin M5C-208. It terminates just short in the utility lawn under shrubs adjacent to the fire hydrant (Photo 3.77 and Photo 3.78).

Photo 3.76. 12-inch additional drainage pipe terminates under hedges near M5C-208

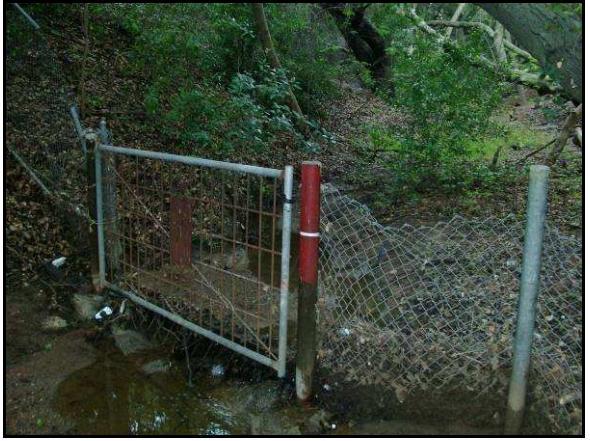
Photo 3.73. Fencing and gate upstream of bar screens

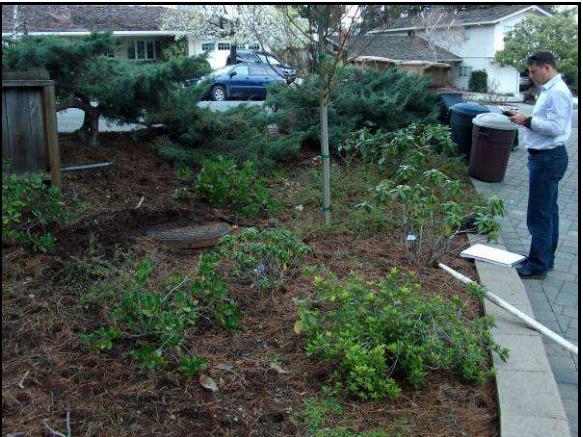
Photo 3.75. View of Manhole M5D-216 looking north

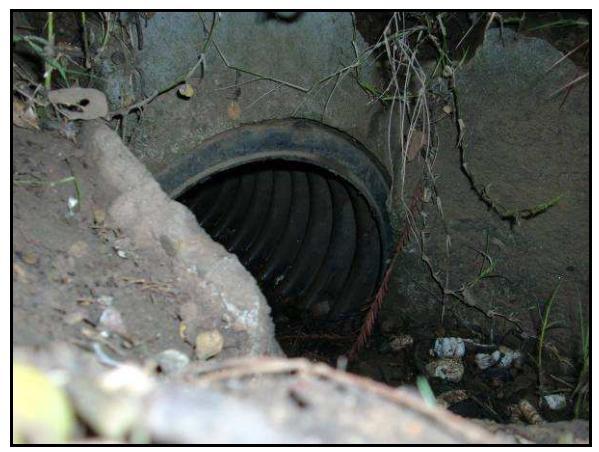
Photo 3.77. View of 12-inch drainage pipe under hedges

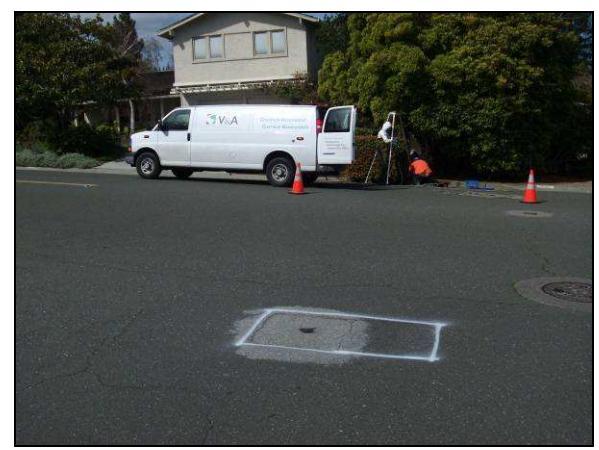
- The gate structure at M5D-207 is paved over (Photo 3.79).
- The Gate Structure M5D-207 was evaluated from a confined space entry proceeding upstream from Catch Basin M5F-206 (Photo 3.79). The gate, gate rails and gate stem all appear to be operational and in good/serviceable condition (Photo 3.80).

Photo 3.78. Marking paint outline of Gate Structure M5D-207

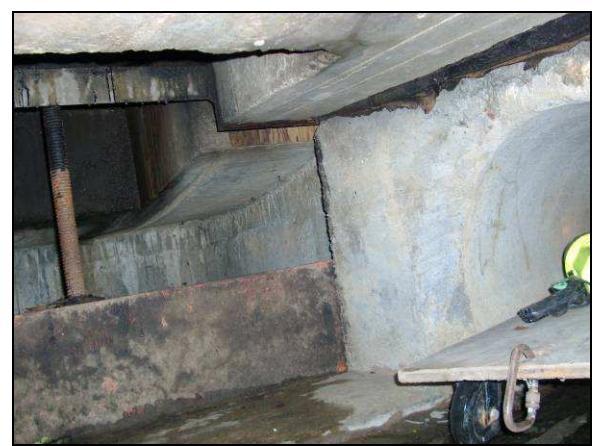
- The gate is set at 10-inches above the invert of the structure (Photo 3.81). Flow levels exceeding 10-inches will flow over the gate into the 18-inch pipe flowing north to Manhole M5D-205 (Photo 3.82).

Photo 3.80. Inside of structure – View of gate position 10-inchs above invert – looking south

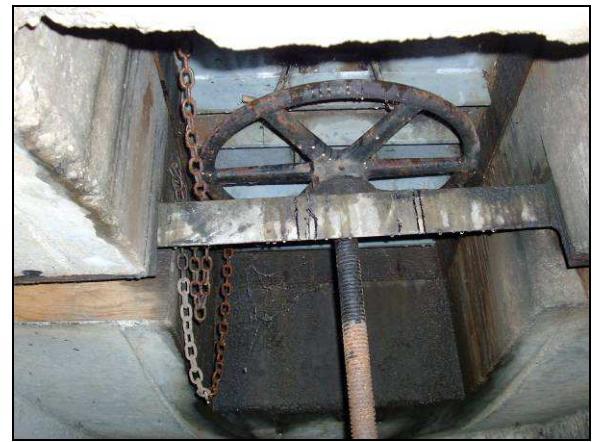
Photo 3.79. Inside of structure – Wheel for adjusting gate position

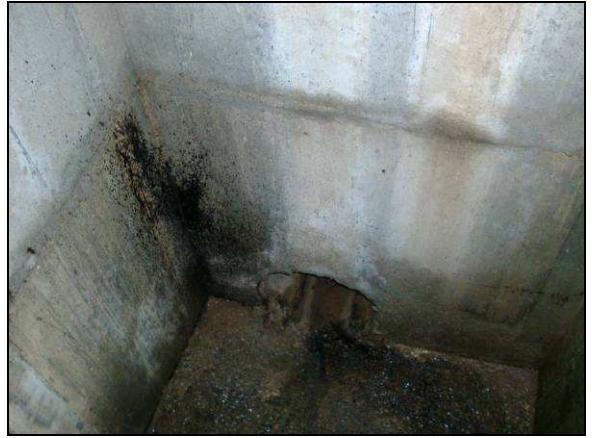
Photo 3.81. Inside of structure – View over gate approximately 8 foot drop to 18-inch inlet below – looking south

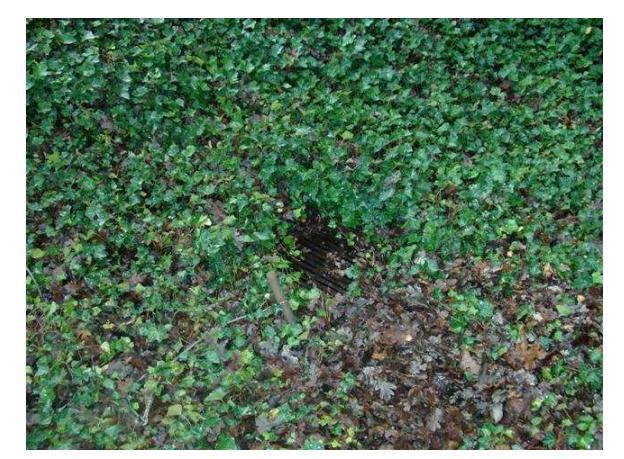
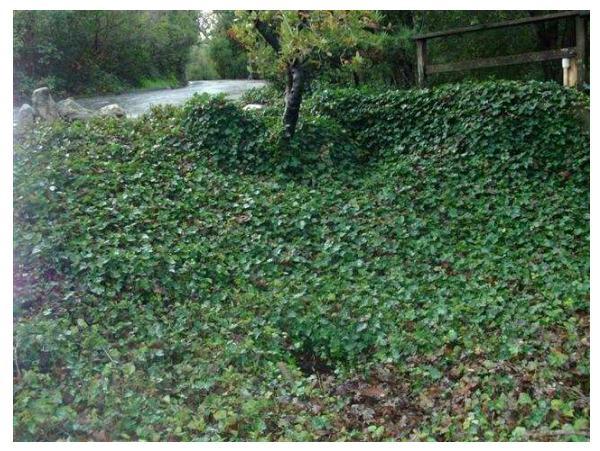
Area view showing susceptibility to burial

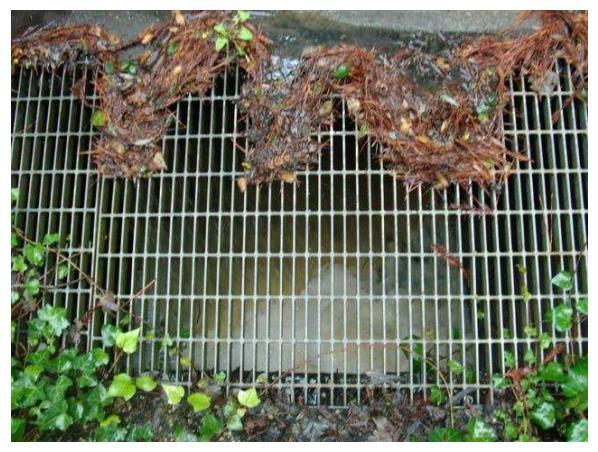
Inlet above creek intake showing turbulent flow

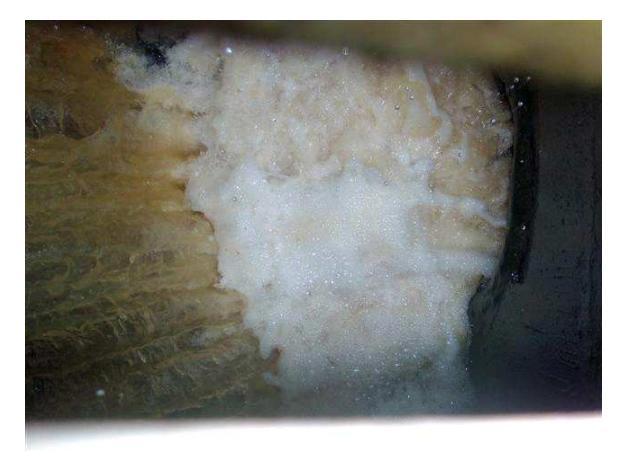
Turbulence at inlet transition from box culvert to circular conduit; no trashrack

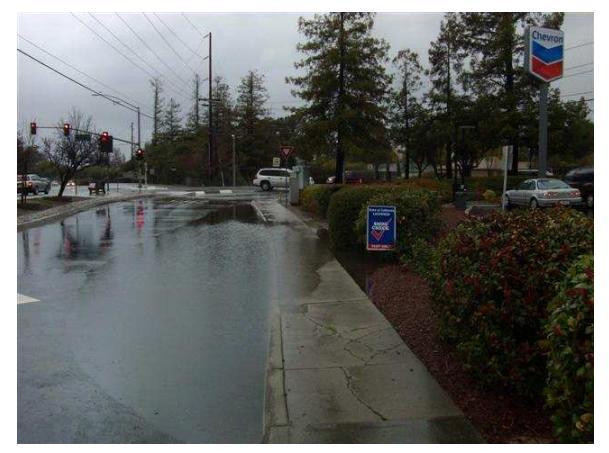
Ponding on offramp from Foothill Expwy., looking north

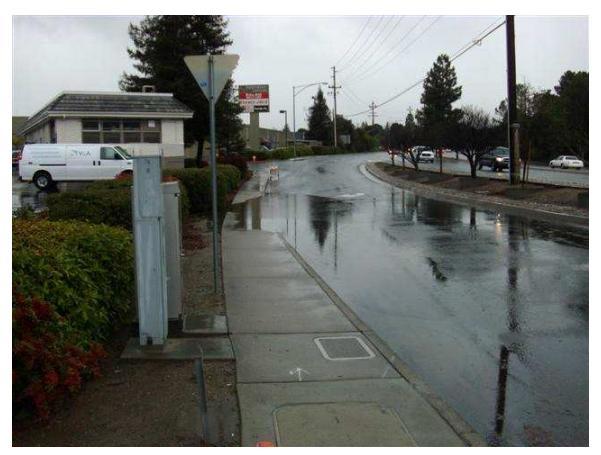
Ponding on offramp from Foothill Expwy., looking south

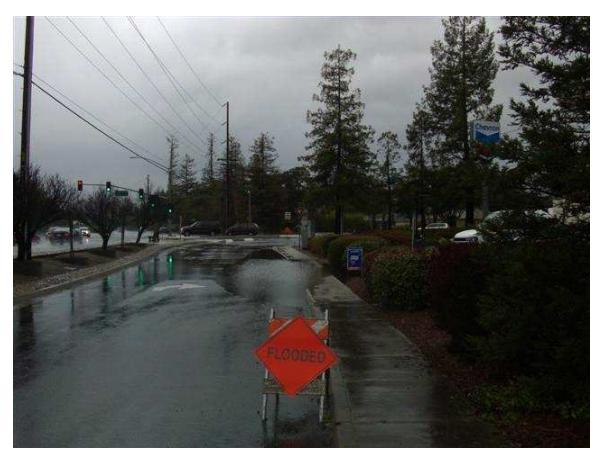
Ponding on offramp from Foothill Expwy., looking north

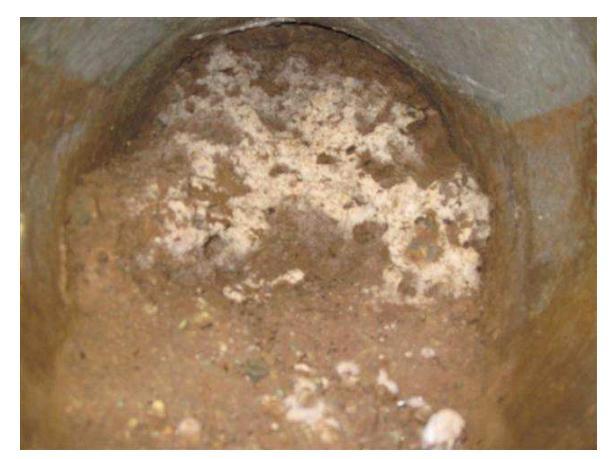
West inlet, plugged

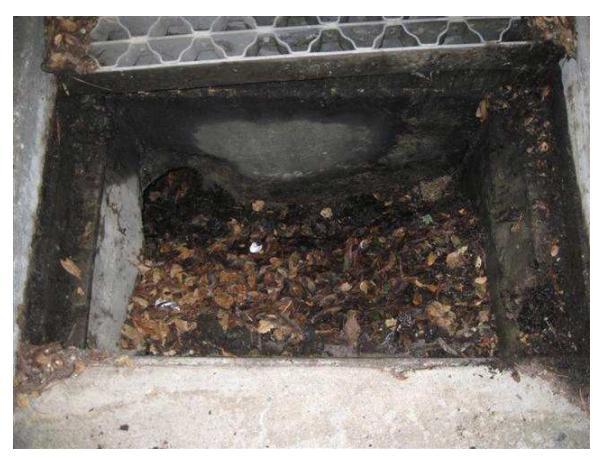
Adjacent and connected to J6D-408 in median; upstream side of basin has about 12 inches of debris; may clog.

Plan view, minor debris

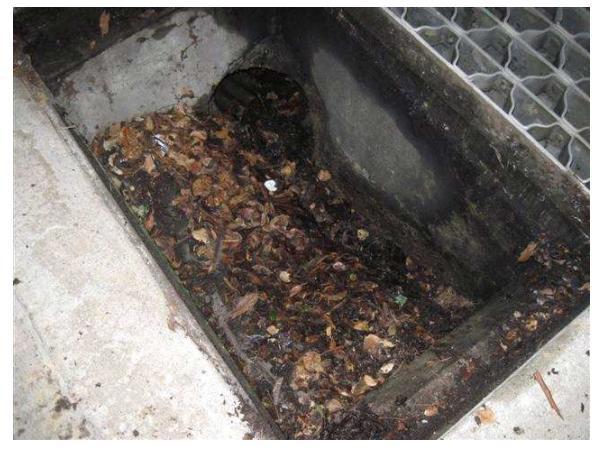
Minor debris in catch basin

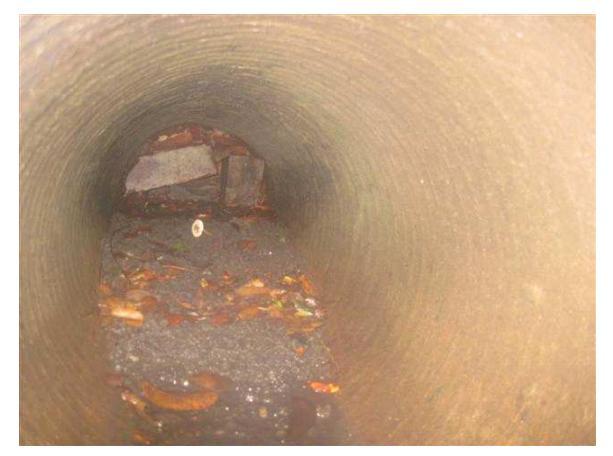
South inlet, plugged, with debris

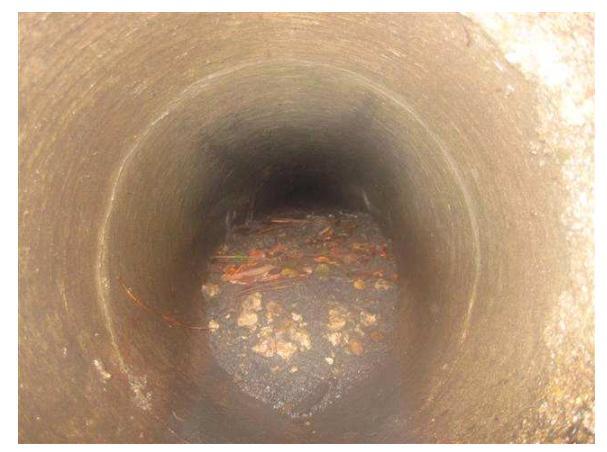
West inlet, south of pair, with debris

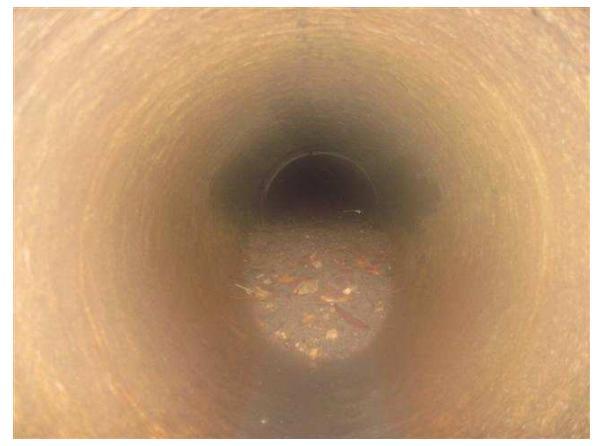
West inlet, north of pair, with debris

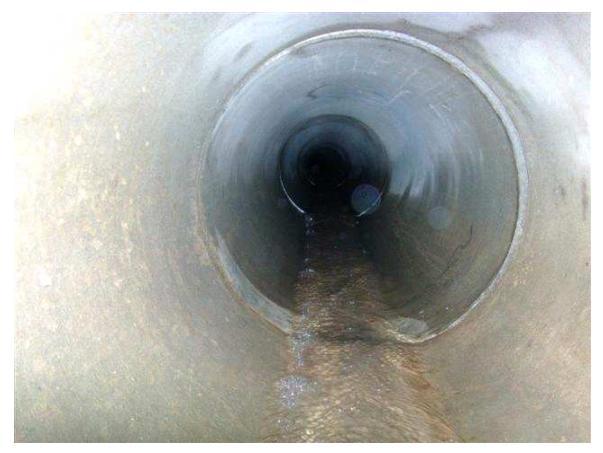
Outlet

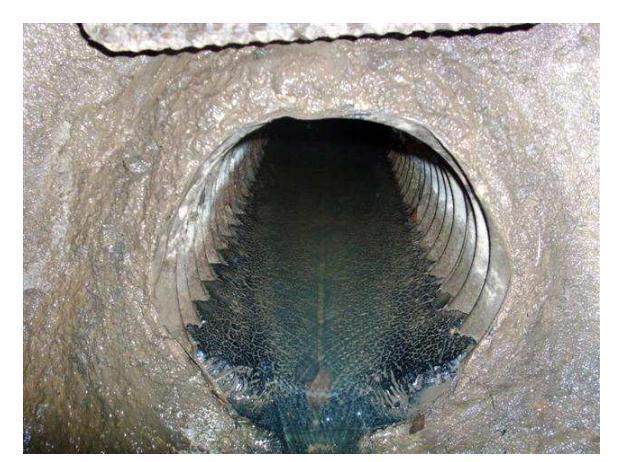
Ditch between Windimer and Sierra Ventura

Inlet B

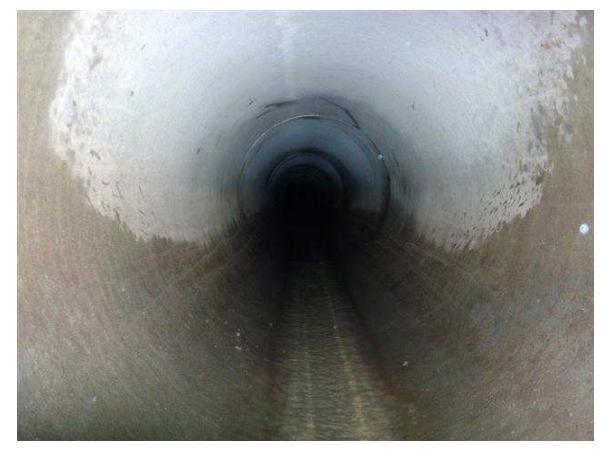
Inlet A

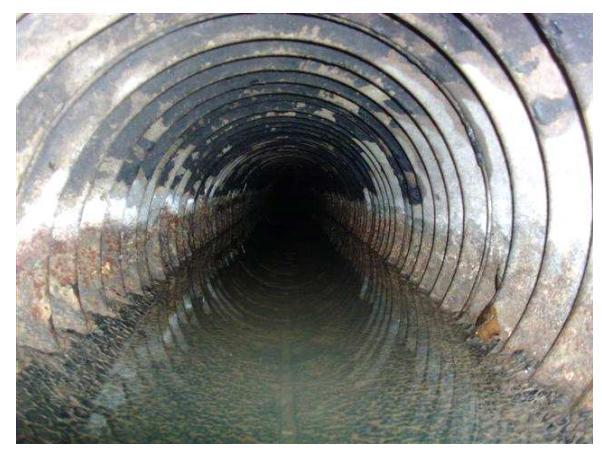
Inlet B

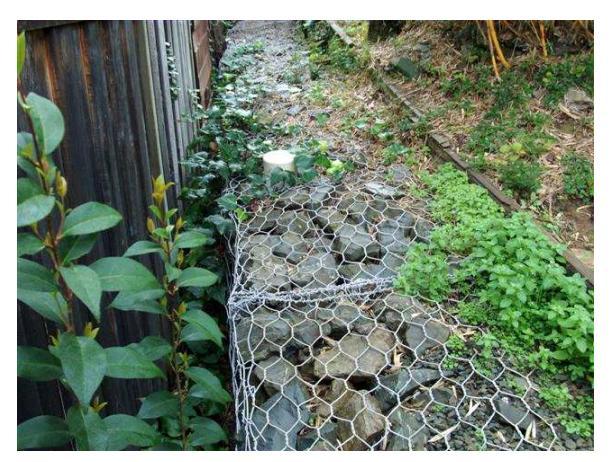
Cage-wrapped rock retaining wall

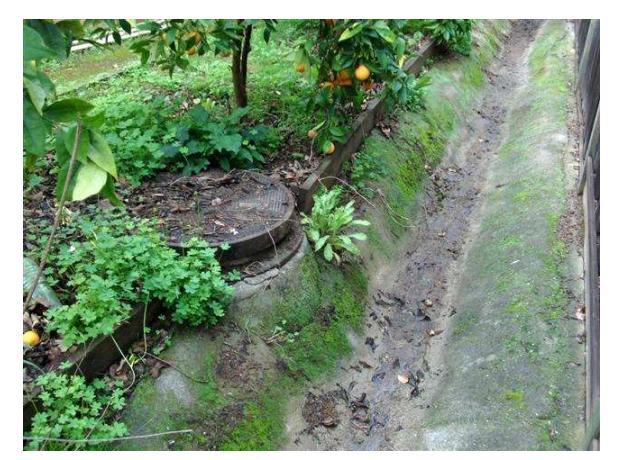
Sanitary sewer manhole in concrete ditch; shared easement

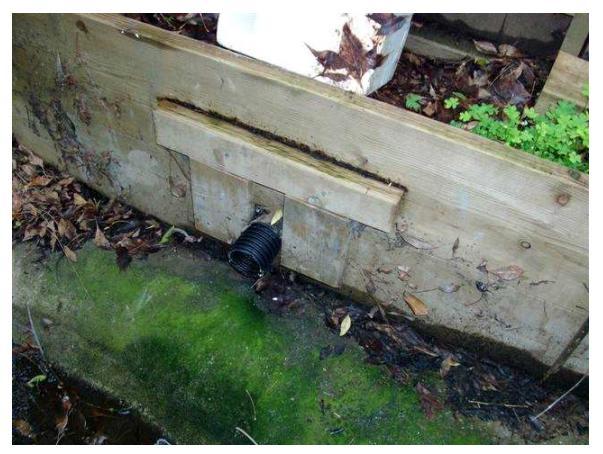
Inlet to ditch from adjacent property

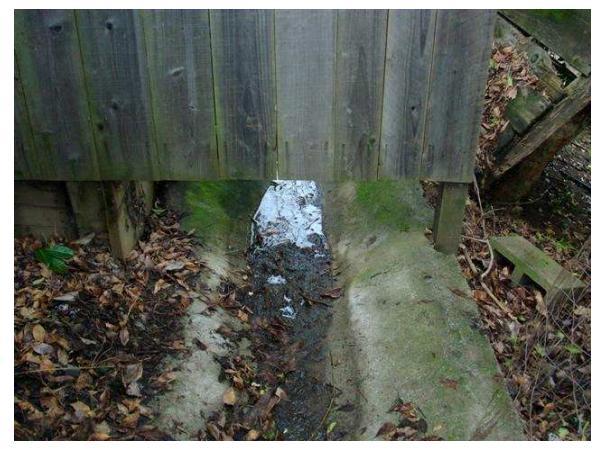
Ditch passing below homeowner fence

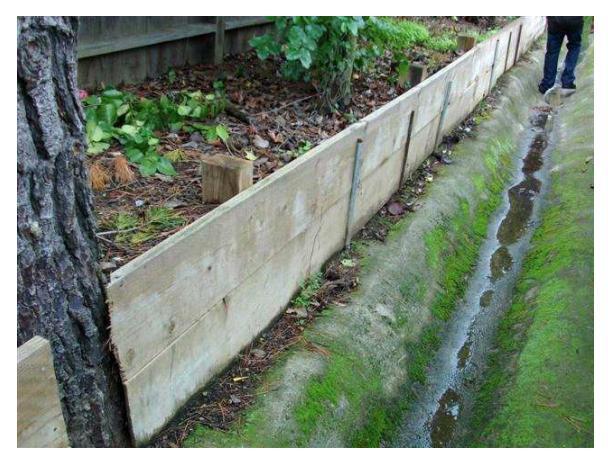
Open concrete channel with damaged retaining walls. Channel fills with debris from hillside and yard trimmings.

Retaining wall along ditch

Stormtech chambers or rock wall as done upstream.

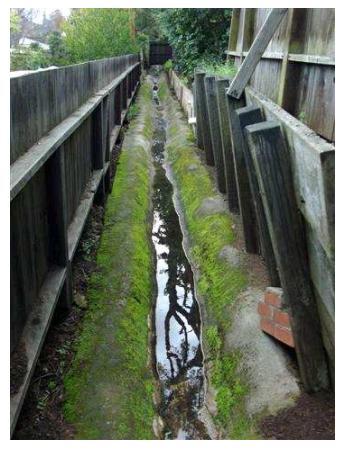
Collapsing retaining walls

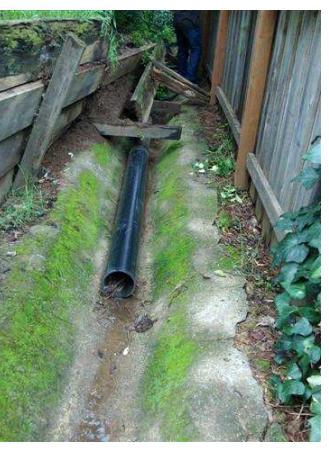
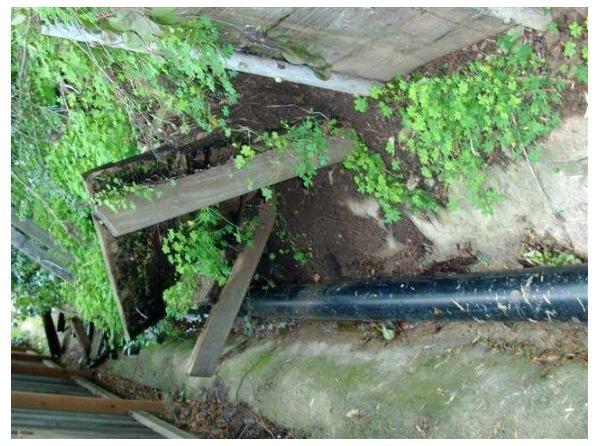
Temporary piping to restore drainage under debris

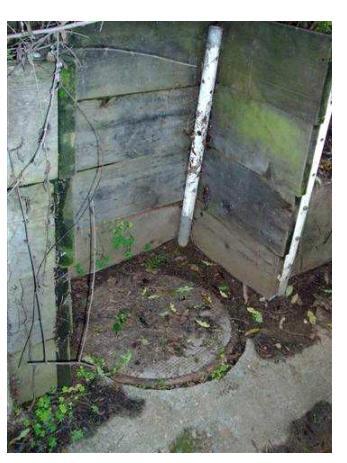
Sanitary sewer manhole in concrete ditch; shared easement

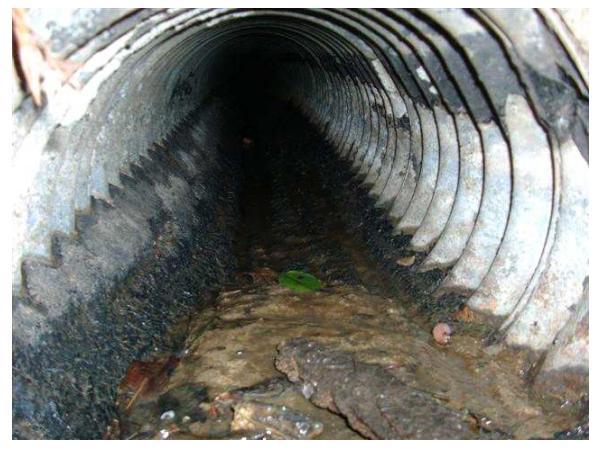
Outlet to corrugated metal pipe with sediment/debris

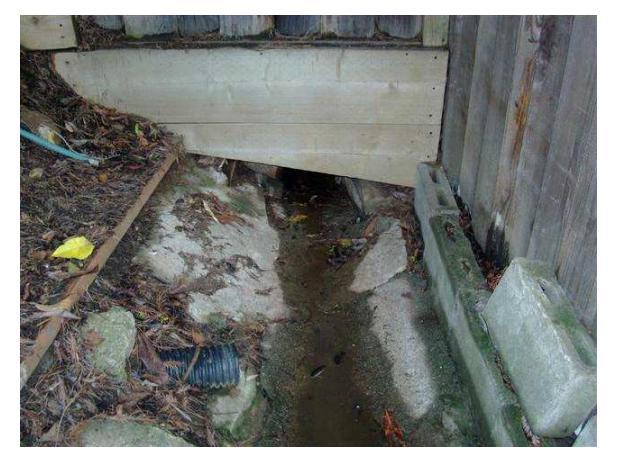
Transition from ditch to corrugated metal pipe

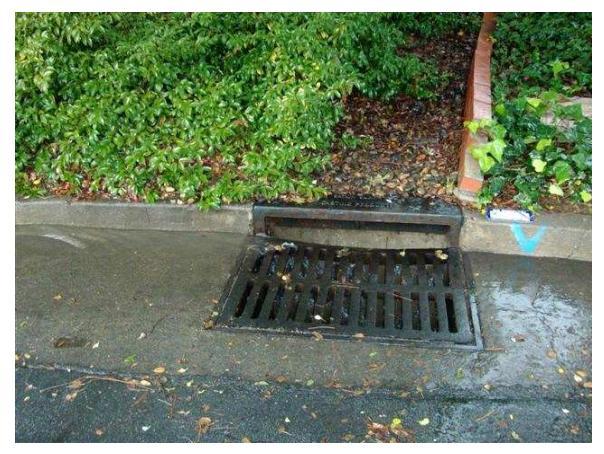
As-found surface conditions

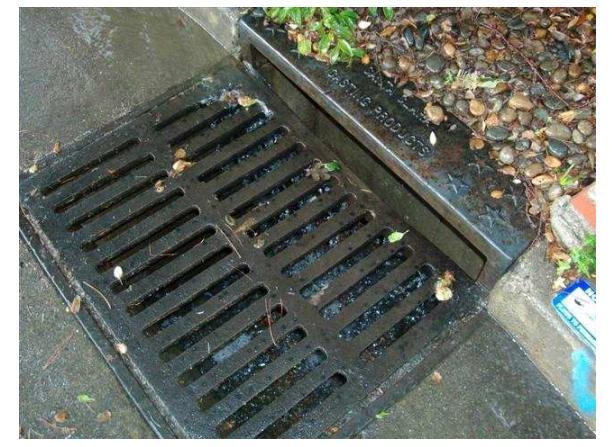
Grating with storm flow entering catch basin

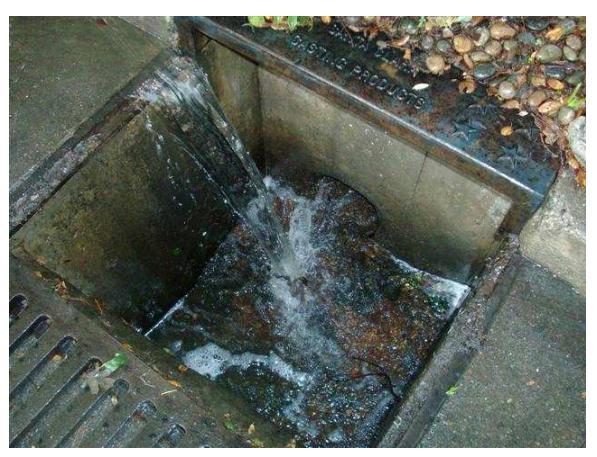
Storm flow entering catch basin

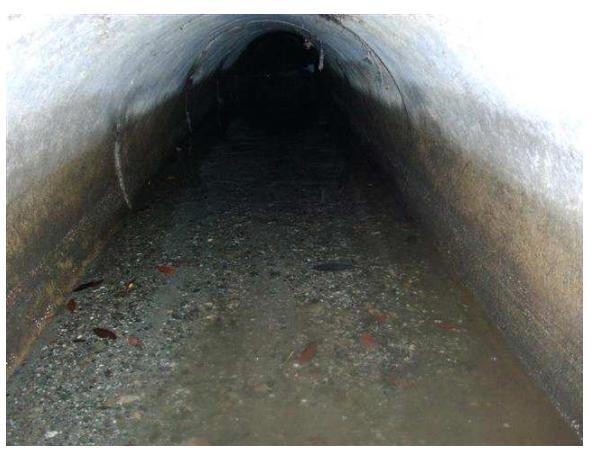
Outlet with grit/gravel

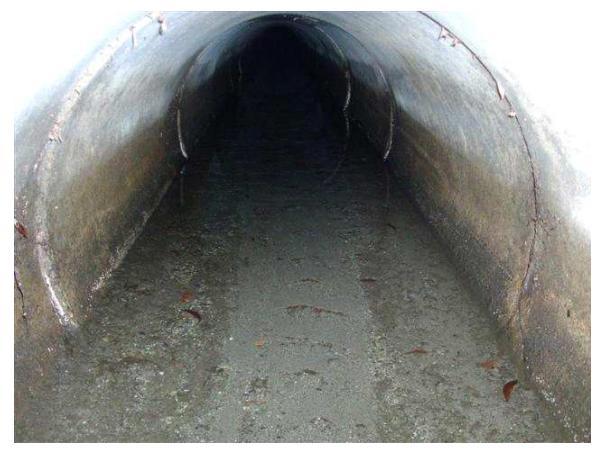
Inlet with grit/gravel

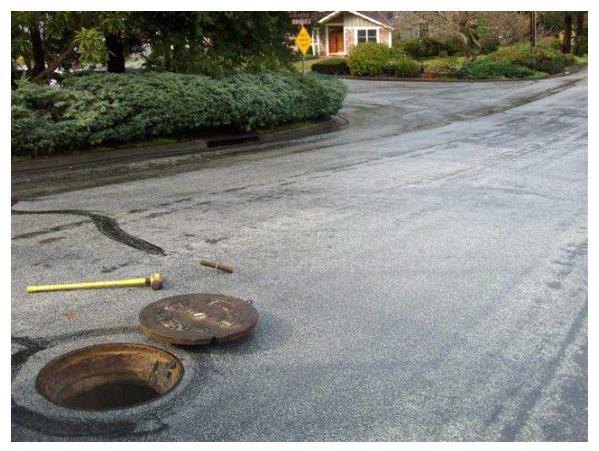
Area view looking west, showing proximity to L5C-110

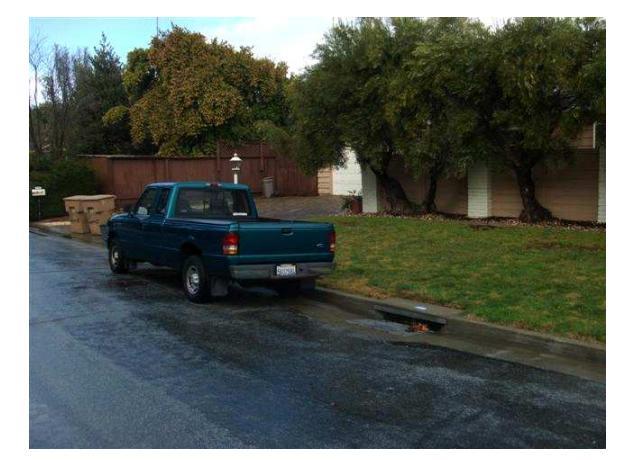
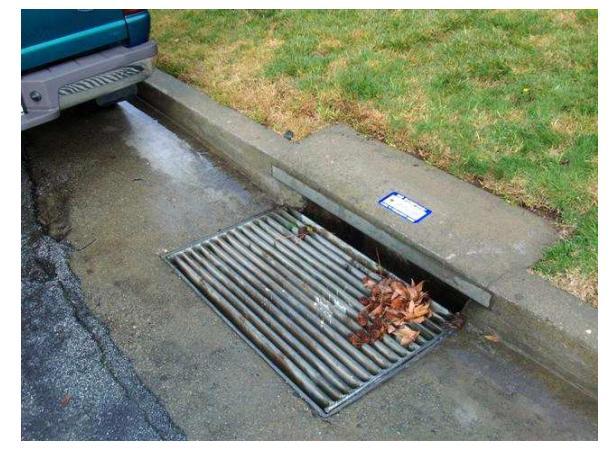
## L5C-111

Area view

Curb inlet

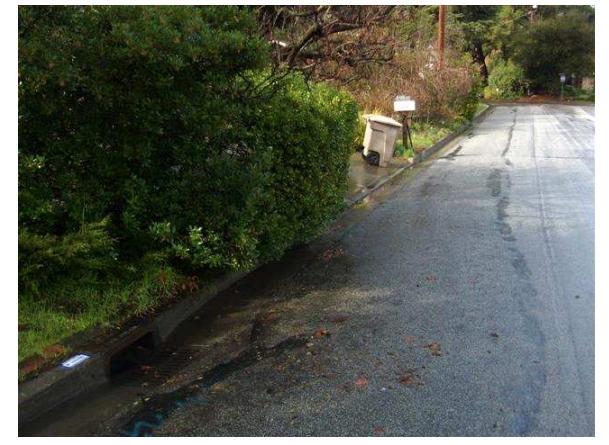
## L5C-108

Area view looking northwest

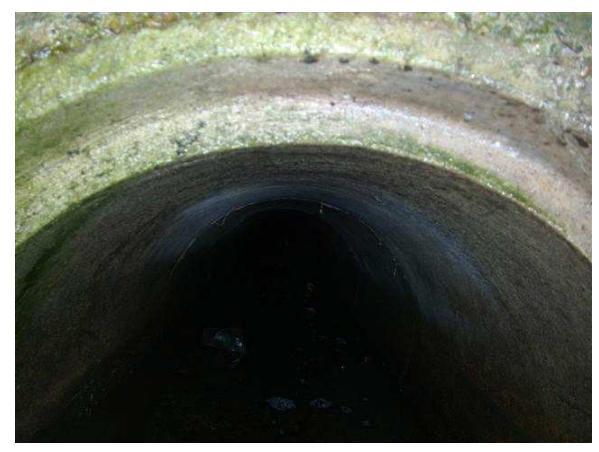
Outlet

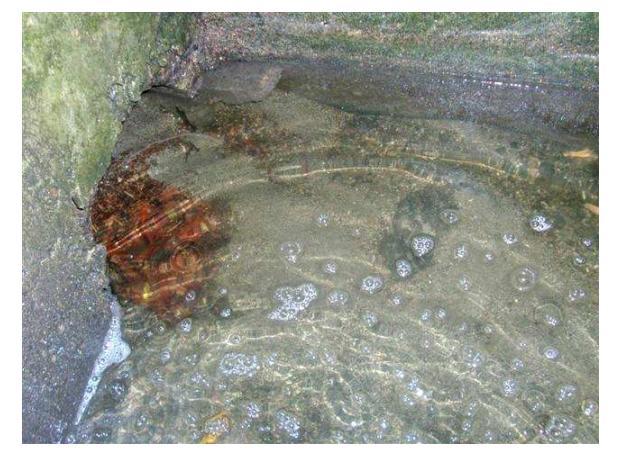
## L5C-108

Grit and gravel in channel

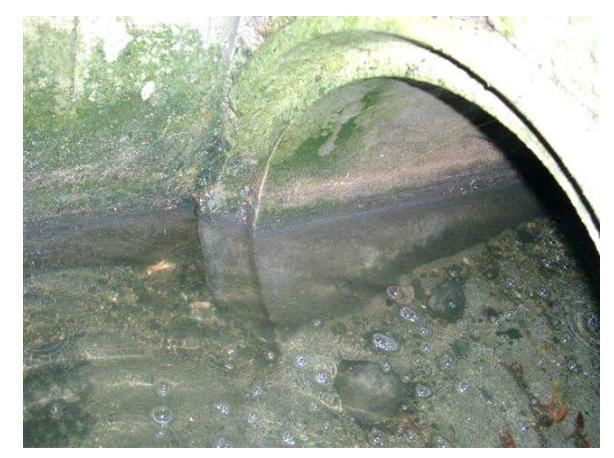
Sediment buildup at outlet

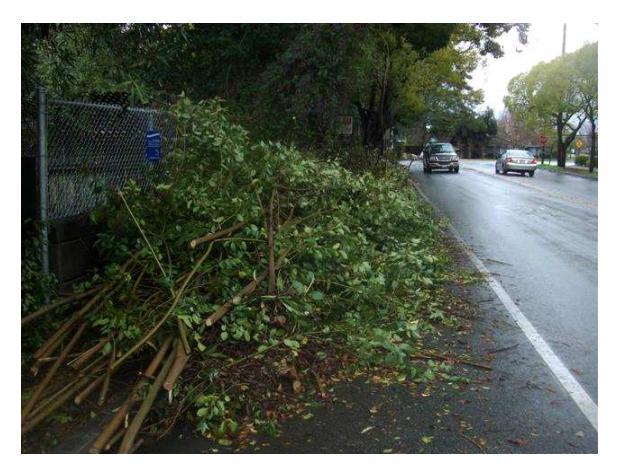
Tree trimmings dumped by resident at Cuesta Dr. crossing of Hale Creek

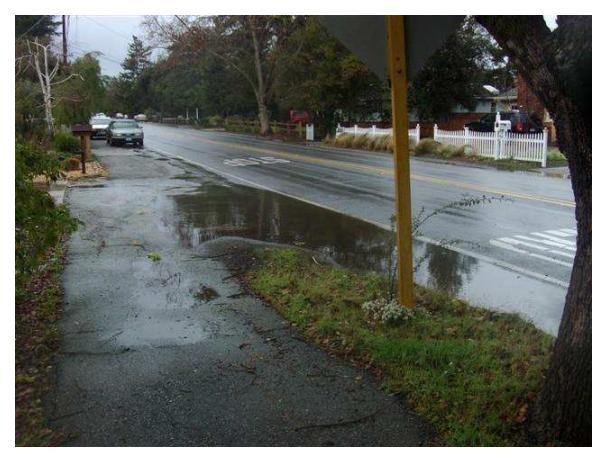
Ponding on south side of Cuesta west of Hale Creek crossing, looking west

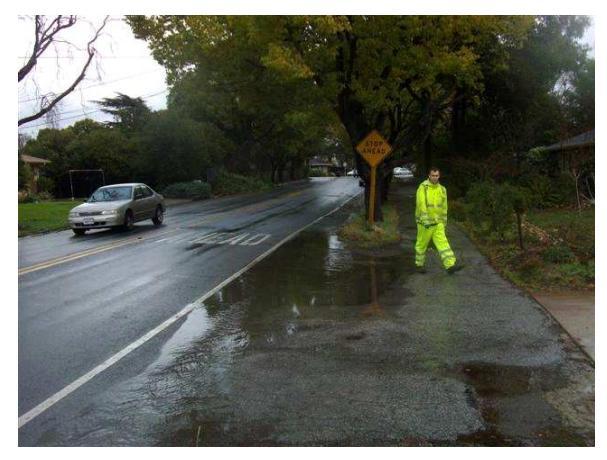
Ponding on south side of Cuesta Dr. west of Hale Creek crossing, looking east

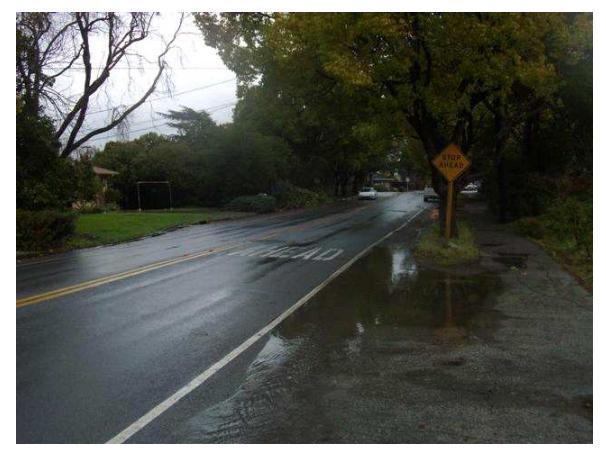
Ponding on south side of Cuesta Dr. west of Hale Creek crossing, looking east

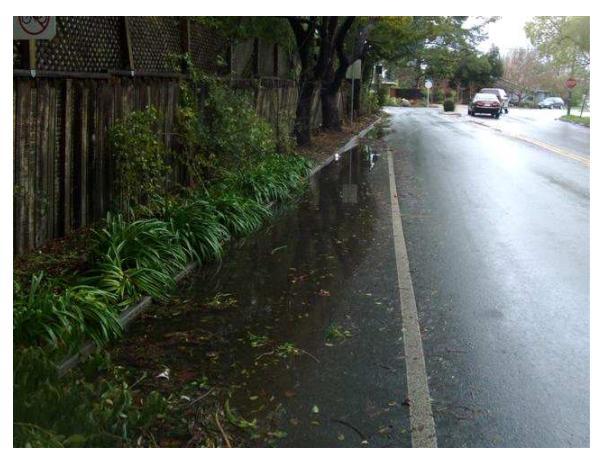
Ponding on north side of Cuesta Dr. east of Hale Creek crossing, looking east

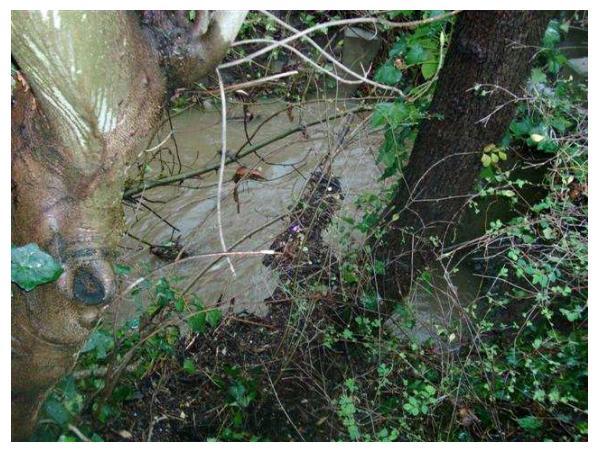
Creek culvert may be undersized; debris gives evidence of overflow roughly at pavement height.

Vegetation with debris showing overflow level

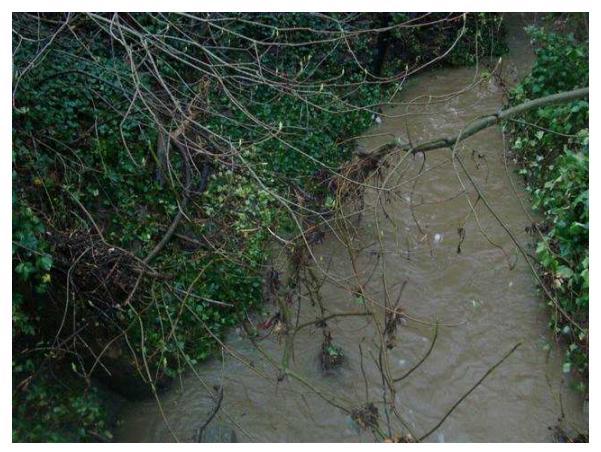
Vegetation in creekbed on upstream side of culvert

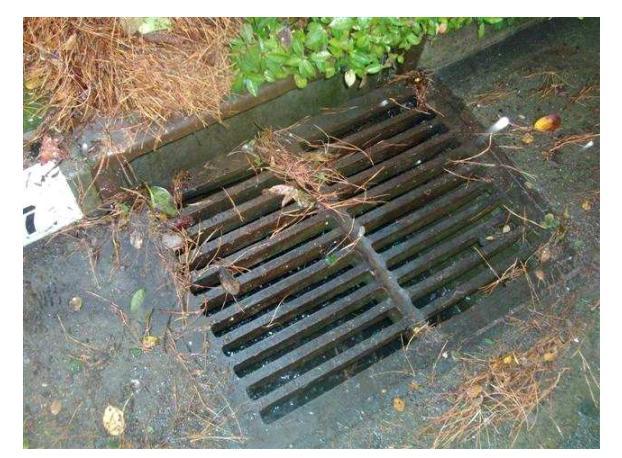
## G2C-609

Inlet accumulates pine needles; pipe flows sluggishly (half full) under light rain, but a short downpour did not cause problems.

Storm inlet after removing pine needles

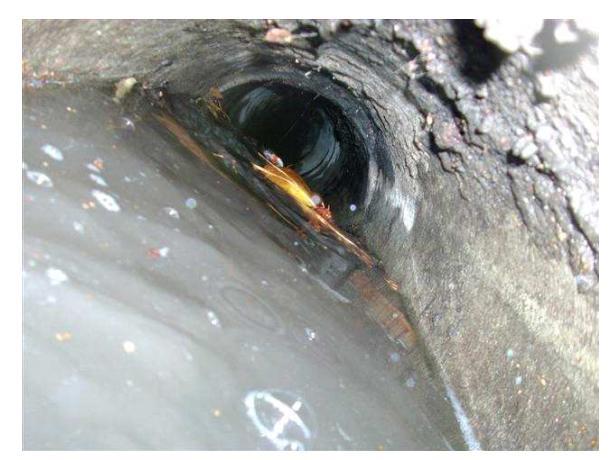
Outlet partially obstructed by debris

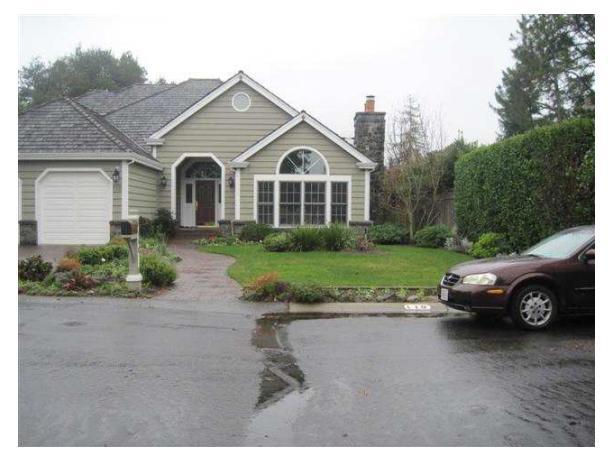
Slight surface ponding at 110 Catalina Ct.

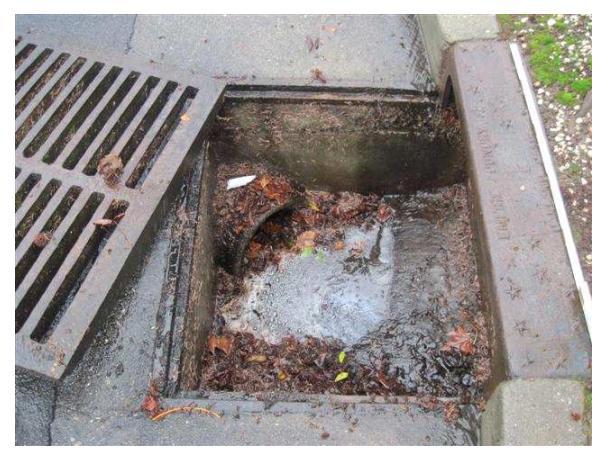
Poor outlet transition

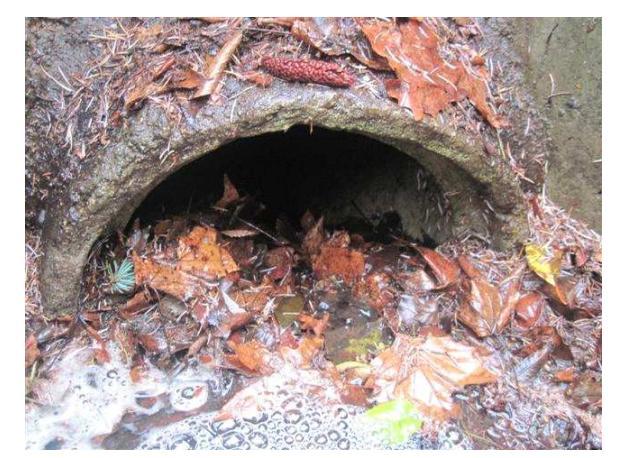
## C2C-315

Outlet with debris

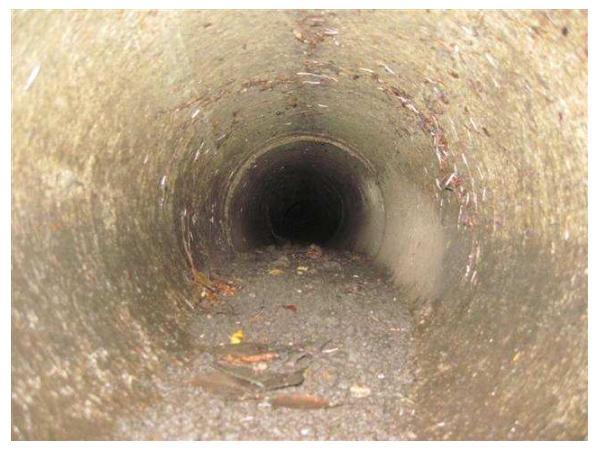
South inlet with debris

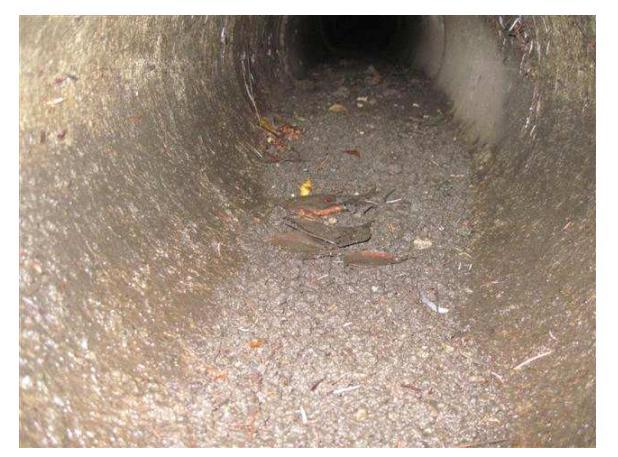
## C2D-314

Debris in south inlet

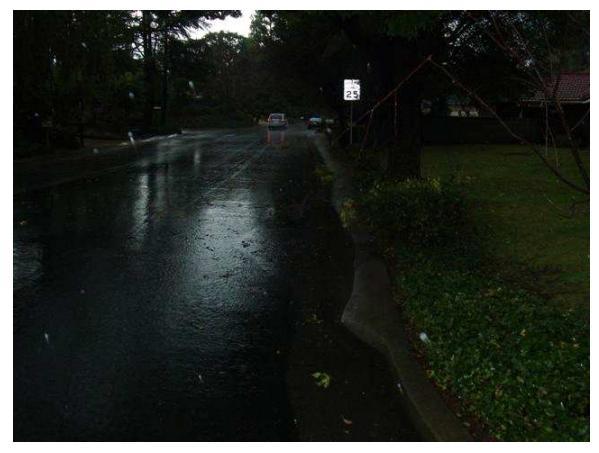
View north along Deodara with ponding

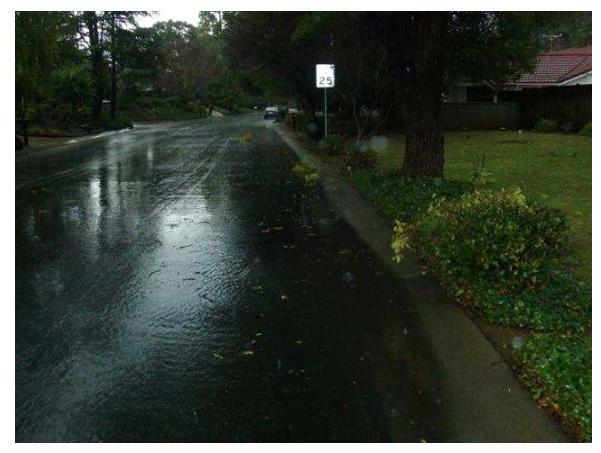
View north along Deodara with ponding

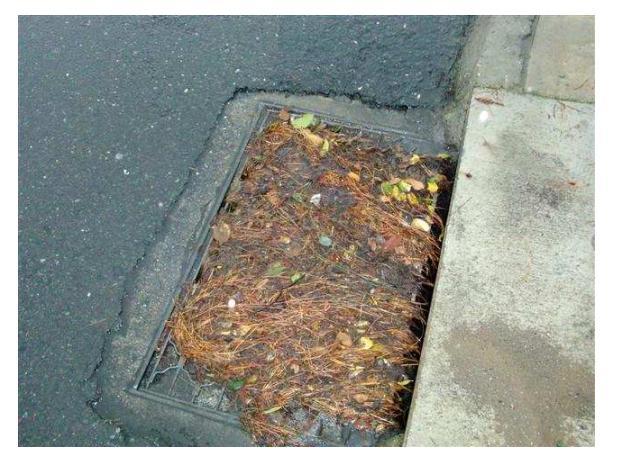
Leaves and debris covering inlet grating

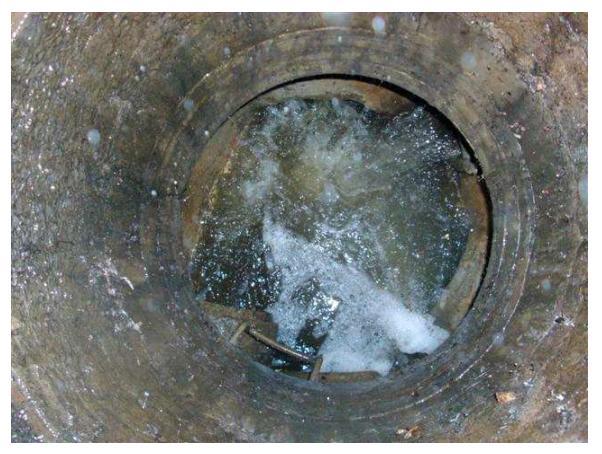
Invert of one inlet appears to be lower than invert of outlet.

Plan view with turbulence from multiple inlets

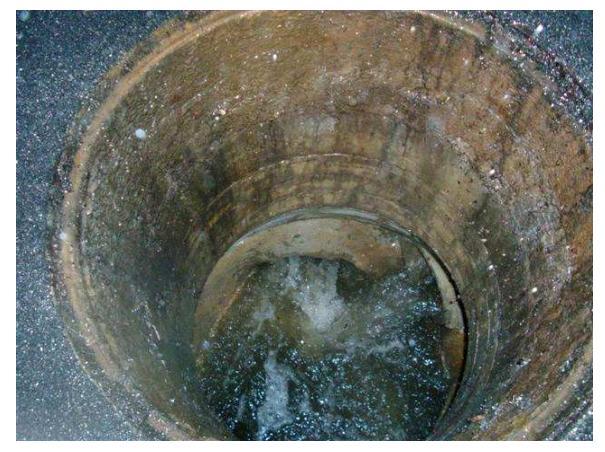
Multiple inlets, causing turbulence

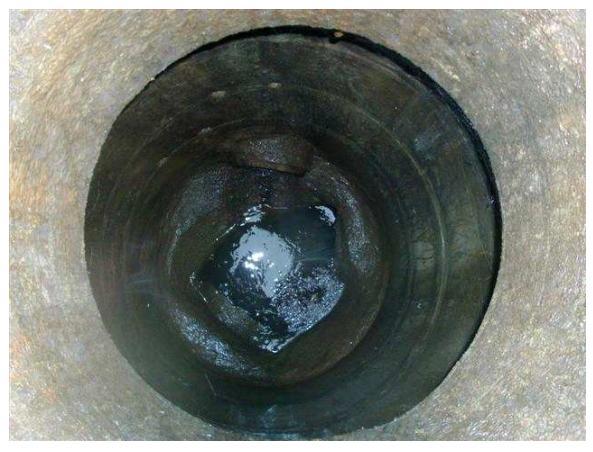
Plan view during wet weather

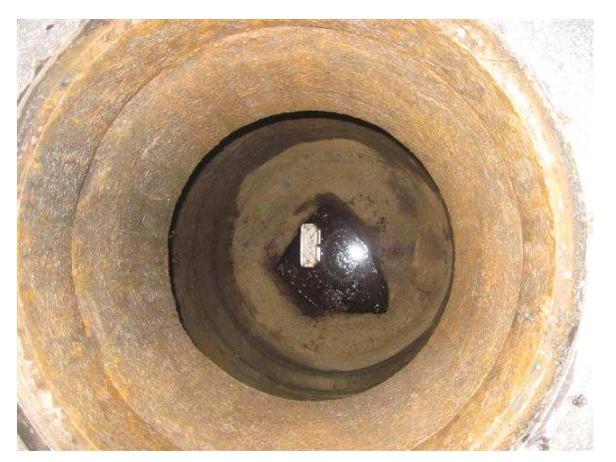
Plan view during dry weather
