# STORM WATER MANAGEMENT MASTER PLAN

City of Los Altos

May 2010

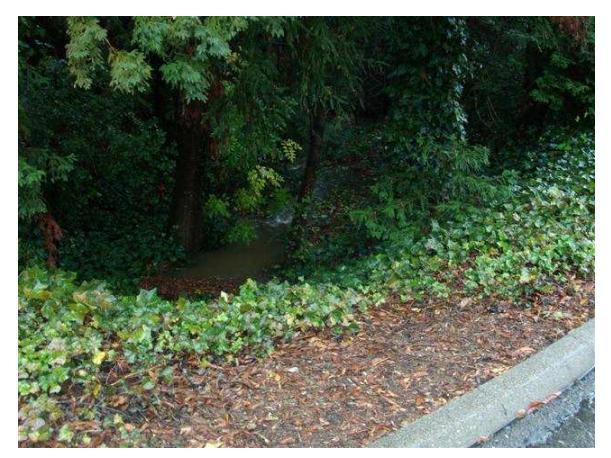
Combines flow from Vineyard into creek undercrossing; surcharged even in dry weather (creek elevation downstream of outfall may be higher).

Downstream view along creekbed

Clear/channelize creek to prevent surcharging.

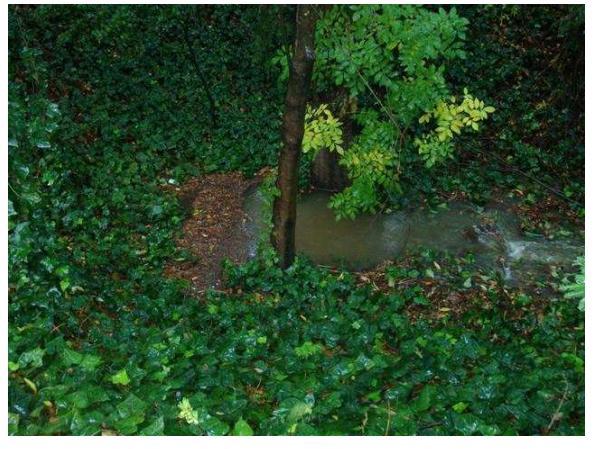
Outfall to creekbed, surcharged due to creekbed invert elevation downstream

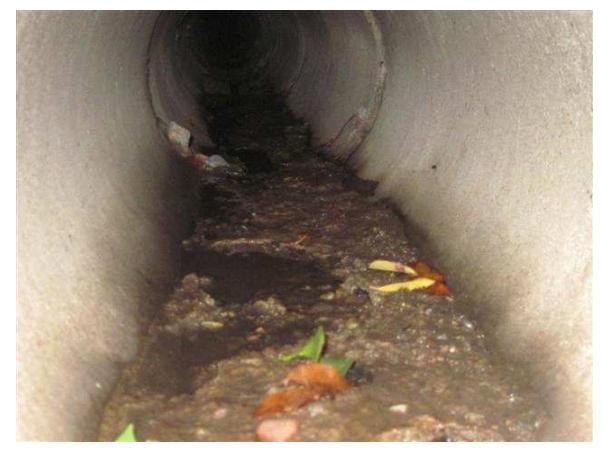
Sediment in downstream pipe

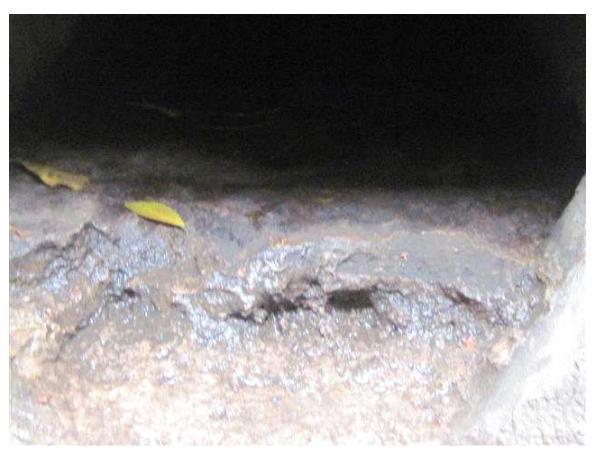
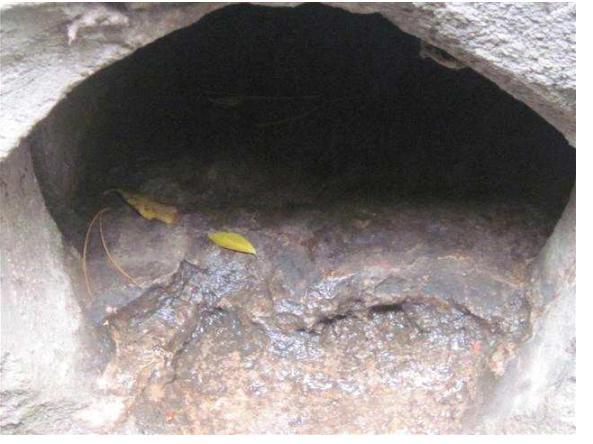
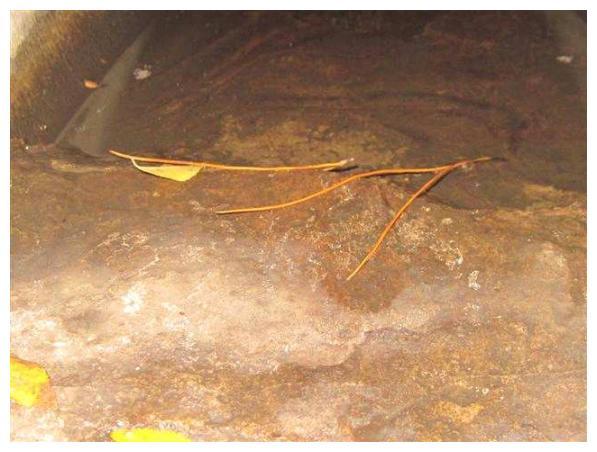
Mortar dam at inlet

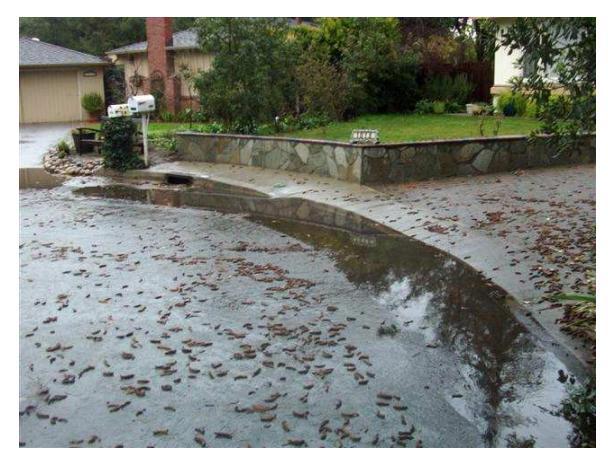
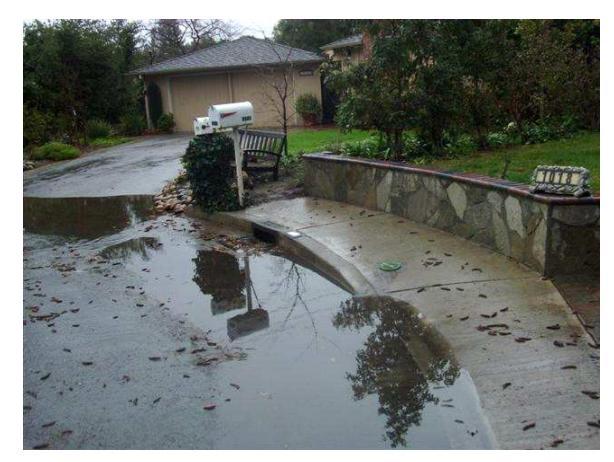
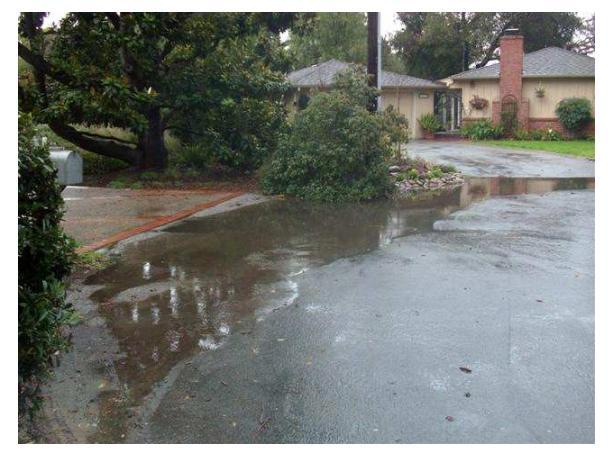
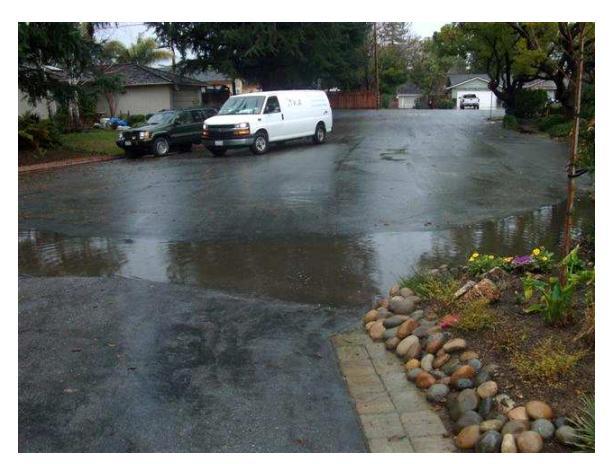
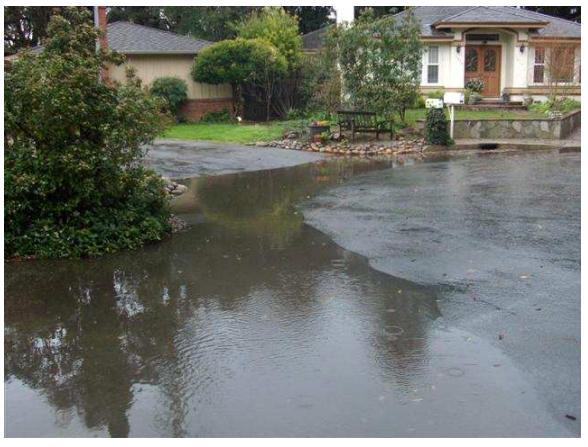
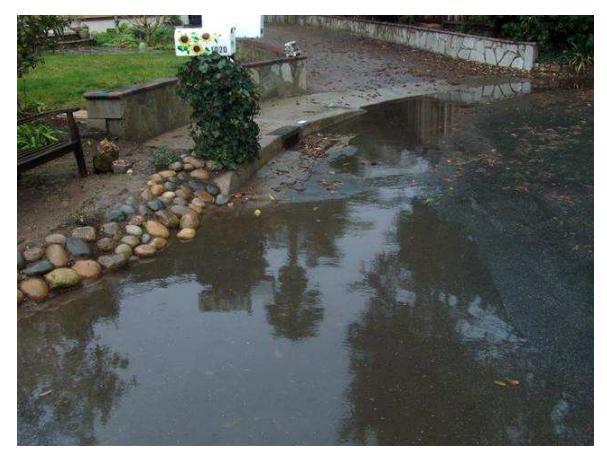
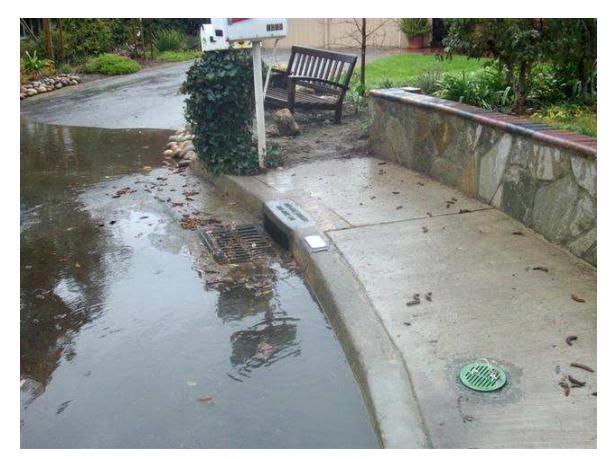
#### H5F-404

Inlet higher than surrounding area, resulting in puddling.

Ponding near curb inlet due to inlet elevation

Ponding around curb inlet due to inlet elevation

Ponding due to inlet elevation

Ponding around inlet due to inlet elevation

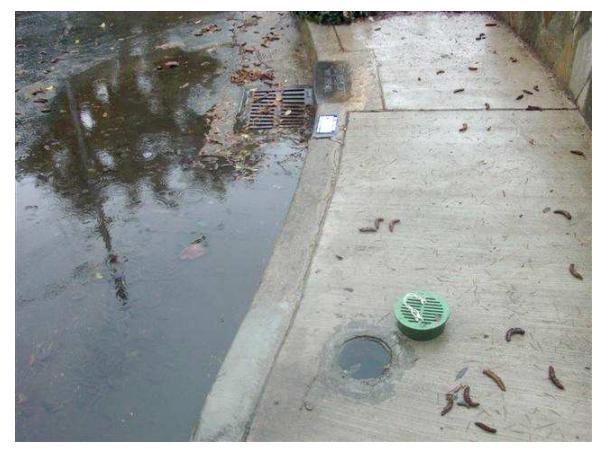
Flooded cleanout adjacent to curb inlet

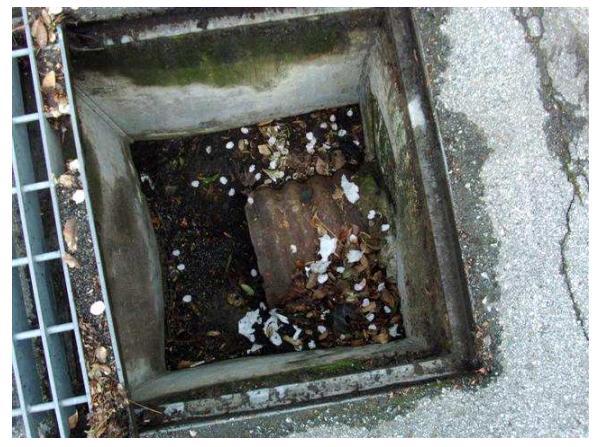
## F4F-212

Catch basin with protruding outlet pipe providing obstruction for debris

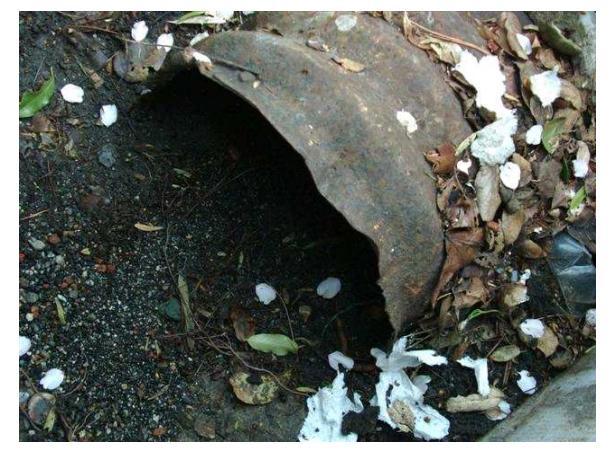
Protruding outlet pipe

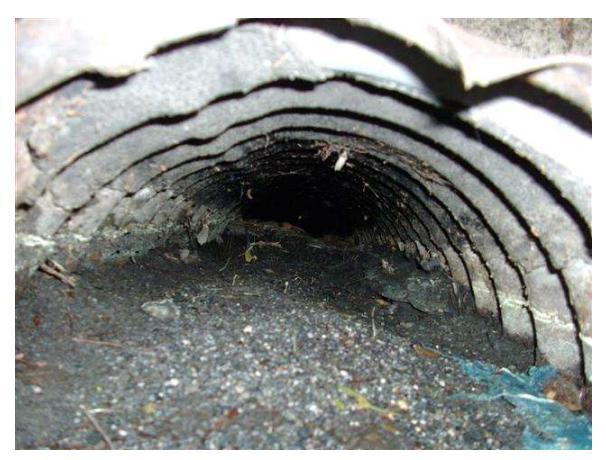
Downstream pipe, half-full with debris

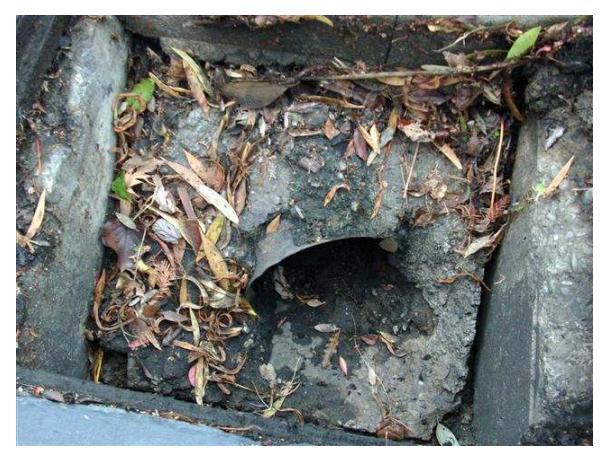
Poorly constructed outlet

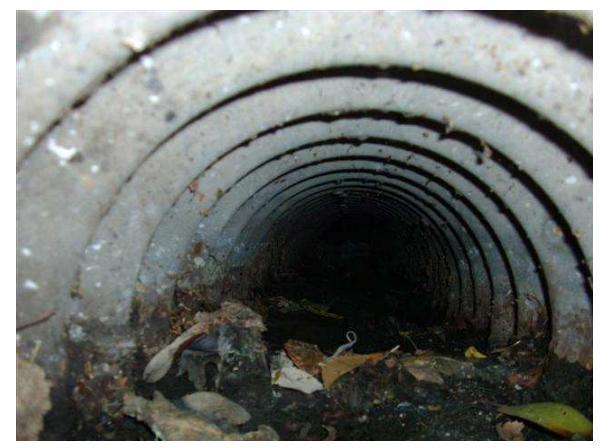
Outlet pipe, half-full with sediment

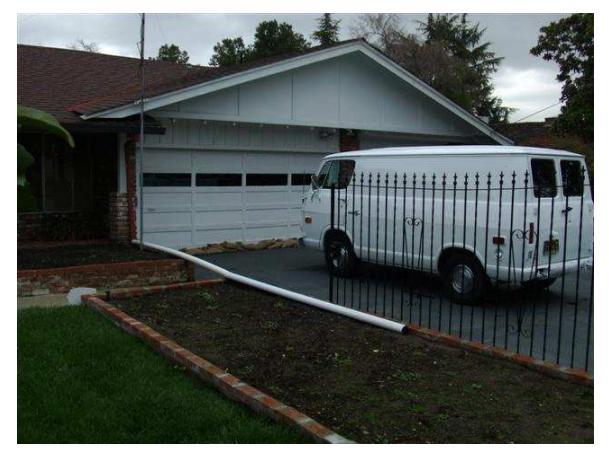
Adjacent property (735 Sunshine Dr.) with sandbags lining garage

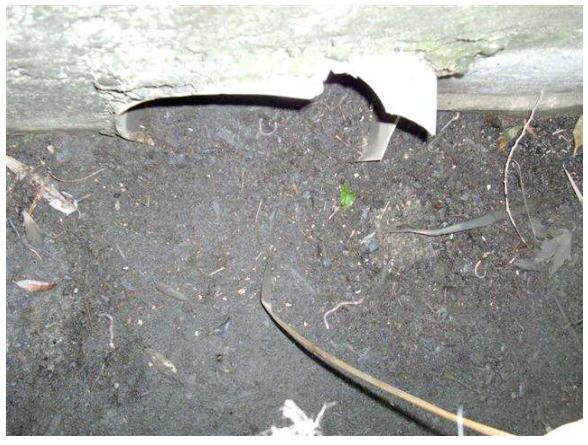
Very shallow; pipe is half full with sediment; pipe makes a bend towards the upstream direction of the channel.

Catch basin half-full with sediment

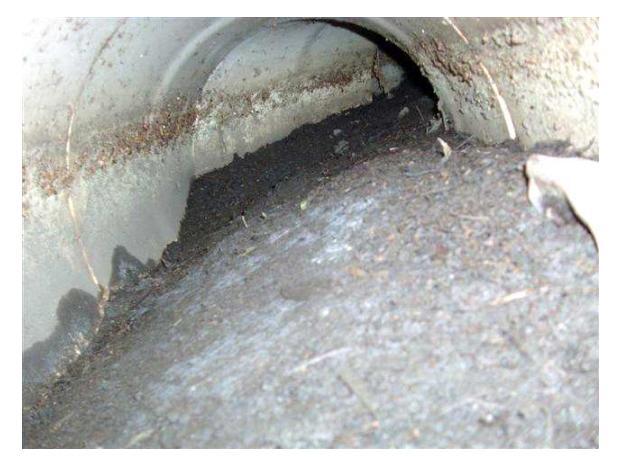
Outlet facing upstream into Hale Creek

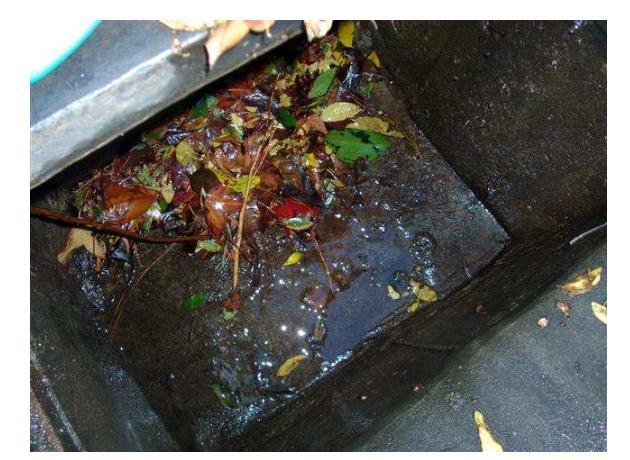
Catch basin with debris

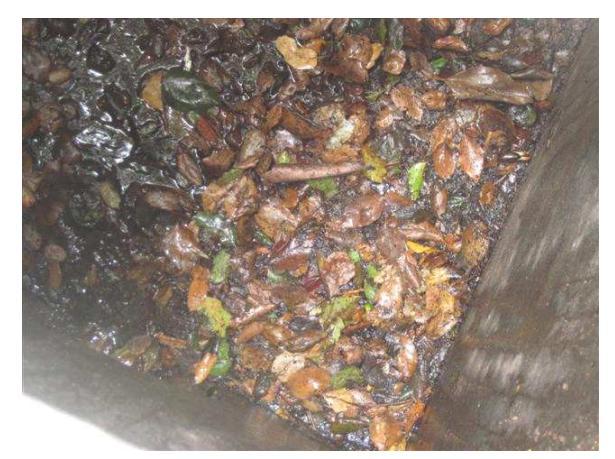
Catch basin with debris

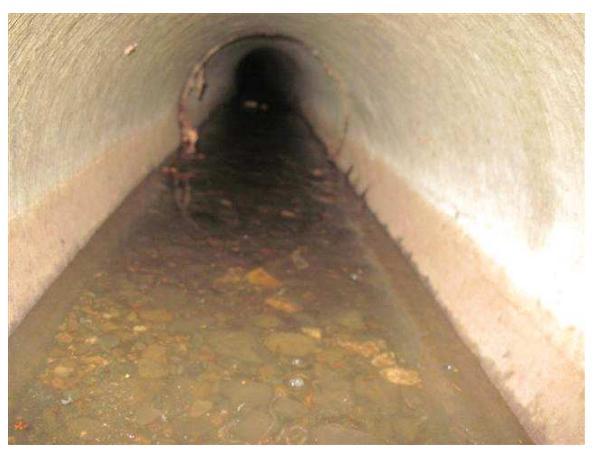
Outlet with gravel/rocks

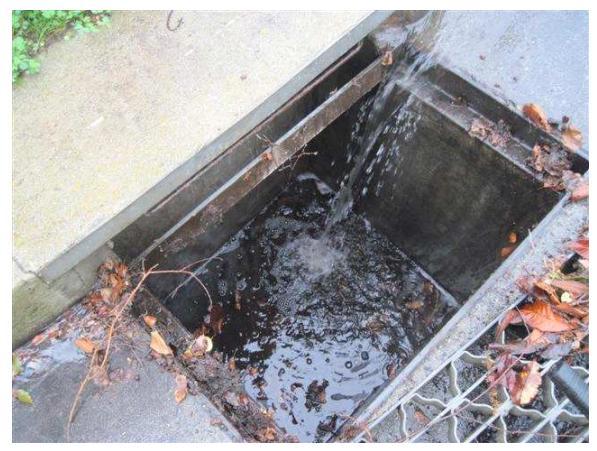
Catch basin with flow backed up

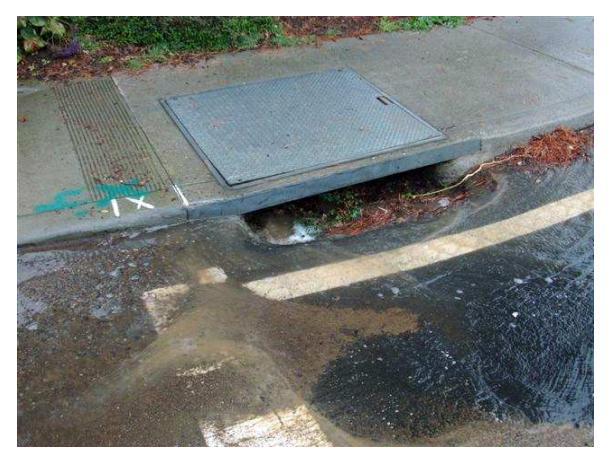
Curb inlet and evidence of overflow/backup

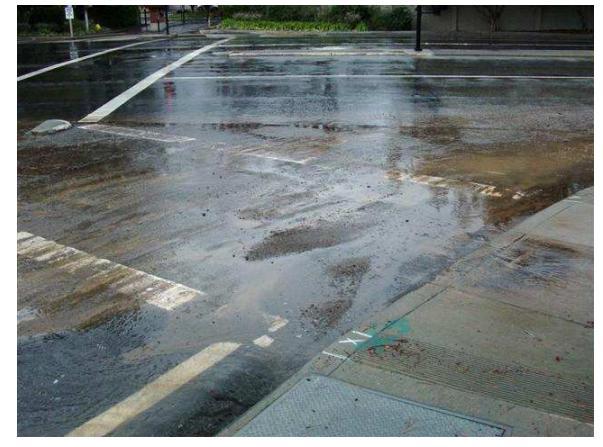
Evidence of ponding at east corner of intersection

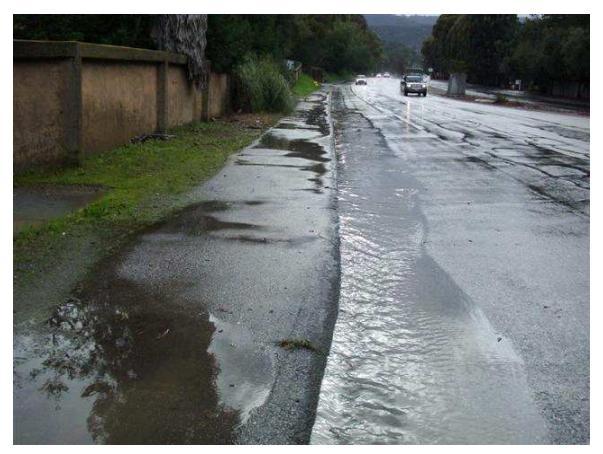
Ponding along El Monte to southwest due to shallow slope

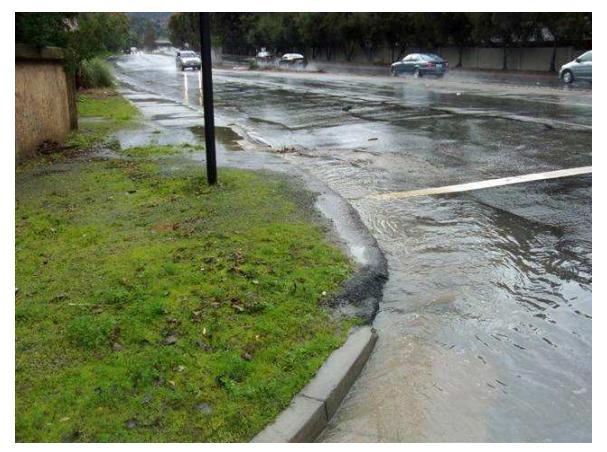
Ponding at south corner of intersection

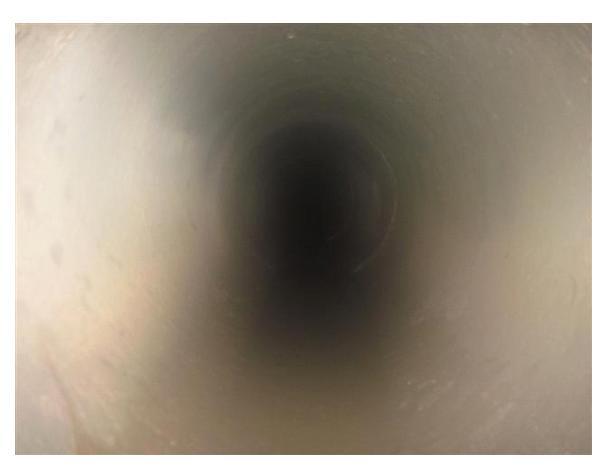
Inlet from southeast

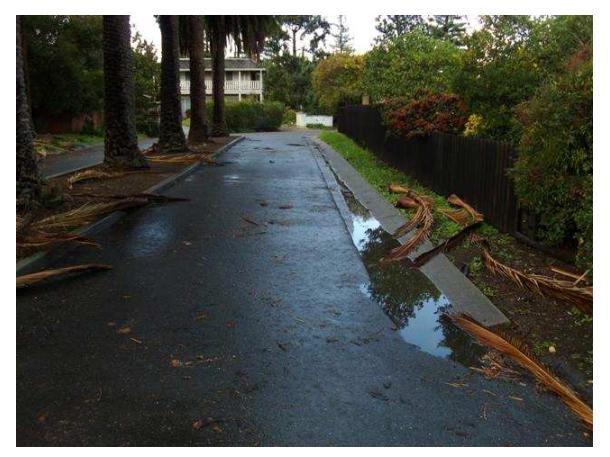
Slight ponding on north side of Paula Ct.

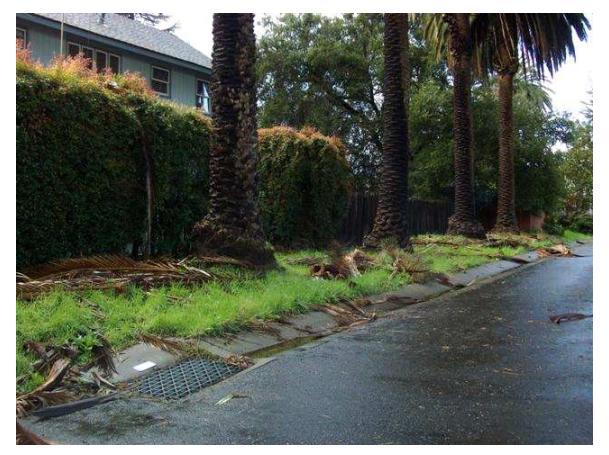
Area view showing debris from palm trees

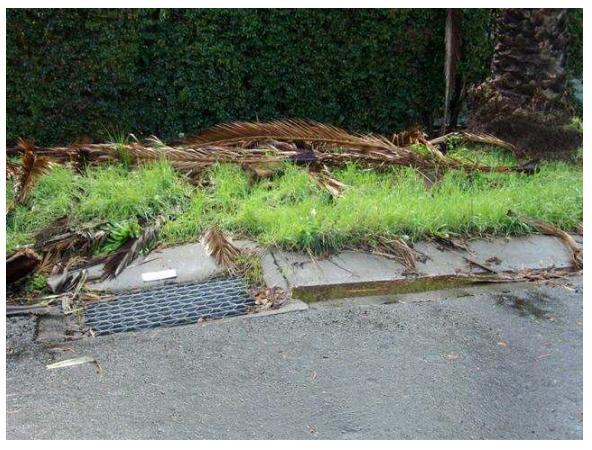
Debris from palm trees near inlet

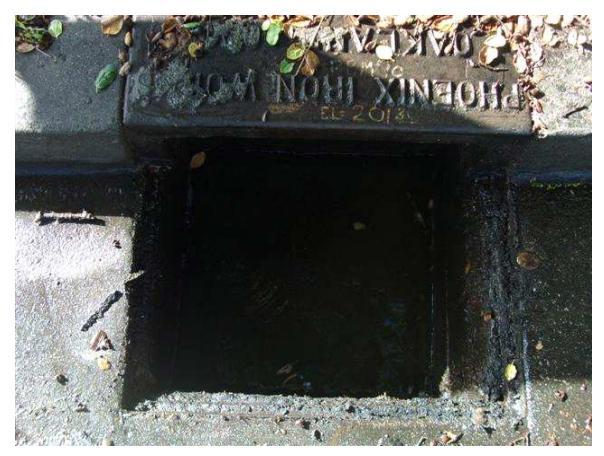
Curb inlet with grating removed

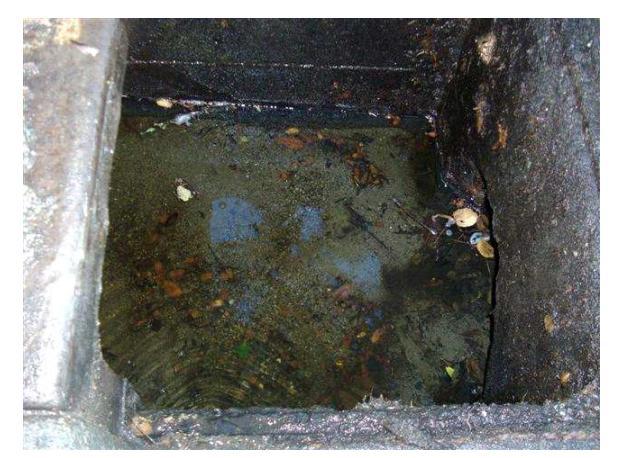
Debris in catch basin

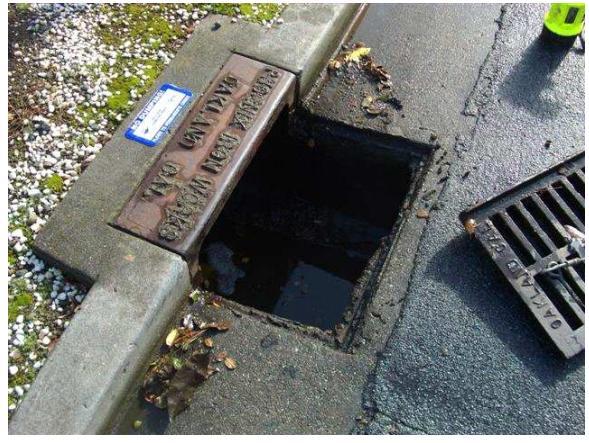
Curb inlet with grating removed

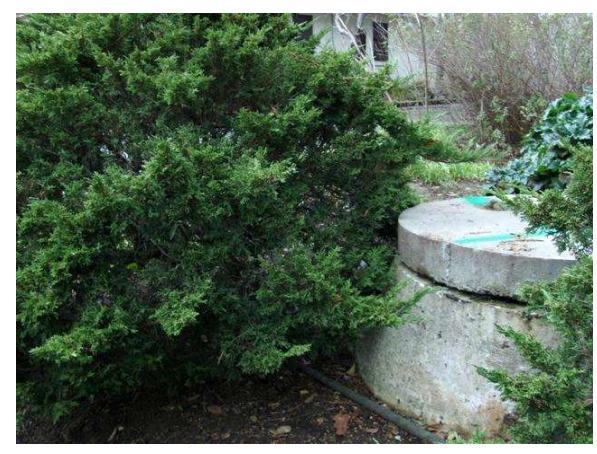
Concrete cone and cover

Replace the concrete lid with a cast iron lid.

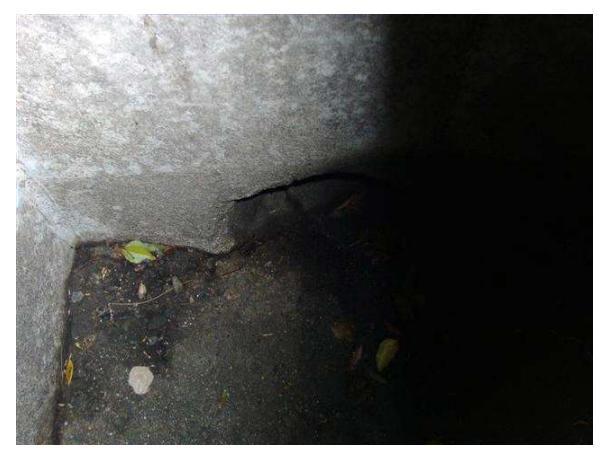
Slight debris.

Plan view showing minor debris

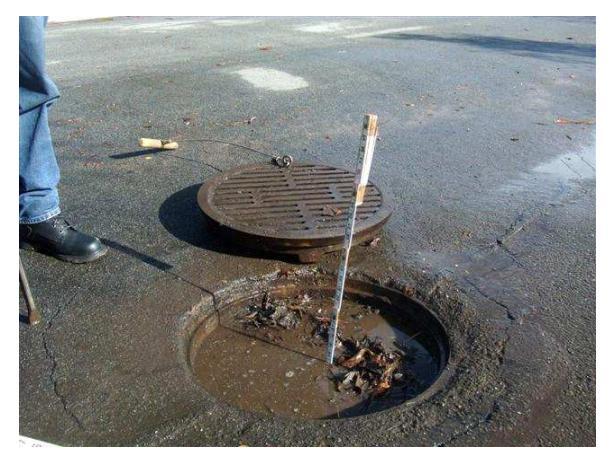
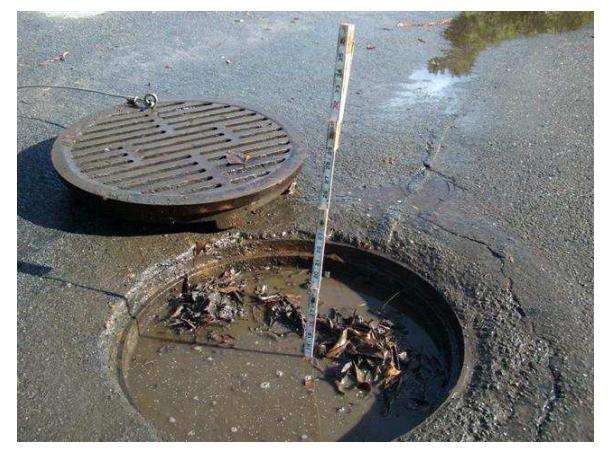
At least 18 in. of soft debris; may be abandoned.

Grating removed; structure full of soft debris to at least 18 inches

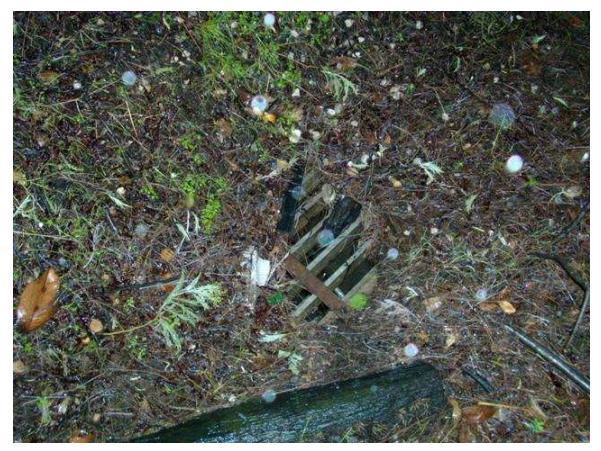
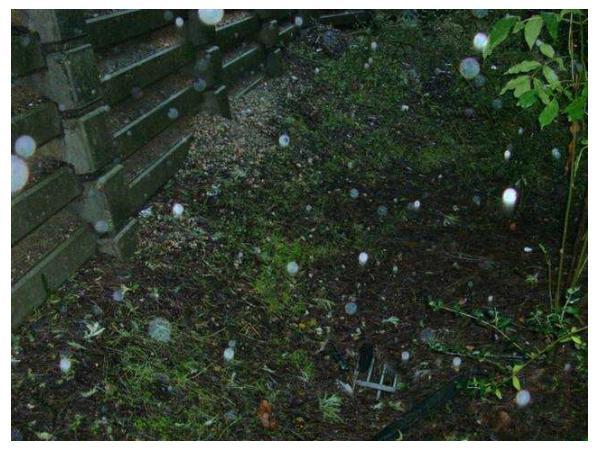
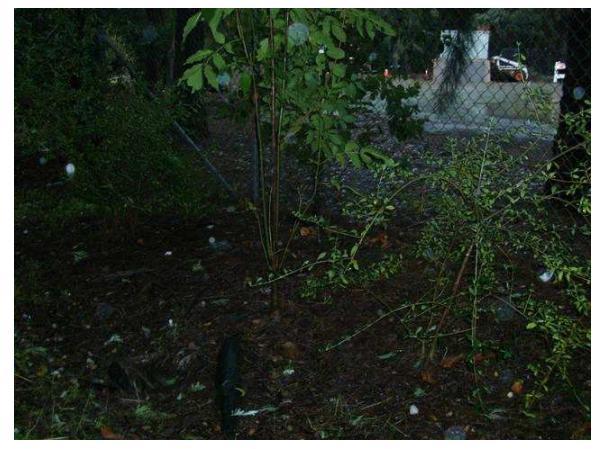
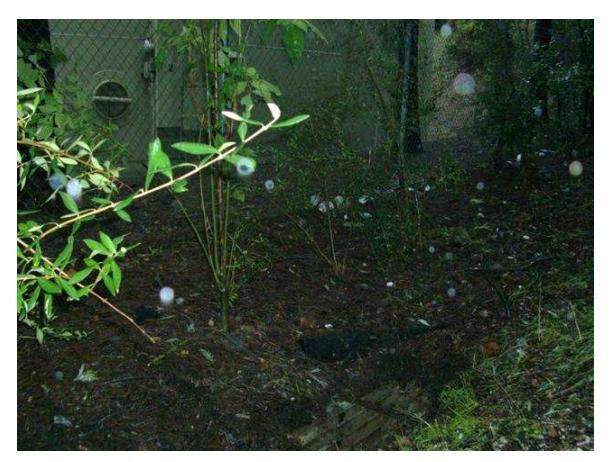
Catch basin near Interstate 280, covered with leaves

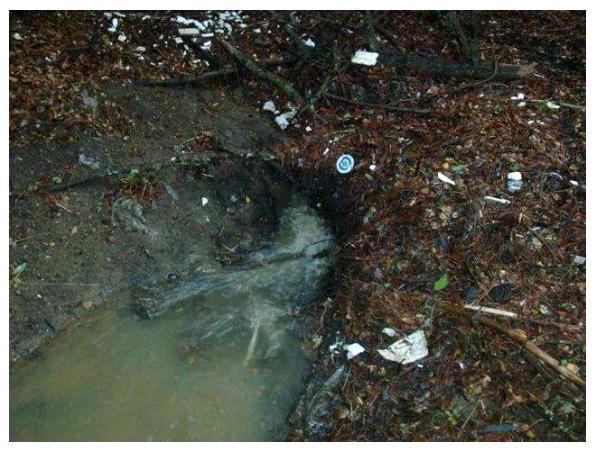
Culvert inlet along Interstate 280 susceptible to burial

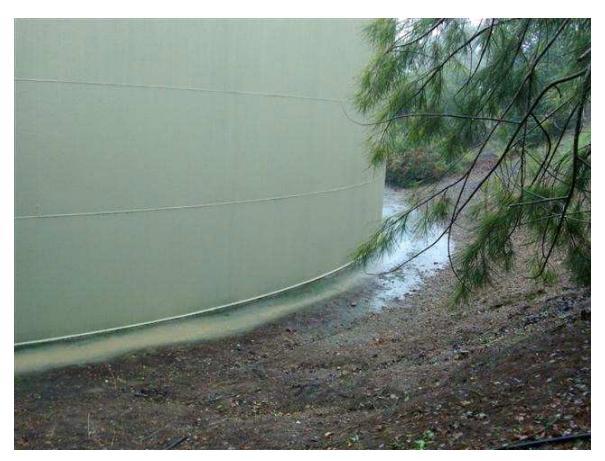
Ponding around water tanks

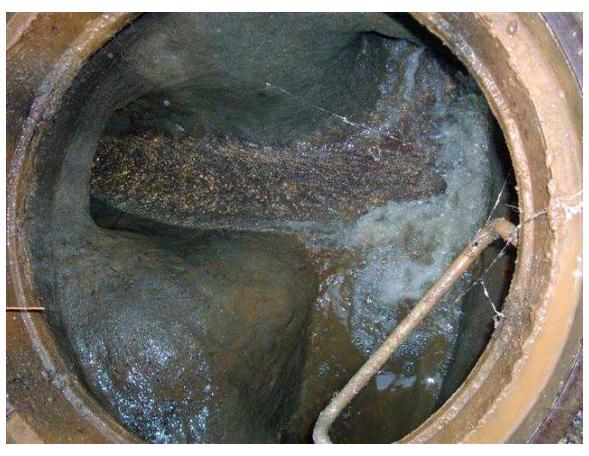
Downstream of N6D-602; high-velocity flow from steep slope splashes against wall at 90-degree bend to outlet; very turbulent.

Plan view showing turbulence

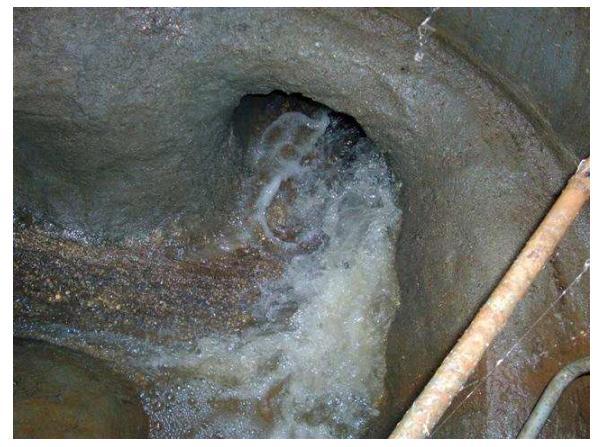
Turbulence at outlet due to abrupt change in direction

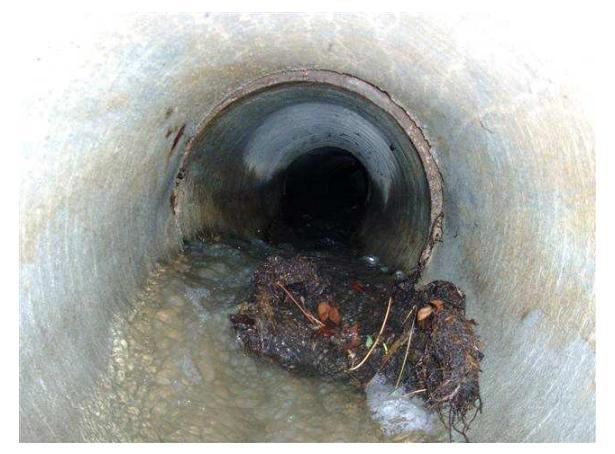
Debris in upstream pipe

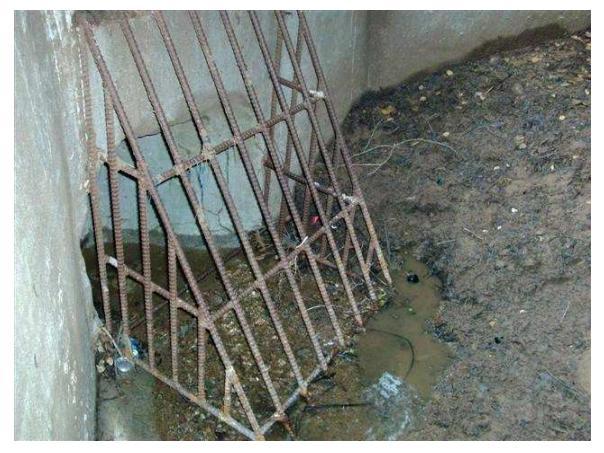
Trash rack

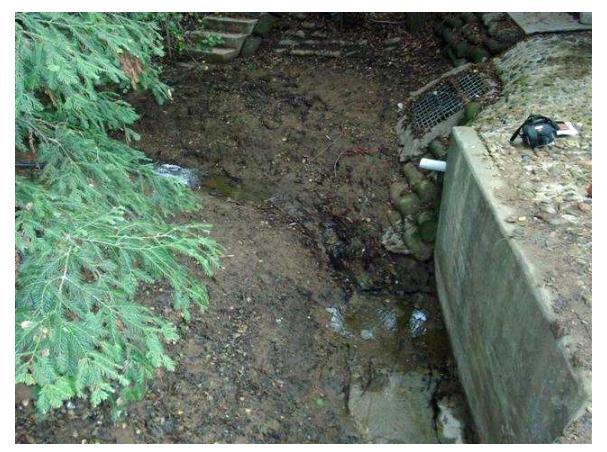
Storm inlets in backyard of 2100 Stonehaven, looking west

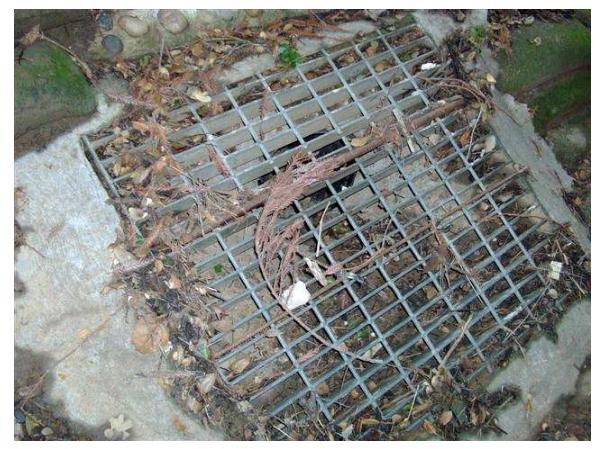
Inlet installed by homeowner

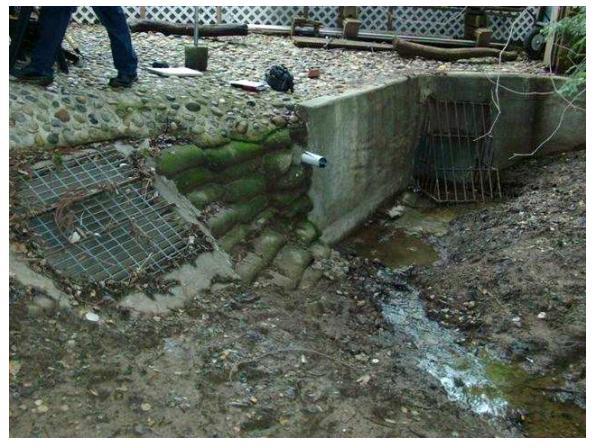
Trash rack and inlet (left) built by homeowner near existing trash rack and inlet

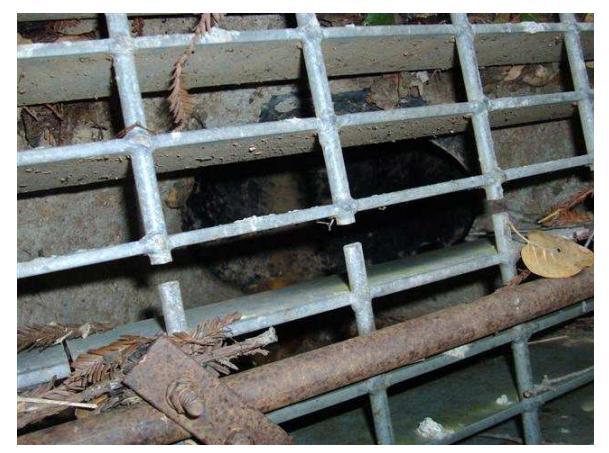
Grating over inlet installed by homeowner

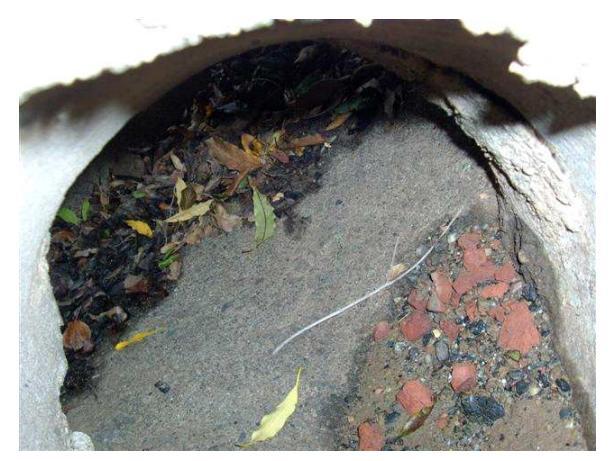
Opening between pair of catch basins

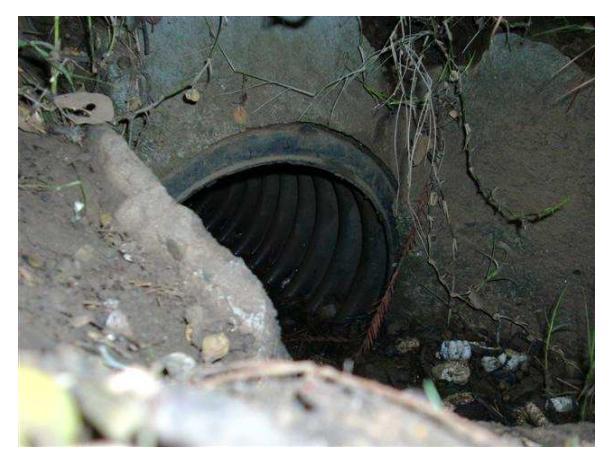
Curb inlet and grating

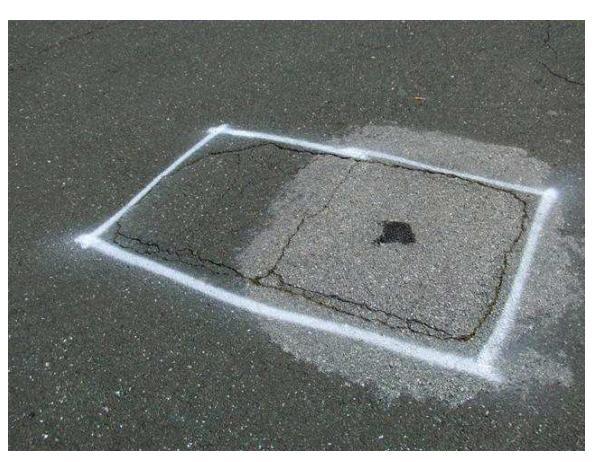
Street-level view of paved-over access hatch
