Facility Condition Assessment Services

Tier 1 Report of
Facility Condition Assessment

For
City of Los Altos
City Hall
3 N. San Antonio Road
Los Altos,
California 94022-3000

Date of Report: September 16, 2016

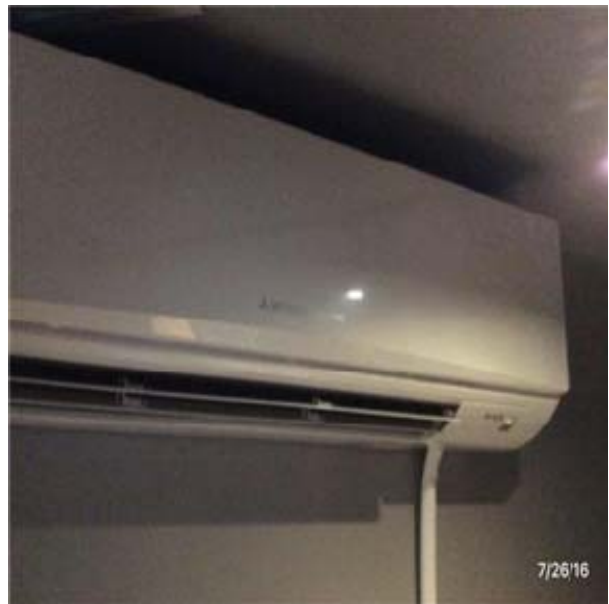
D3032 Direct Expansion Systems:- View of Split-System (Indoor Unit Only - Cooling, Heating Coils and Circulation Fan)

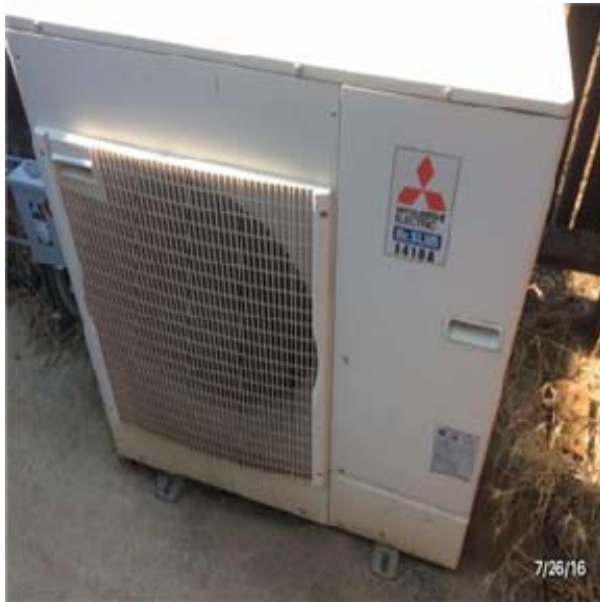
D3032 Direct Expansion Systems:- View of Split-System (Outdoor Unit Only - Compressor and Condenser)

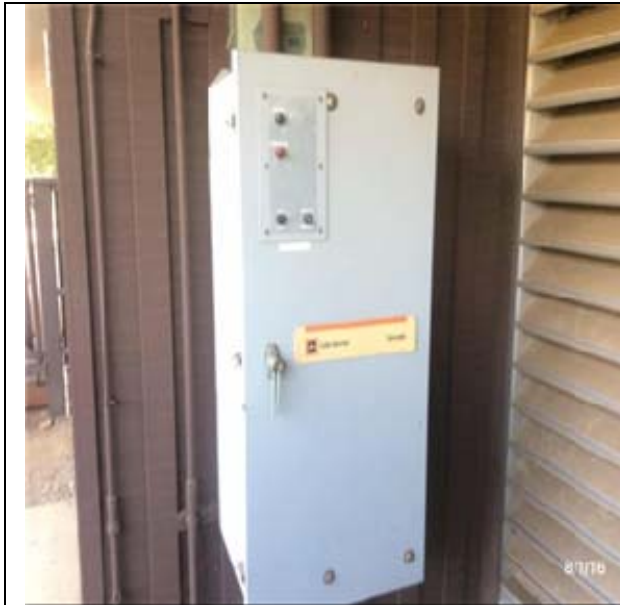
D5012 Low Tension Service & Dist:- View of Emergency Generator Transfer Switch

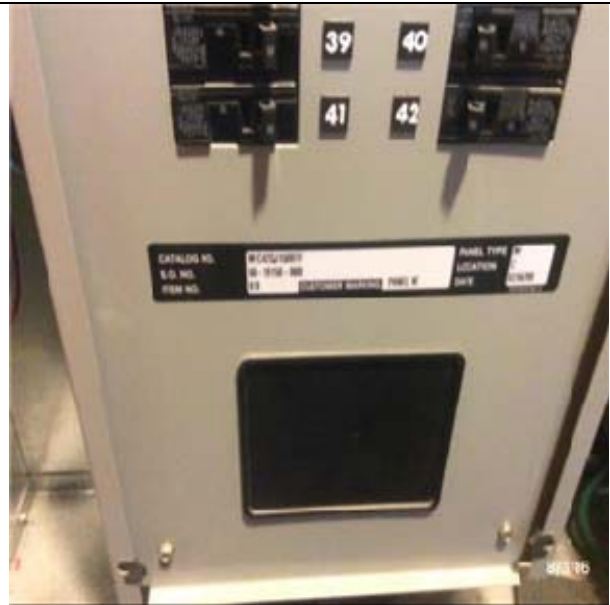
D5012 Low Tension Service & Dist:- View of Panelboard - 120/240volts, 60 to 2000amp

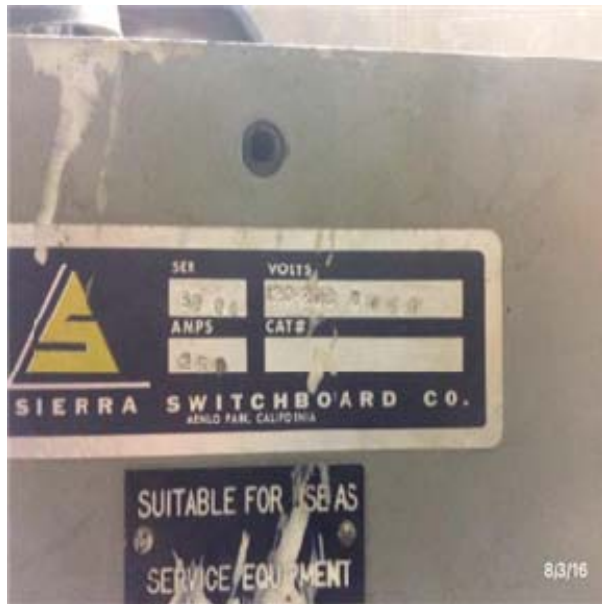
D5012 Low Tension Service & Dist:- View of Switchboard - 120/208volts, 400 to 2000amp

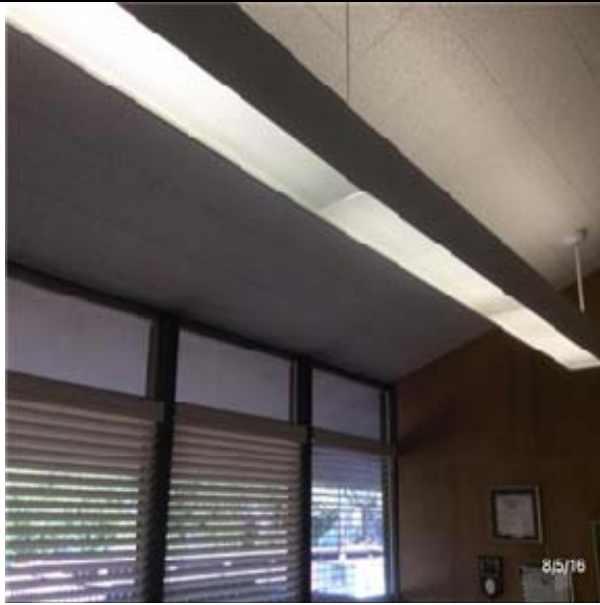
D5022 Lighting Equipment:- View of Z_LEGACY Fluorescent Strip Light Fixtures

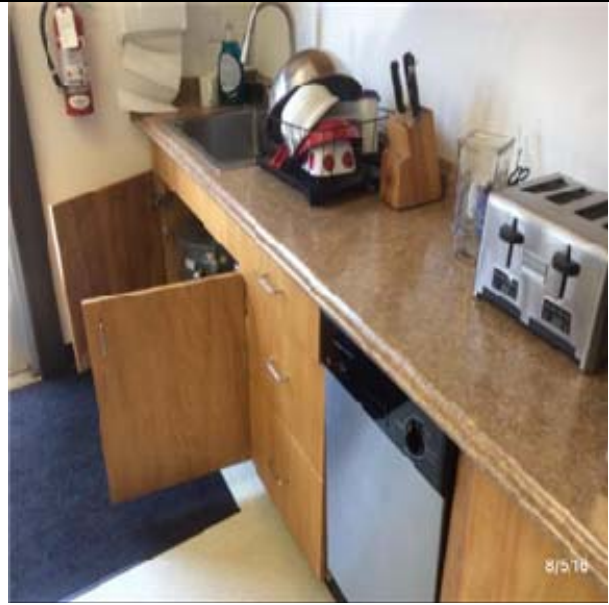
E1095 Unit Kitchens:- View of Unit Kitchens - Counter Top - Laminated

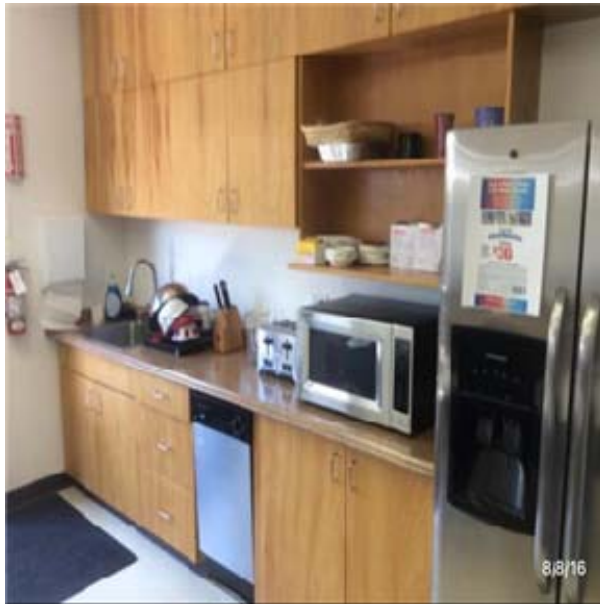
E2012 Fixed Casework:- View of Fixed Casework - Wall Mounted Cabinets - Standard

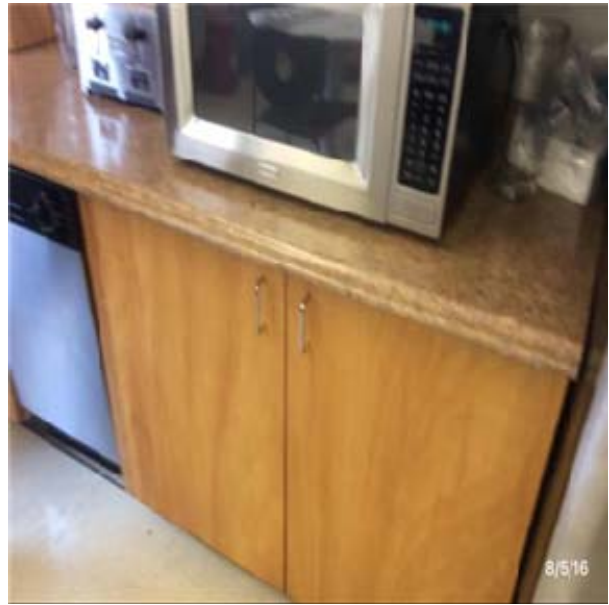
E2012 Fixed Casework:- View of Kitchen Cabinet(s) - Standard
