AGENDA REPORT

SUBJECT: Receive an update on the Halsey House Historic Structures Report, and direct staff accordingly

HISTORIC STRUCTURE REPORT - DRAFT

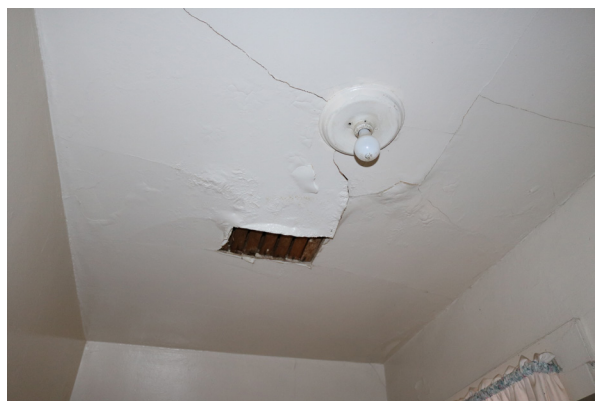
Water damage and exposed lath in East Restroom (ARG, 2019).

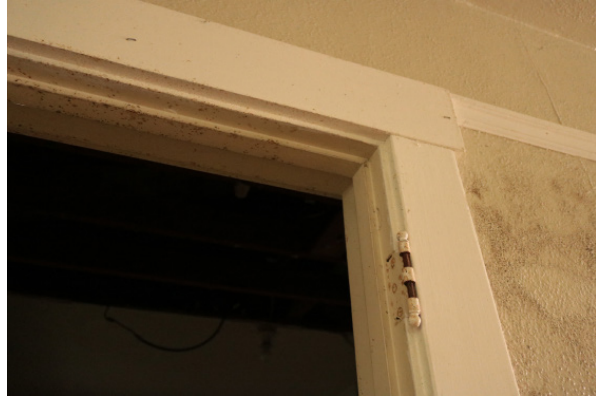
Mold along the wall and door trim at the north wall of the West Kitchen (ARG, 2019).

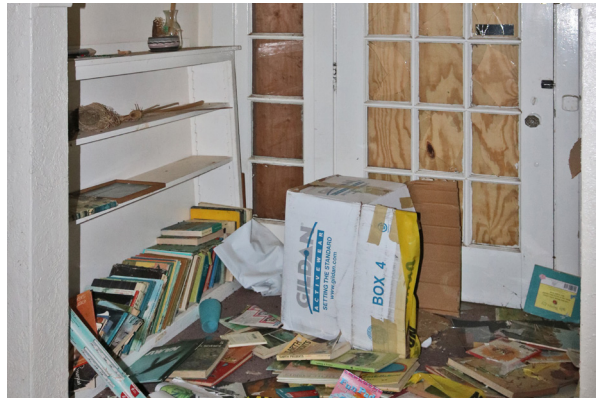
Painted wood built-in bookcase at the Book Nook (ARG, 2019).

There are two types of interior wood casework: the painted open wood shelves of the Kid's Room and the Book Nook, and the painted wood casework of the kitchens, West Restroom, and the East Hall. The painted wood shelves are in fair condition with light scuffing and paint loss present.

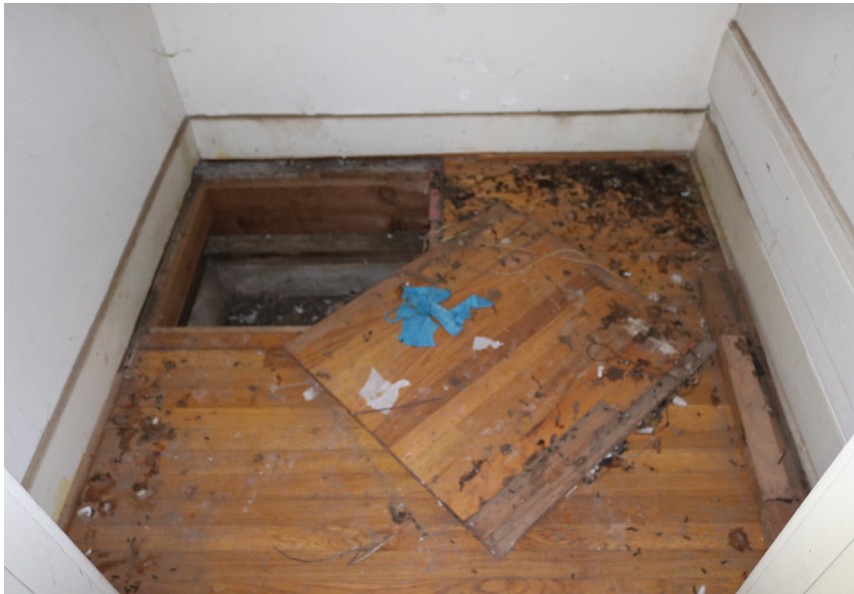
*View of access panel at floor inside
closet at south end of east wing.*

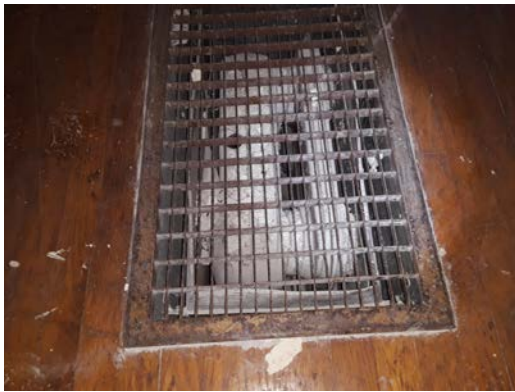
M2.1 Floor Heater

1. No cooling equipment serves building.
2. No exhaust fans found in bathrooms. Adequate operable windows are present.
3. No kitchen range observed. Range hood not required or observed.
4. Heating is accomplished by four, natural gas fired, drop-in floor heaters and two wall heaters. Single wall flues serving floor units are routed in crawl space to flue stacks located on exterior wall and terminating above roof eave. All furnace units are old and in poor condition. Exhibit M2.1, M2.2

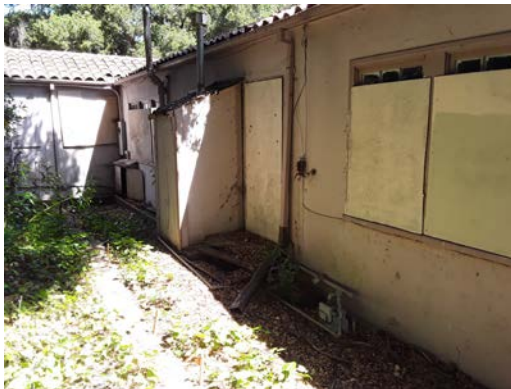
3. Natural gas piping is galvanized.
4. Domestic water heater - gas fired tank type and located in exterior utility closet in poor condition. Gas branch serving WH is routed on top of soil from branch near meter, is not per California Plumbing Code (CPC) and appears to be a hazard. Exhibit P2

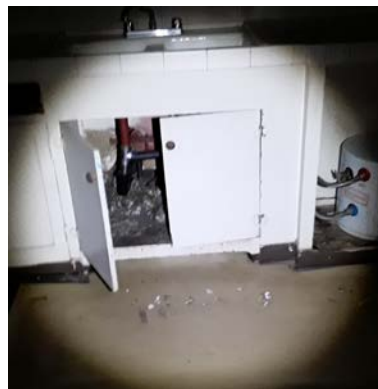
5. Kitchen - sink, faucet and piping is in poor condition and served by a small tank type electric water heater. Exhibit P3
6. Utility room - sink and piping is in poor condition. Water pipe utility hook up is close to ungrounded non-GFCI electrical outlet appears to be a hazard. Exhibit P4.1

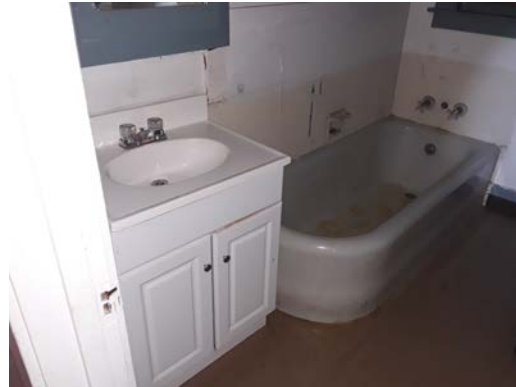
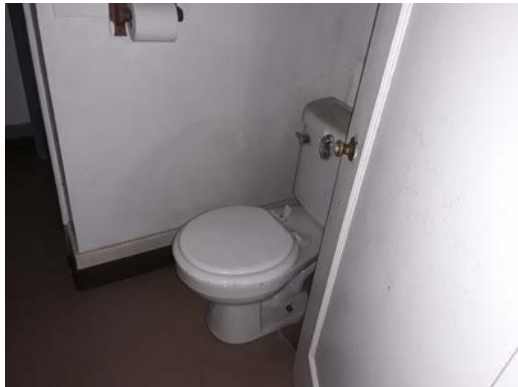
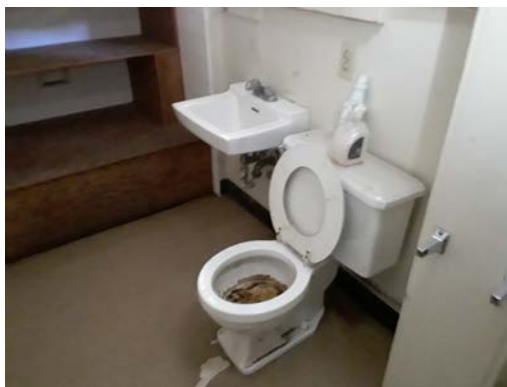
7. West wing bathroom - tub and valving is in poor condition. Non-ADA, non-low flow water closet and lavatory is in fair condition. Shower stall water valves are old and not pressure temperature compensating. Exhibit P5.1, 5.2, 5.3
